THE KFARNABRAKH LANDSLIDE OF NOVEMBER 30TH, 2015: A Geological and Geotechnical Evaluation of the Landslide and Risk of Future Failures

**THE KFARNABRAKH LANDSLIDE OF NOVEMBER 30TH, 2015:
*A Geological and Geotechnical Evaluation of the Landslide
and Risk of Future Failures***

Report of the NSF Sponsored GEER Association Team

GEER Association Report No. GEER-047

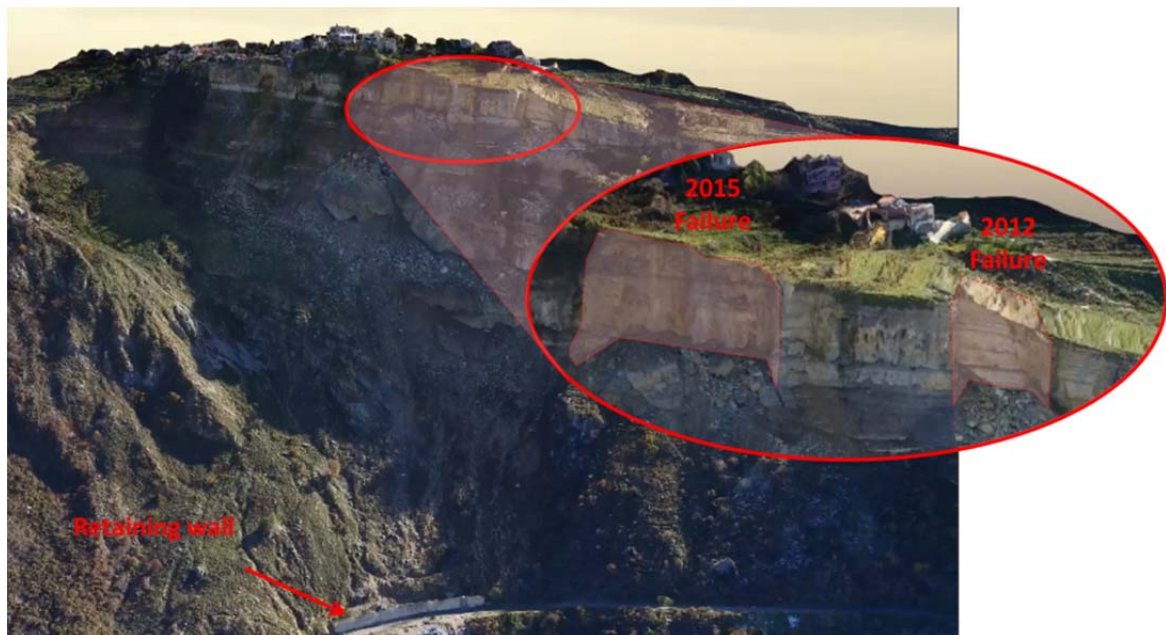
Figure 3: Location of the 2012 and 2015 landslides (Picture generated form Point cloud 3D representation)

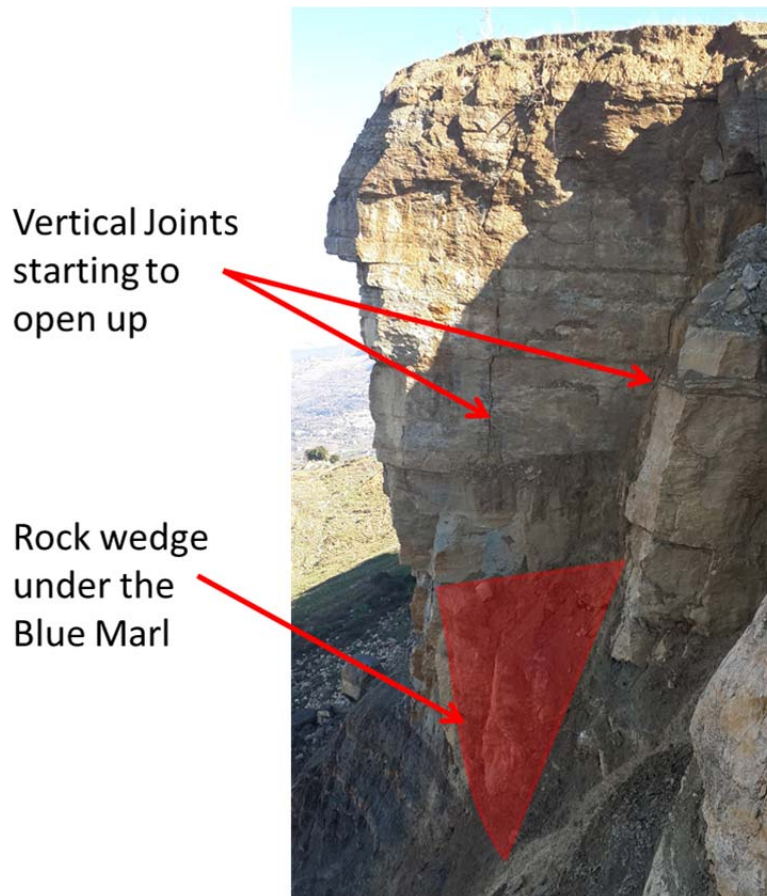
separation between the block and surrounding rock. This behavior was evident during the site visit when looking at the cliff sides as can be seen in Figure 14. The surface crack shown in Appendix Figure A-4 is located on ground surface right above the vertical corner joint shown below. As a result of these cracks, water flow through the joints is cutoff and the grass on the surface exhibits a change in color from green to yellow. This can be seen by observing images taken from Google Earth at dates prior to the 2015 failure (Figure 15). Notice the change in the grass color.

Figure 14: Side view of the cliff showing the highly jointed rock mass with some vertical joints starting to open up (Picture taken at 33°42'00"N 35°37'38"E)

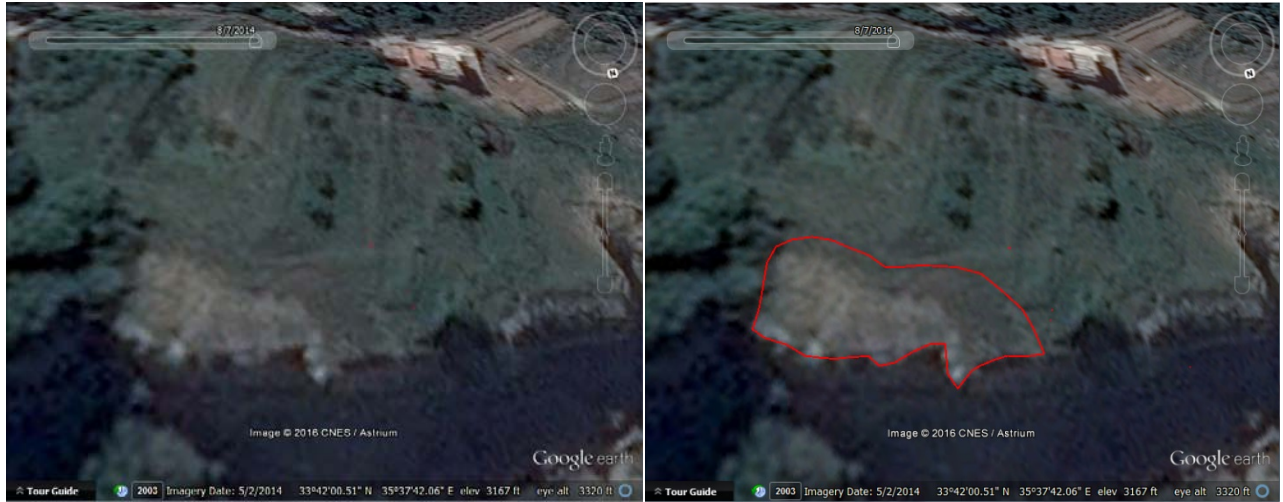
Figure 15: Change in color of grass as joints open and cut water supply prior to failing in August 2014- Red line presents 2015 failure zone (pictures from Google Earth Pro)

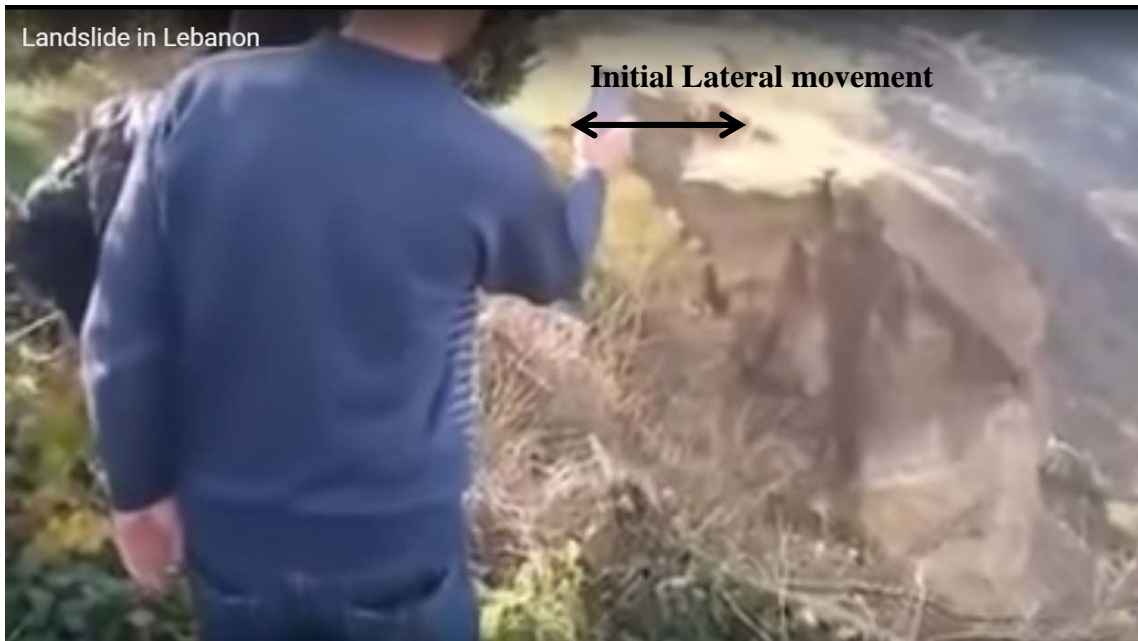
As the joints open, the water starts flowing down the joints (rather than across it) in addition to allowing more surface water to seep into the ground since the joint expansion is usually accompanied by cracks in the top soil extending to the surface. The water seeping through the vertical joints can now reach the Blue Marl layer (a high plasticity-low friction strata) causing its top portion to get saturated. The saturated Blue Marl, like all high plasticity clays, loses significant portion of its unsaturated strength once it gets saturated which creates a layer acting almost like a lubricant underneath the already mobilized rock mass, and thus facilitating its horizontal slippage (Figure 13-C). The horizontal slippage during the early stage of the rock mass failure can be seen during the video recordings (Figure 16). This theory can also help

Figure 16: Snapshot from video of landslide showing a lateral displacement of the rock mass with a gap created between it and the stable ground

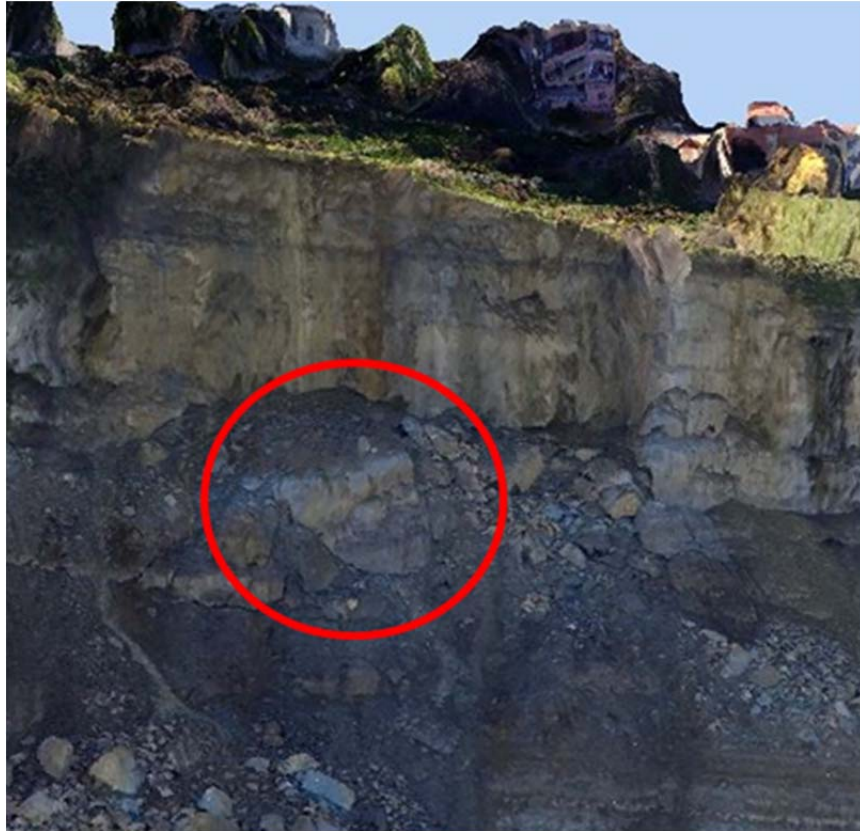
earlier link starting at the 1:11 mark. This failure results in the wedge sliding down the slope after tensile cracks develop on along the backside. The rock wedge can be seen in the images of the site as shown in Figure 17.

Figure 17: Wedge previously supporting the Blue Marl (Picture generated form Point cloud 3D representation)

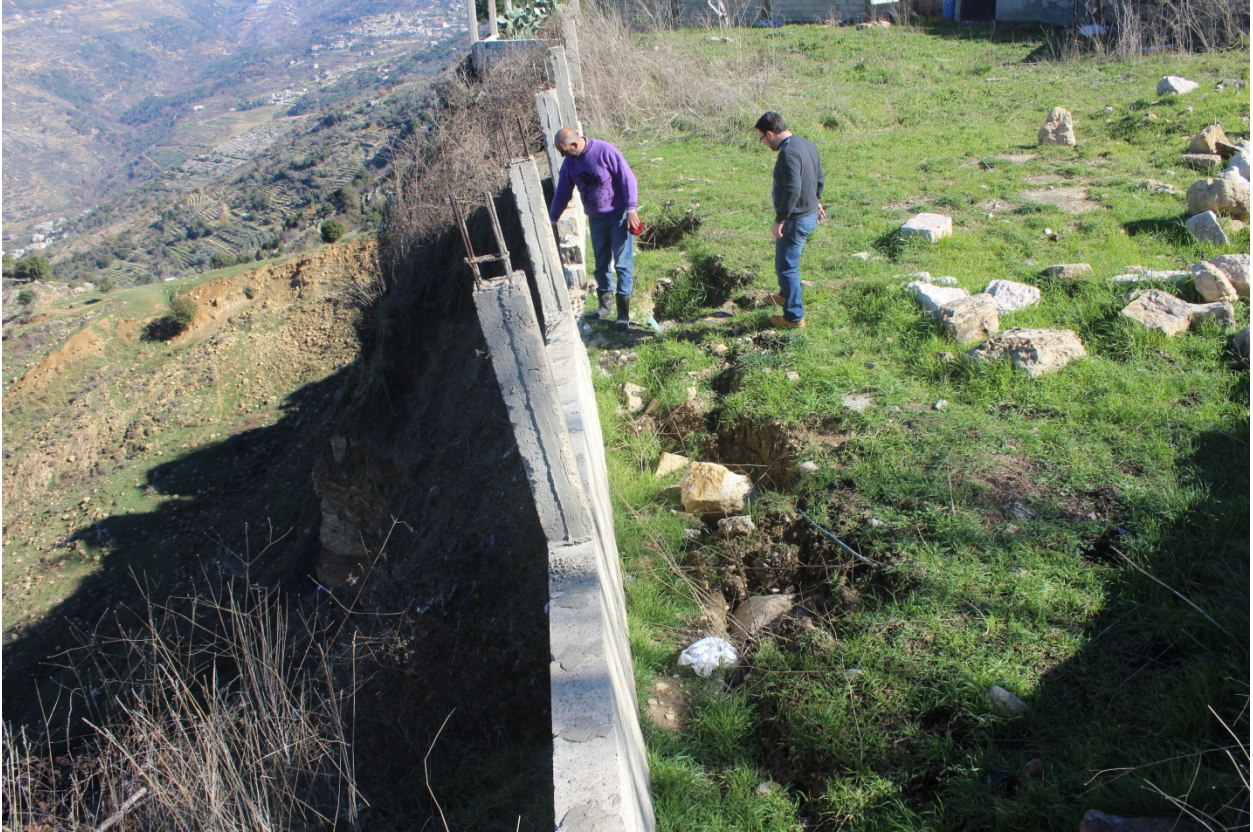
Figure A.6: Damage to backyard fence after 2015 landslide
