Landslide Hazard and Risk Level Assessment of  
Quarried Slopes in Lebanon using Drone Imagery

A thesis

for the degree of Master of Science in Civil and Environmental Engineering

August 2020

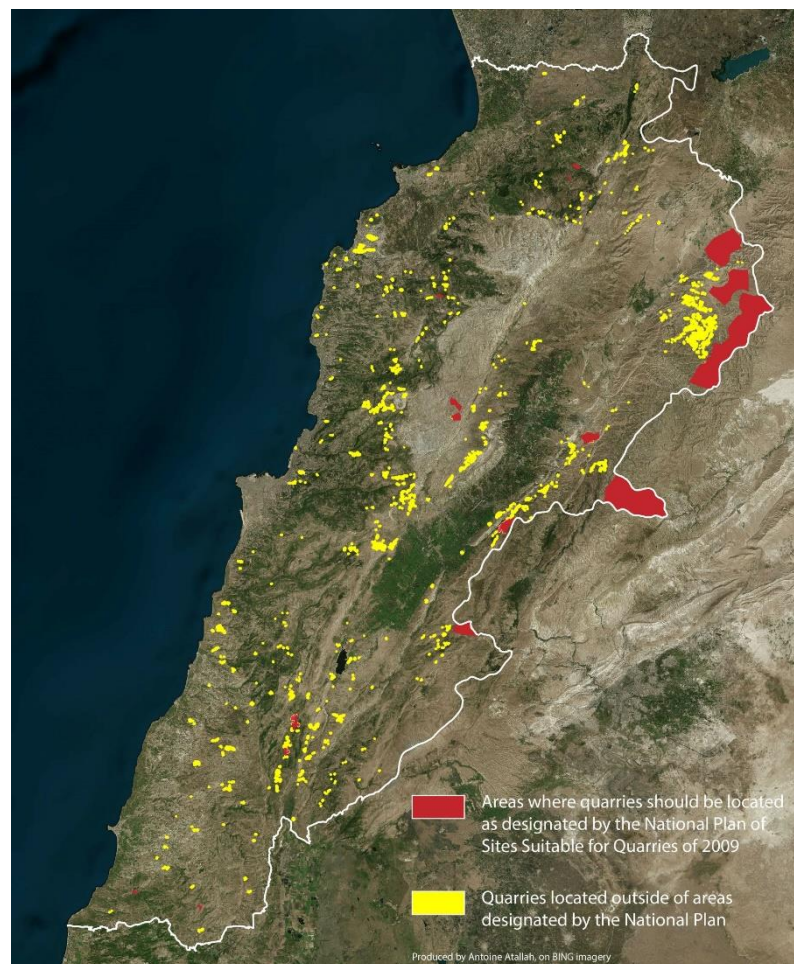
*Figure 1: Areas where quarries should be located vs actual quarries' location*

In a trial to regulate and organize quarrying activities in the country, a national plan designating sites suitable for quarrying activities was produced in 2009. The map proposed unpopulated areas where the damages on the surrounding environment are minimal as suitable mining locations. Nevertheless, open-pit mining continued outside the specified areas (Fig. 1), and in the last two decades, unsupervised quarrying activities have even extended to urban areas, provoking localized landslides, destabilizing buildings and threatening a total of 20,000 apartments by unstable slopes beneath (Fig. 2a and Fig. 2b) (Darwish et al., 2010). The proximity of quarries to urban

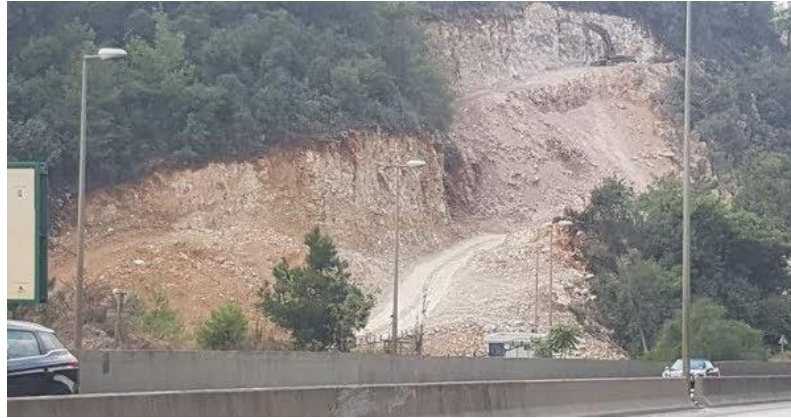
*Figure 4: Quarry in Roumie, Maten area*

The operations at four neighbor quarries in the region of Roumie, Maten, along with heavy rainfall triggered rock fall, and the failing rock mass reached a nearby local road according to El-Nashra news (Fig. 3).

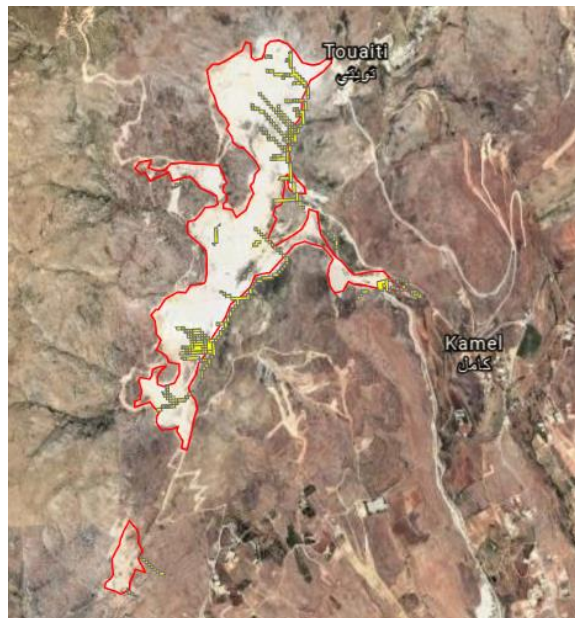
*Figure 7: Earthquake landslide hazard predicted by the regional scale map in Touaiti*

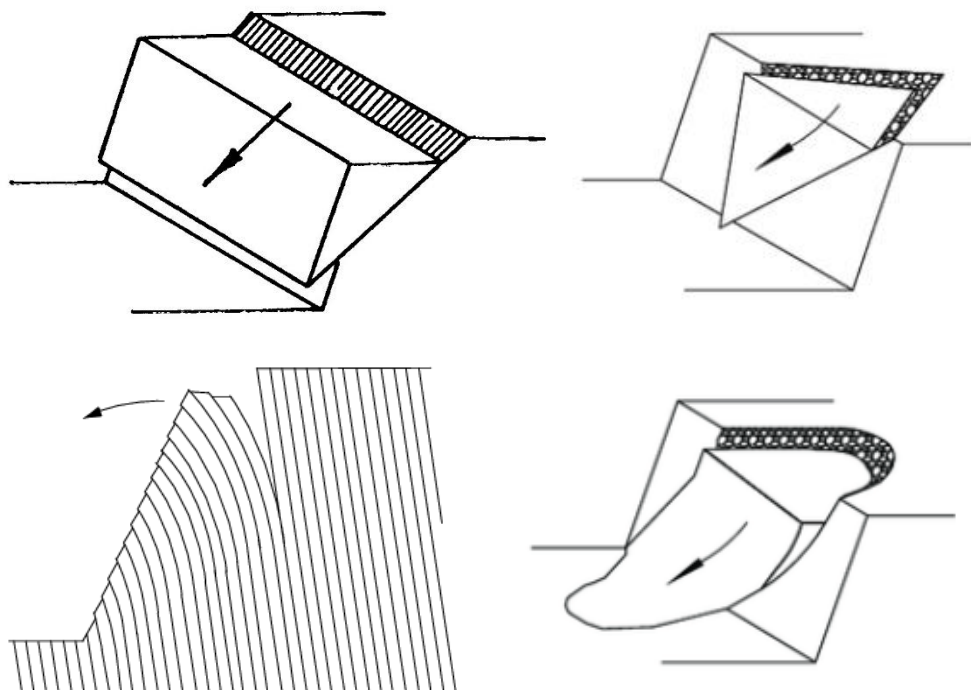
Figure 8: (a) Planar sliding (b) wedge sliding (c) toppling failure (d) circular failure

These discontinuities make the slope susceptible to four modes of failure: planar sliding, wedge sliding, toppling failures and circular failures. Planar sliding is usually governed by one discontinuity surface that is daylighting the slope face, and along which sliding occurs (Fig. 8a). Wedge sliding however, is defined by two intersecting joints having their line of intersection daylighting the slope, usually due to excavation activities and hence is considered a particular case from planar sliding. In this mode of failure, sliding occurs either on the line of intersection, or along the steeper of the two discontinuity planes in the direction of maximum dip (Fig. 8b). In toppling failure, rock slabs or columns (depending on their dimensions) dipping into the slope face usually rotate about a fixed point at their bases with slippage occurring simultaneously between the rock layers (Fig. 8c). For circular failures to occur, the intact rock material has to be very weak or the rock mass as a whole has to be extremely fractured. This type of failure is not controlled by structural discontinuities, and progresses following a circular arc at the base (Fig. 8d) (Norrish and Wyllie, 1996).

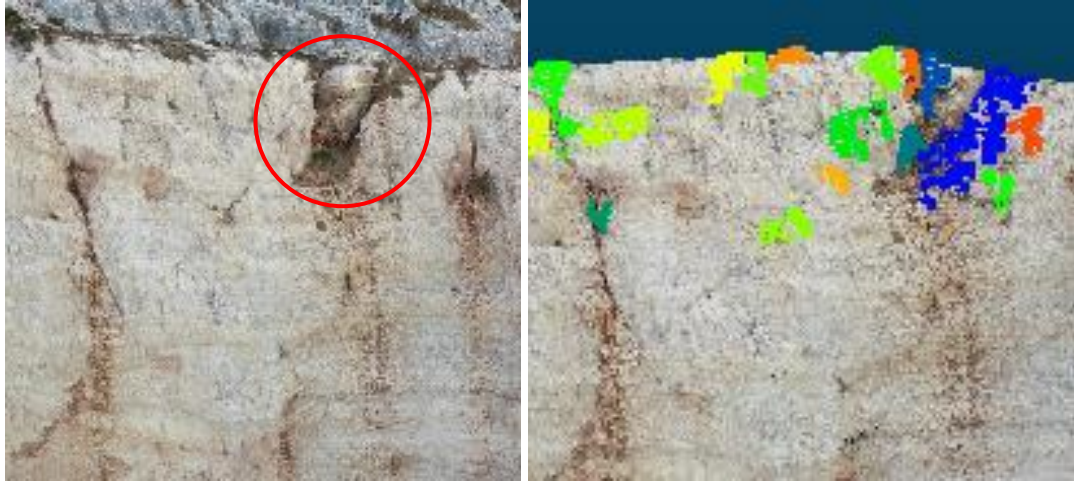
Figure 14: Joints successfully detected using DSE and viewed in CloudCompare

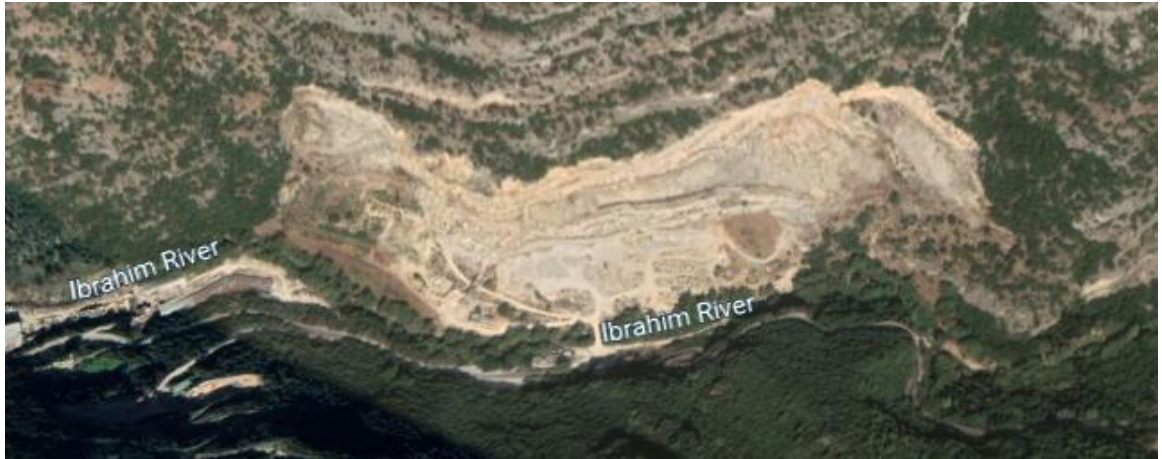
Figure 18: Google Earth image of the quarried slope detected in Halate, Jbeil

seismic events, similar to the Bafliyeh slope. A Google Earth image of the selected site is presented in Fig. 18. The factors of safety obtained in the site specific analysis were compared with the regional scale assessment of the Halate slope, as well as the reach angles and sliding block weights.

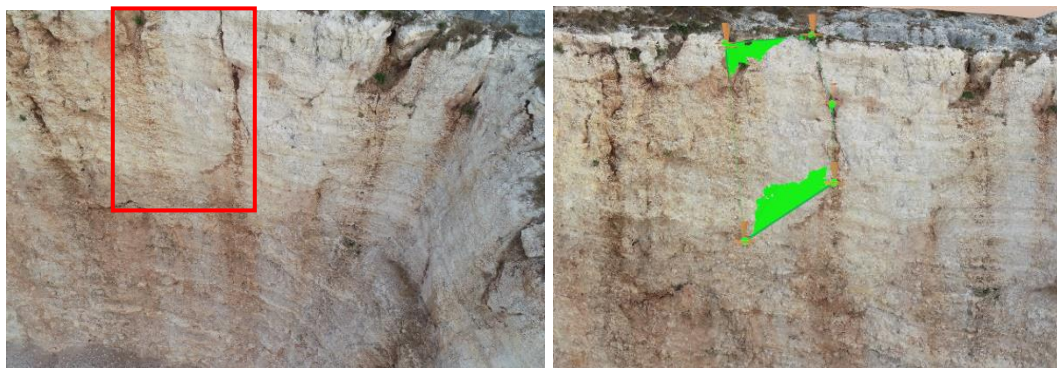
*Figure 21: (a) Rectangular block detected in joint set 10 (b) Area delineated for calculation in CloudCompare*

Joint sets 7 and 10 fall in the critical region of flexural toppling (closed zone formed by the slip limit and lateral limits). Both joint sets are nearly vertical (dip of  $90^{\circ}$ ) (Fig. 22b), which explains their susceptibility to fail by flexural toppling. By inspecting the 3D model (Fig. 11), joint set 7 is composed of vertical short discontinuities that are a result of excavation activities and are focused on the lower part of the slope. These discontinuities are not persistent into the slope face and thus there are no back to back formed rock columns that would cause flexural toppling failure by rotating around the base. Joint set 10 (Fig. 21a) has a massive block that can topple at the top of the slope, but the left joints of the block are not developed enough to cause the block to detach from the slope face and fail by toppling. In addition, the area of the block face was calculated in CloudCompare (Fig. 21b) and was determined to be 207.38 m<sup>2</sup>, which results in a weight of approximately 4769.74 kN using the unit weight of limestone (23 kN/m<sup>3</sup>), and by assuming a 1 meter depth into the slope face. The block weight is a large force acting downwards, and thus it will act against external applied loads, enforcing again the very low probability of this scenario occurring. On the other hand, the right and base discontinuities of the block that are extending to the upper surface have a higher tendency to fail in a wedge sliding mode given that they are more developed and fractured. Therefore, this mode will not be analyzed further, as it is unlikely to occur on the slope face.

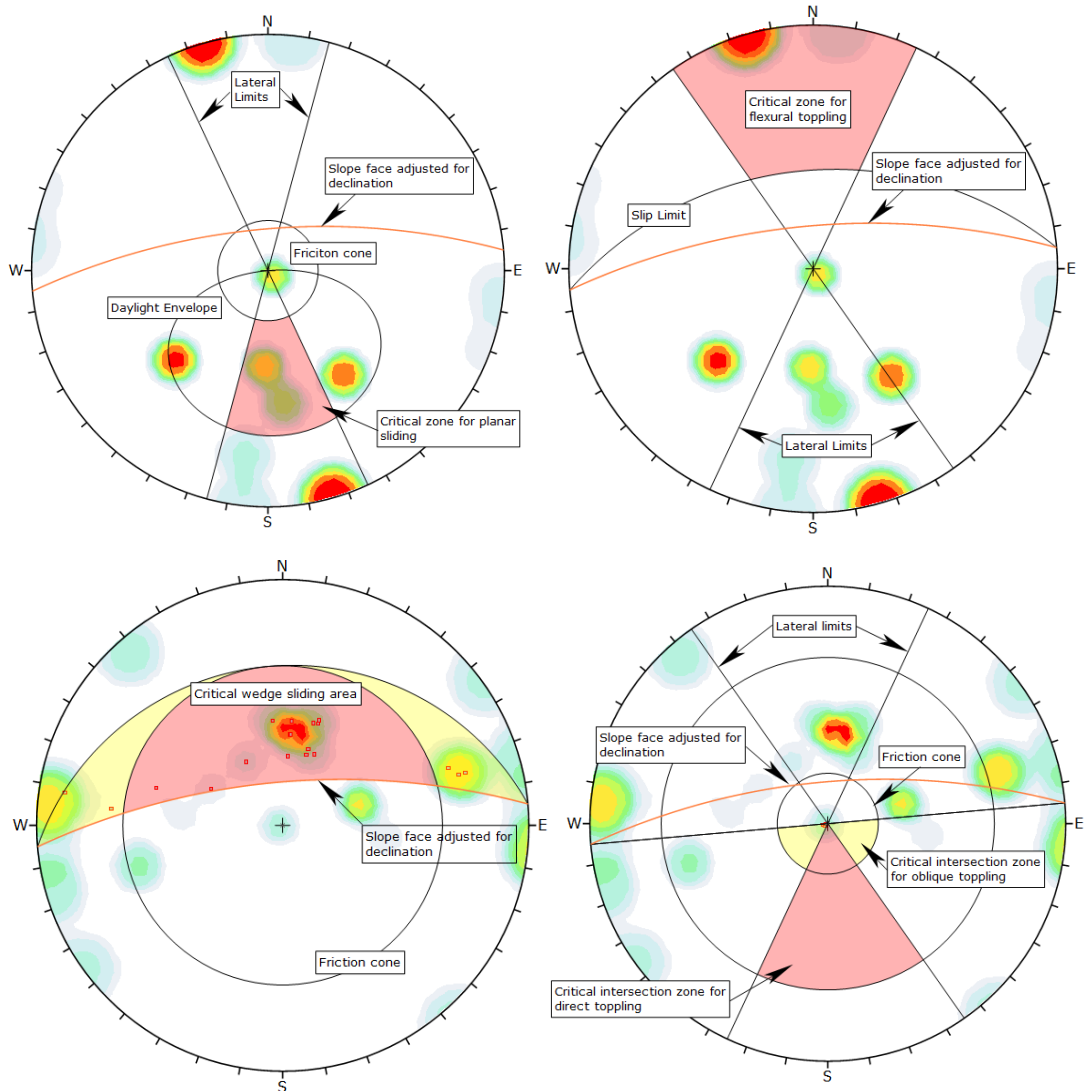
Figure 22: Kinematic analysis (a) Planar sliding (b) Flexural toppling (c) Wedge sliding (d) Direct and oblique toppling

The analysis of direct and oblique toppling resulted in no chance of direct toppling for intersecting joints and a 4.89% probability of oblique toppling which is considered very low and thus this mode of failure is not analyzed further (Fig. 22d).

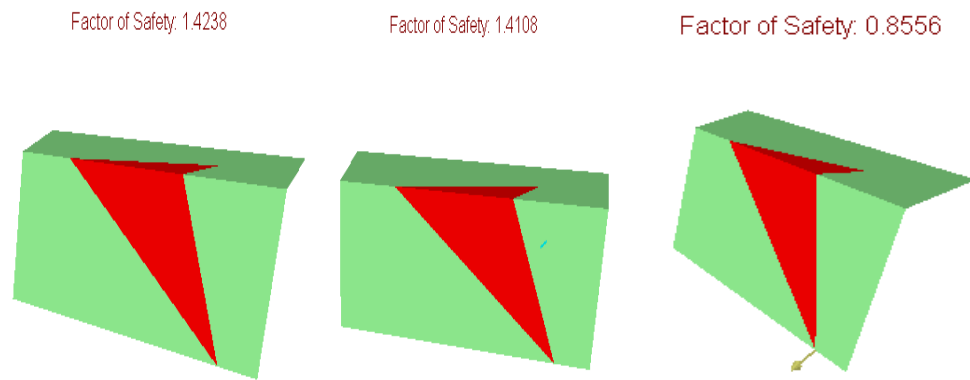
Figure 23: Factor of safety of the wedge formed by JS 5 and JS 3 (a) Dry conditions (b) Wet conditions (c) Seismic loading

From SWEDGE analysis for intersection of joints 3 and 5, the sliding of the block is expected to occur in all three scenarios on joint 5, as it is the more exposed joint with the easiest and steepest path for the wedge to follow in case of failure.

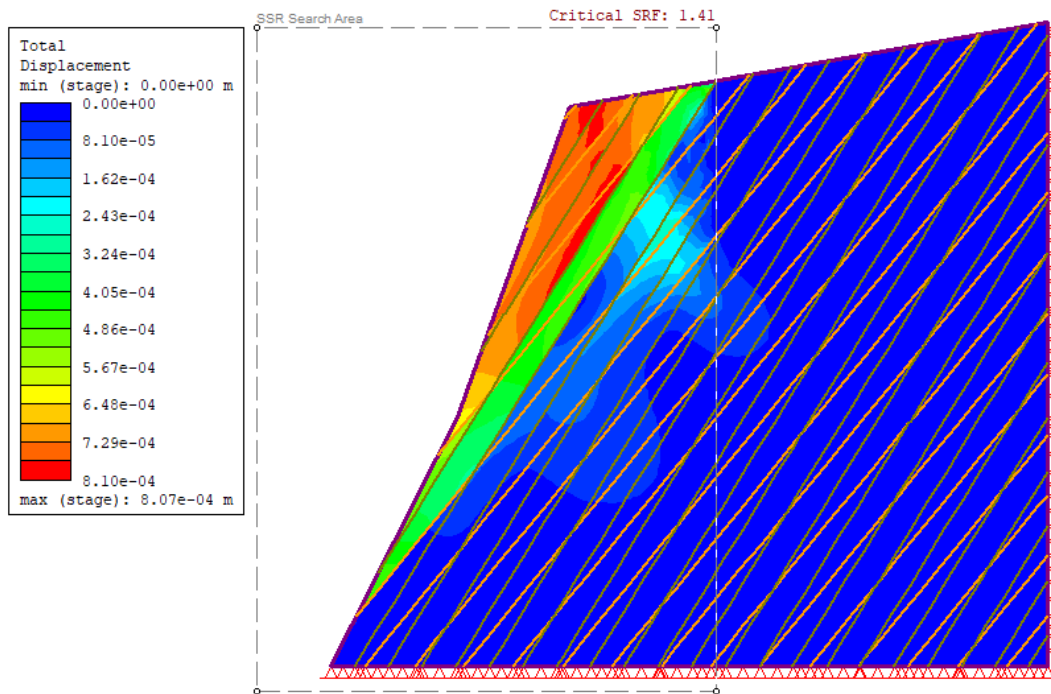
Figure 25: Slope elevation with joint sets 3 and 5 under dry conditions in RS2

This discrepancy is expected because of the limitations of LEM previously described in Chapter 2. In addition, in FEM in RS2, the user has more control over joints properties such that persistence, length and spacing, that can be used as input. This is not an available option in SWEDGE, where the user can only use the dip and dip direction as input, and the software assumes the persistence and length, which might not be representative of the actual measurements made on the slope face. In RS2, the intact rock mass is modelled using a different shear strength model than the joints (Generalized Hoek-Brown for intact rock and Barton-Bandis for joints), while in SWEDGE, a shear strength model is only used for joints, and thus RS2 better simulates the case at hand and better represents the real-life scenario. Nevertheless, these factors of safety present simply an indication of stability rather than confirmation. No model is totally accurate without field observation and validation.

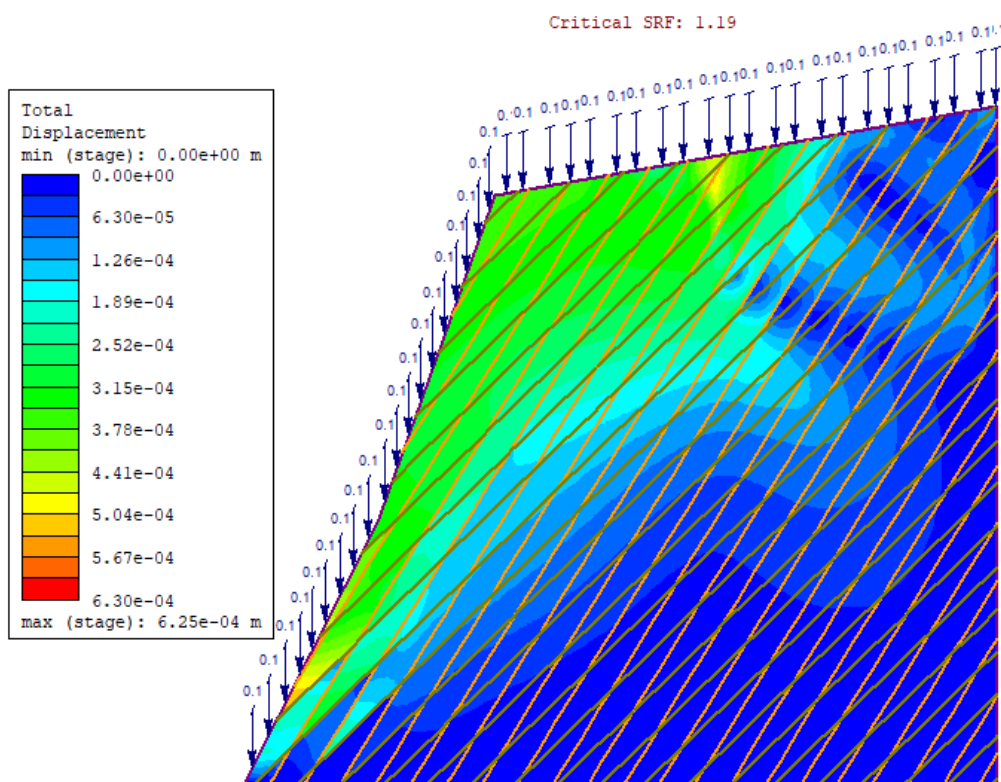
Figure 26: Slope elevation with joint sets 4 and 5 under wet conditions in RS2

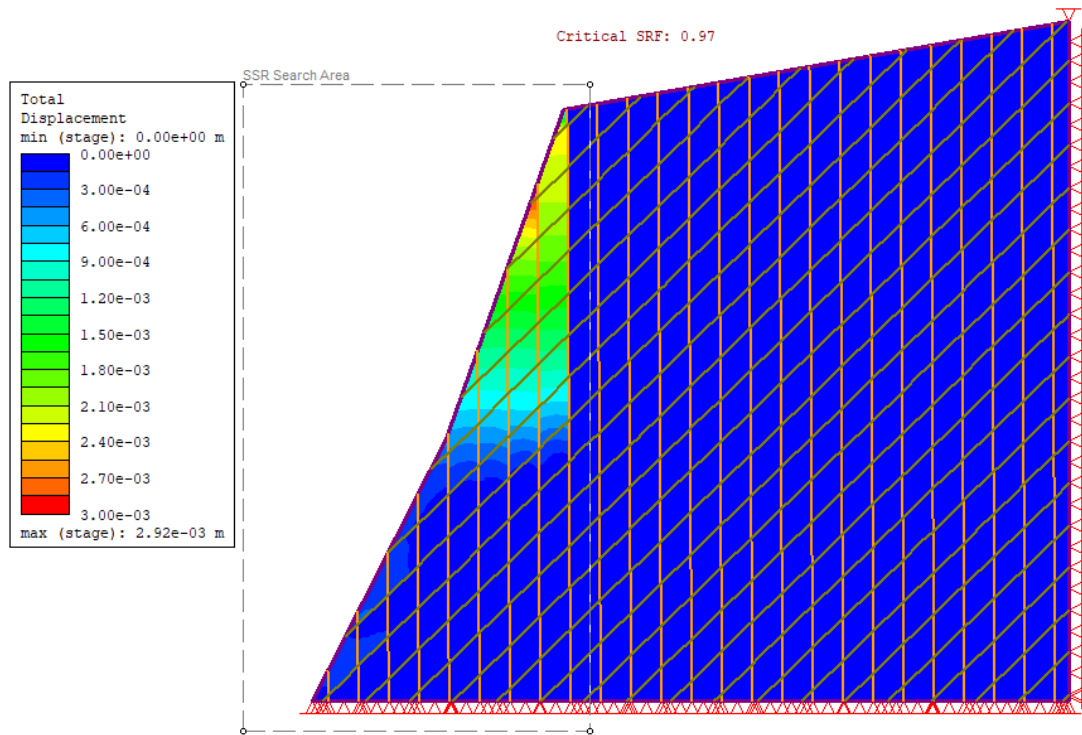
Figure 27: Slope elevation with joint sets 10 and 4 under static seismic loading in RS2

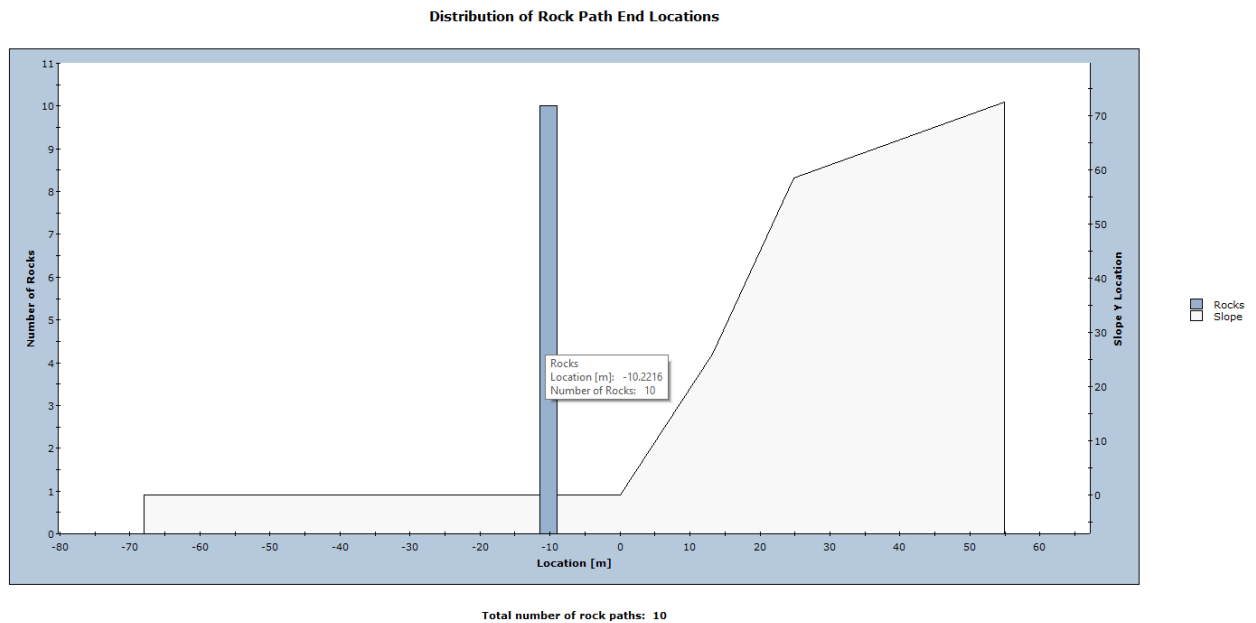
Figure 28: End location of wedge formed by joint sets 2 and 5 in case of failure as taken from RocFall

<b>Joint Set Intersections</b>	<b>Weight (MN)</b>	<b>Runout distance (m)</b>	<b>Angle of Reach (°)</b>
<b>JS 5 and JS 6</b>	2.78	5.30	84.82
<b>JS 2 and JS 3</b>	99.39	12.68	77.77
<b>JS 5 and JS 3</b>	12.66	7.76	82.44
<b>JS 2 and JS 4</b>	0.64	5.30	84.82
<b>JS 8 and JS 4</b>	0.66	5.30	84.82
<b>JS 3 and JS 4</b>	0.67	5.30	84.82
<b>JS 9 and JS 4</b>	0.65	5.30	84.82
<b>JS 9 and JS 3</b>	52.74	12.68	77.77
<b>JS 2 and JS 8</b>	46.10	10.22	80.09
<b>JS 3 and JS 8</b>	53.33	12.68	77.77
<b>JS 2 and JS 9</b>	32.02	10.22	80.09
<b>JS 8 and JS 5</b>	22.82	7.76	82.44
<b>JS 9 and JS 5</b>	26.24	10.22	80.09
<b>JS 2 and JS 5</b>	30.24	10.22	80.09
<b>JS 6 and JS 4</b>	0.33	7.76	82.44
<b>JS 5 and JS 4</b>	0.63	7.76	82.44
<b>JS 10 and JS 4</b>	0.53	7.76	82.44
<b>JS 10 and JS 5</b>	4.79	7.76	82.44

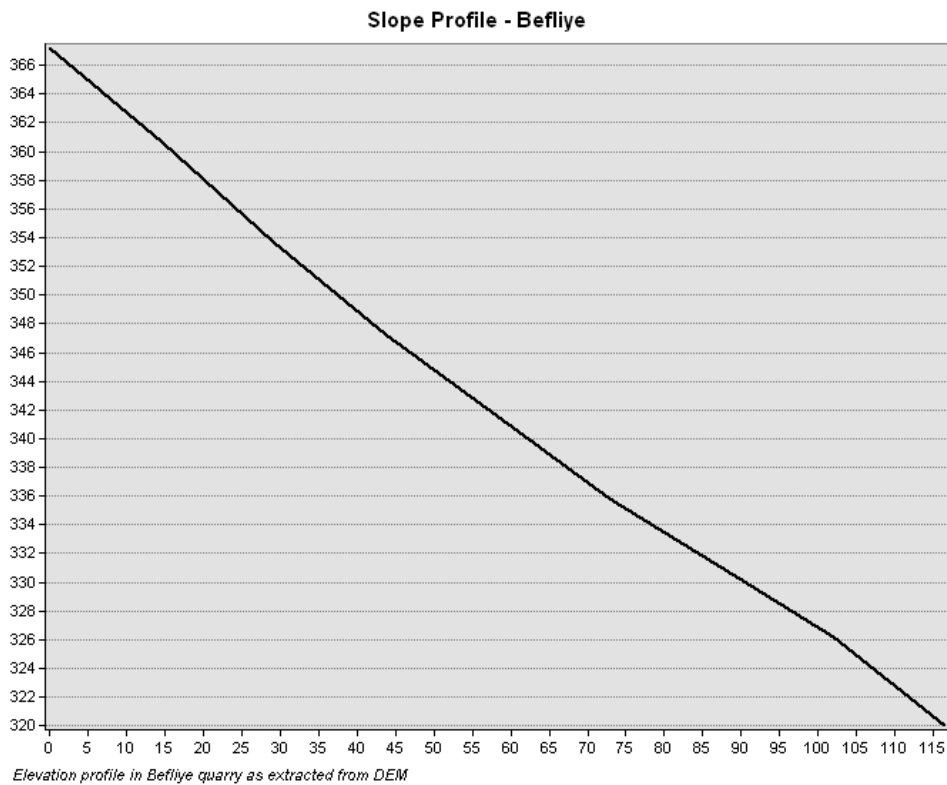
Figure 29: Slope profile as extracted from AcrMap for Befliye quarry

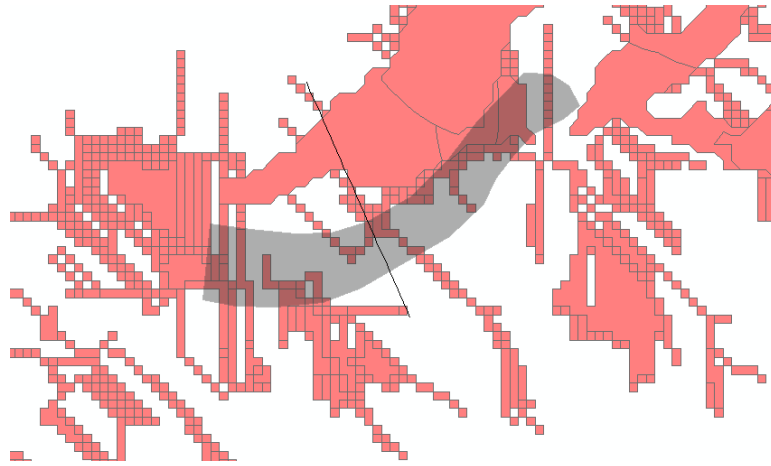
Figure 32: Pixelated rain hazards (pink) at the quarry site in Halat (grey polygon)

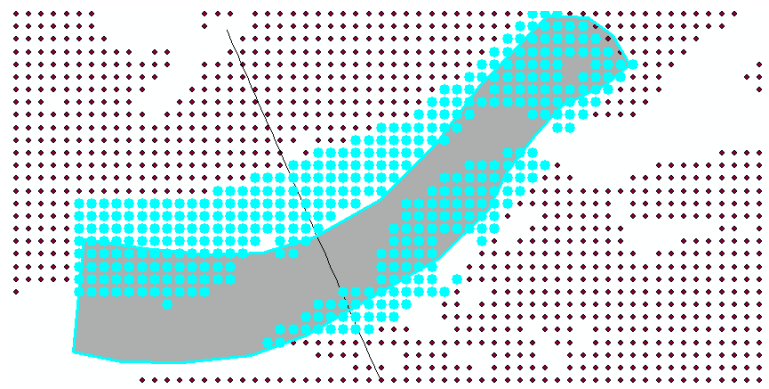
Figure 33: FS raster converted into point file for FS determination on site

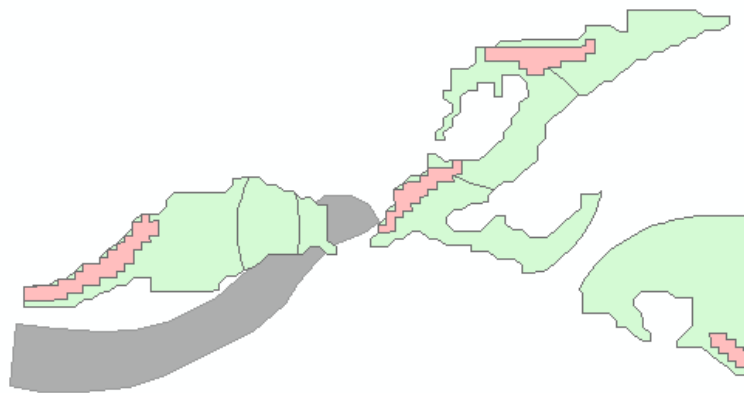
*Figure 34: Regional-scale runout analysis at Halat quarry in ArcMap*

The regional scale assessment does not take into consideration the presence, effects and interactions of discontinuities and is based on Mohr-Coulomb criteria solely, whereas the site specific assessment takes these factors fully into account, and more reliable models are used for the analysis of rock material. Nevertheless, the regional assessment when capturing the quarried slopes, provides a good approximation (in this case with a difference of 14.3% in rainfall events and 3.33% in seismic events) of the possible hazard levels.

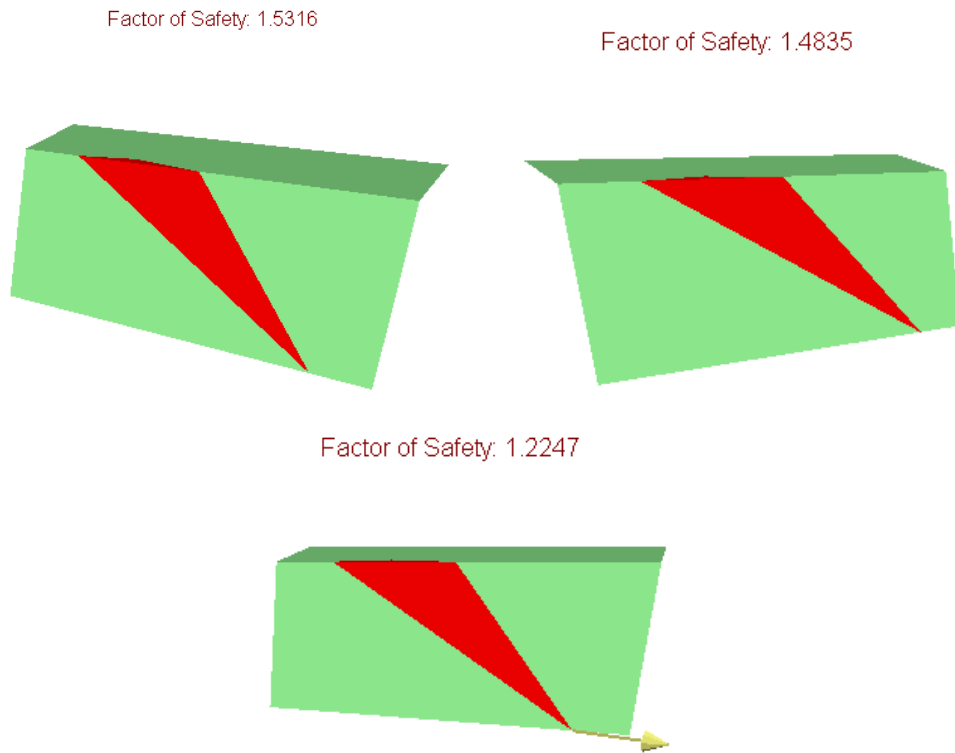
Figure 38: JS 5 and JS 6 (a) Dry conditions (b) 17% saturation (c) 0.25g ground acceleration

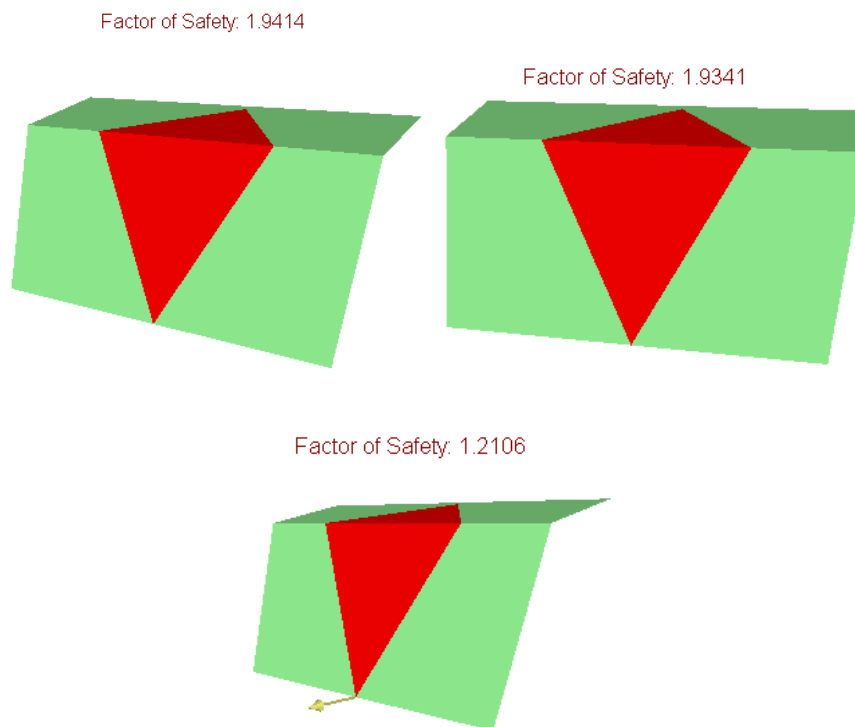
Figure 39: JS 2 and JS 3 (a) Dry conditions (b) 17% saturation (c) 0.25g ground acceleration

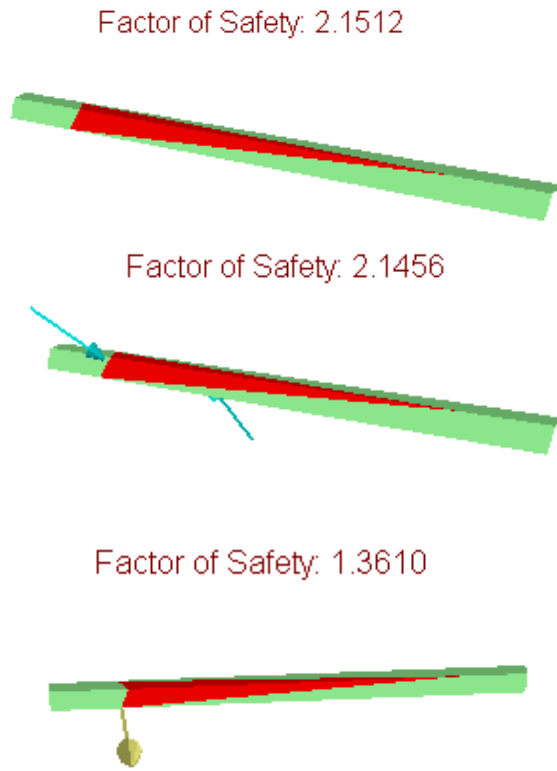
Figure 40: JS 2 and JS 4 (a) Dry conditions (b) 17% saturation (c) 0.25g ground acceleration

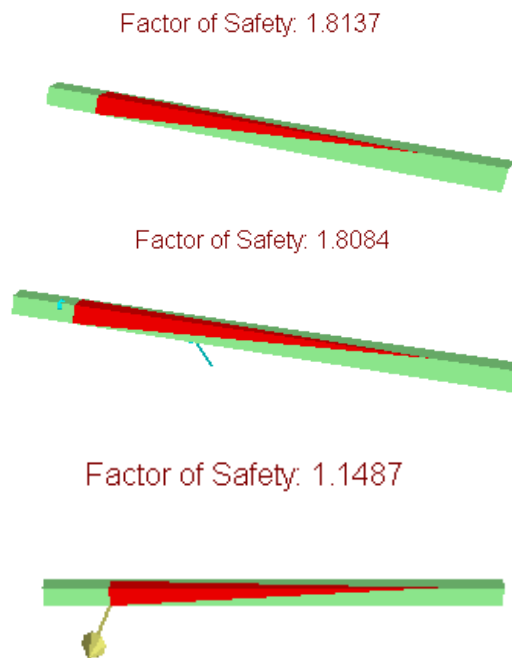
Figure 41: JS 8 and JS 4 (a) Dry conditions (b) 17% saturation (c) 0.25g ground acceleration

Factor of Safety: 1.8052

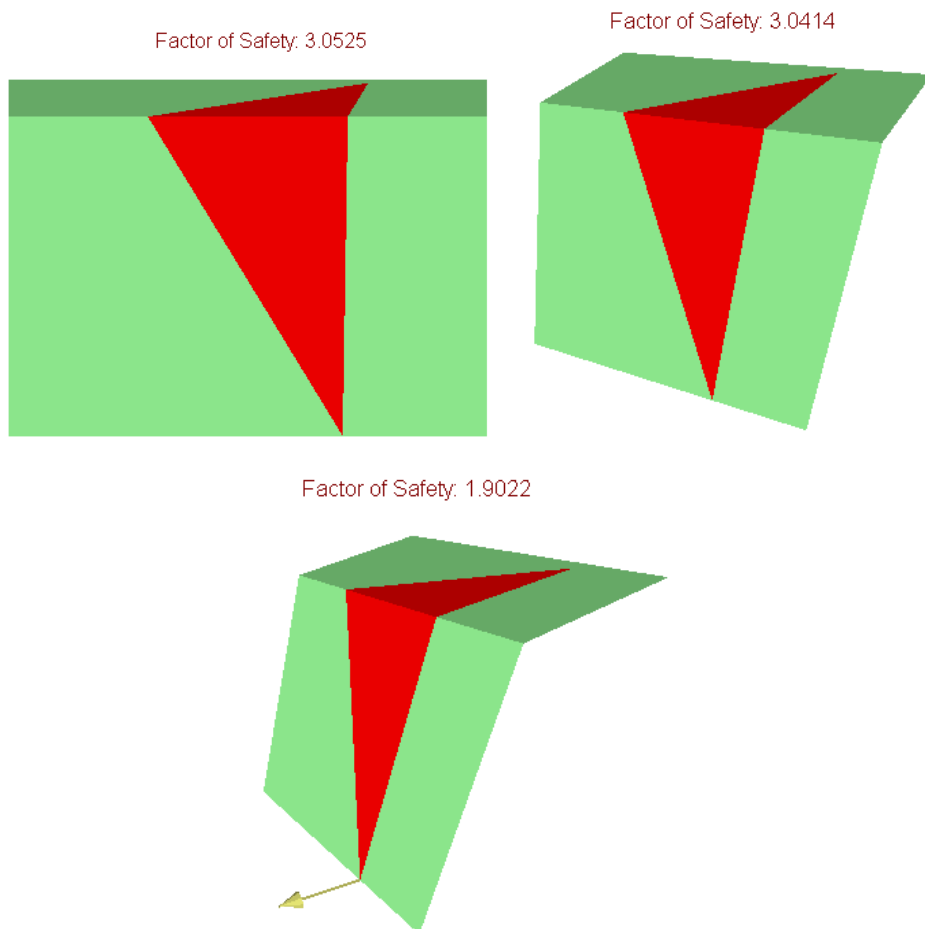
Figure 46: JS 3 and JS 8 (a) Dry conditions (b) 17% saturation (c) 0.25g ground acceleration

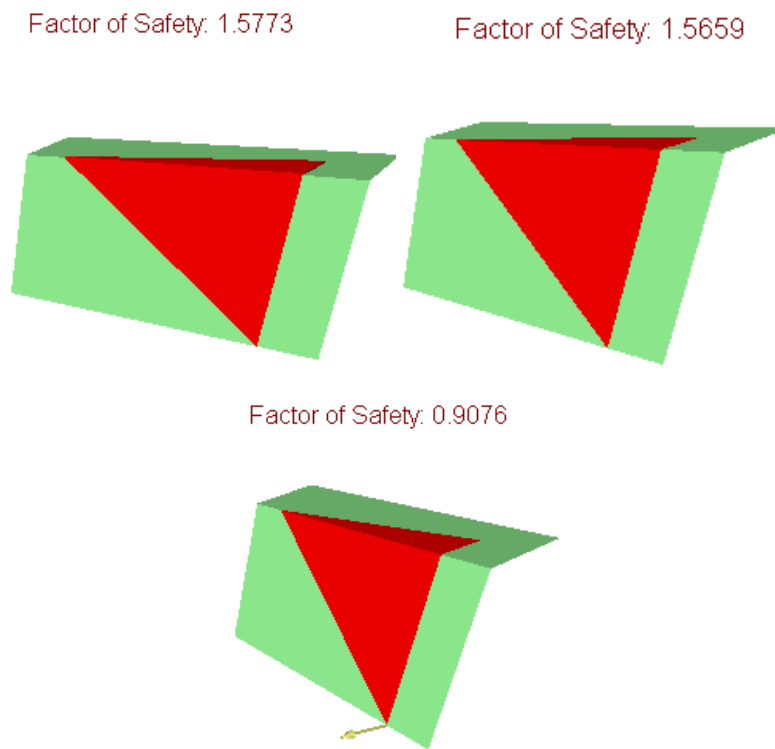
Figure 48: JS 8 and JS 5 (a) Dry conditions (b) 17% saturation (c) 0.25g ground acceleration

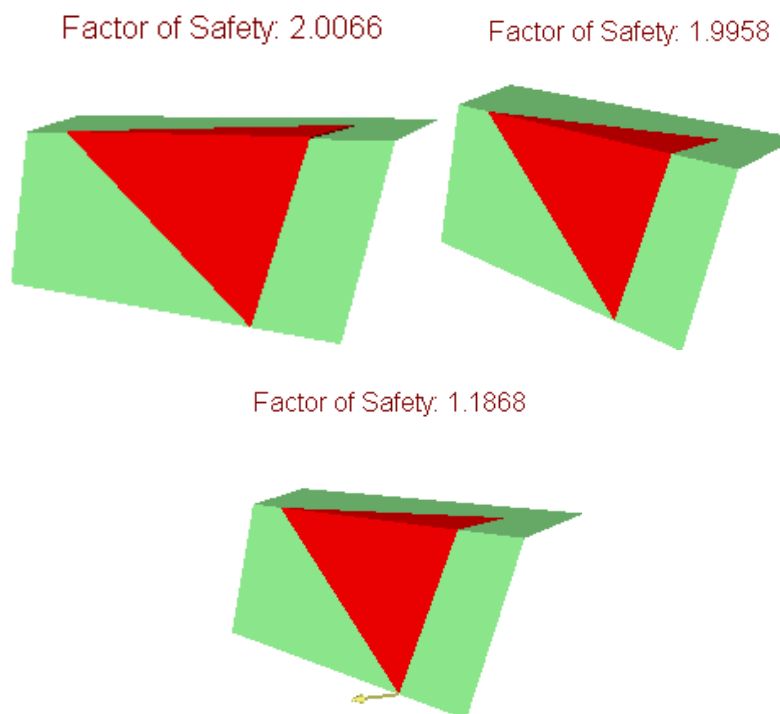
Figure 49: JS 9 and JS 5 (a) Dry conditions (b) 17% saturation (c) 0.25g ground acceleration

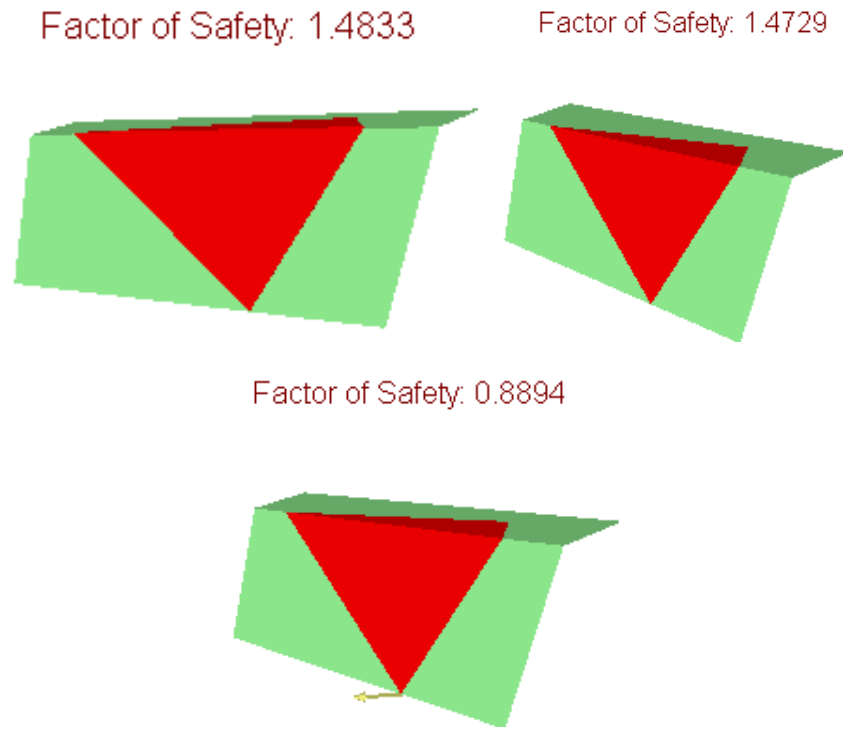
Figure 50: JS 2 and JS 5 (a) Dry conditions (b) 17% saturation (c) 0.25g ground acceleration

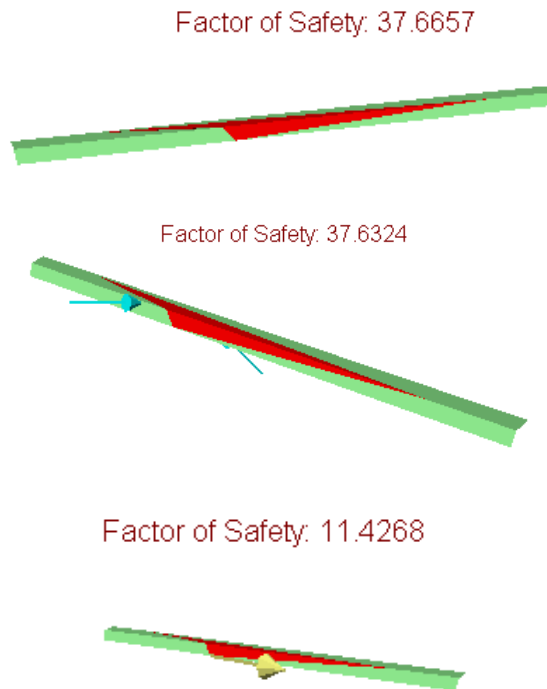
Figure 51: JS 6 and JS 4 (a) Dry conditions (b) 17% saturation (c) 0.25g ground acceleration

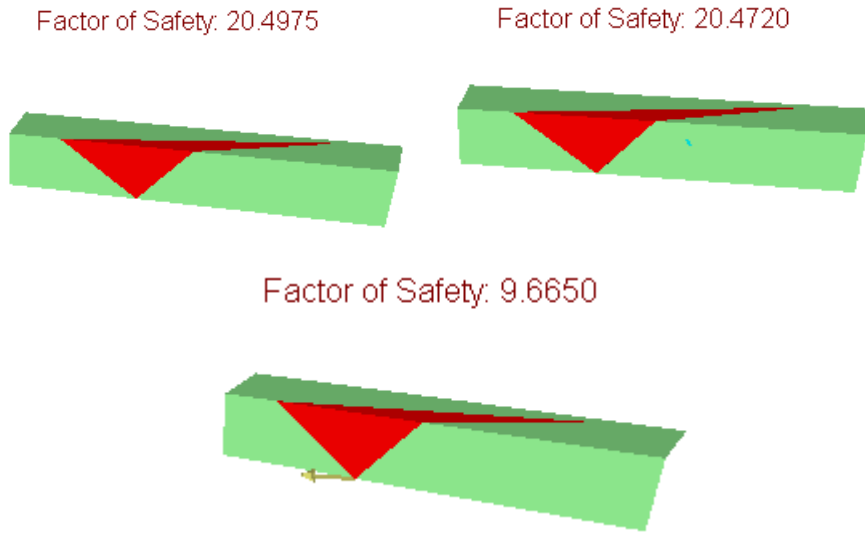
Figure 54: JS 10 and JS 5 (a) Dry conditions (b) 17% saturation (c) 0.25g ground acceleration

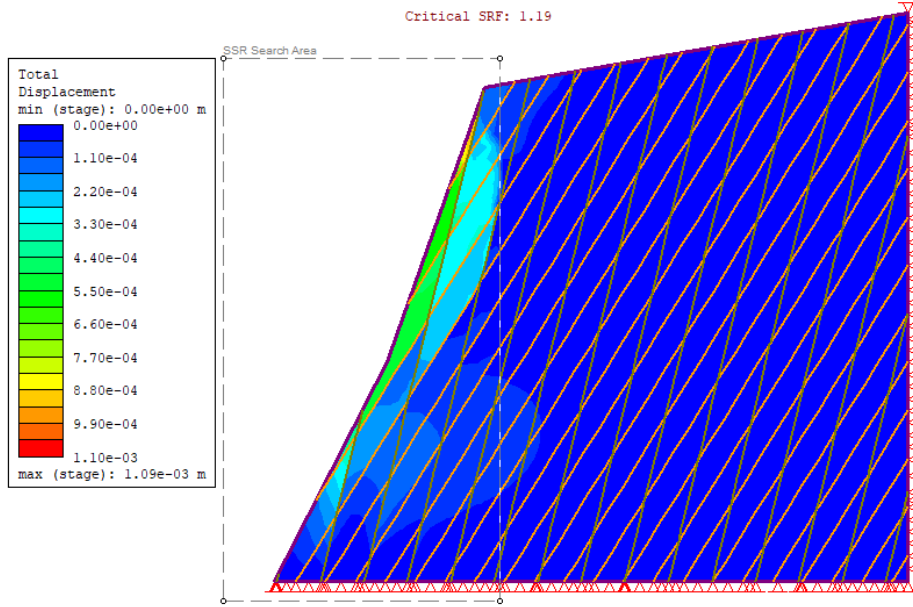
Figure 57: JS 5 and JS 6 (0.25g ground acceleration)

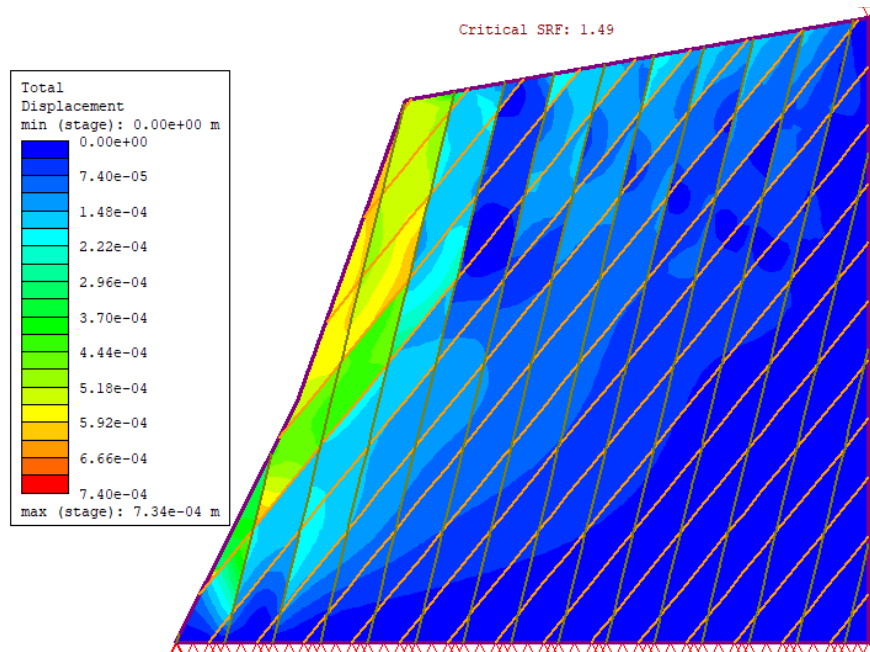
Figure 58: JS 3 and JS 6 (dry conditions)

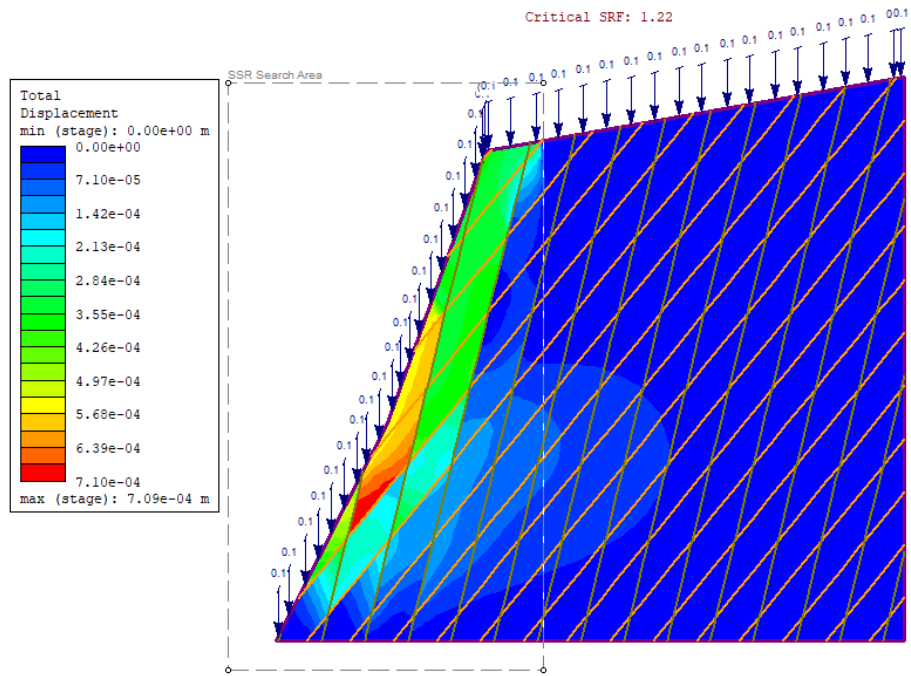
Figure 59: JS 3 and JS 6 (rainfall intensity 0.103 mm/day)

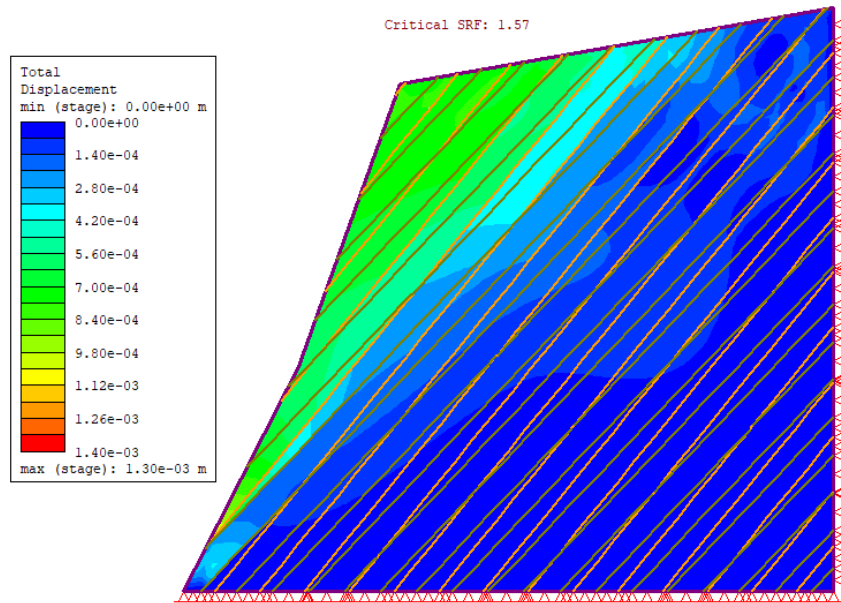
Figure 61: JS 2 and JS 3 (dry conditions)

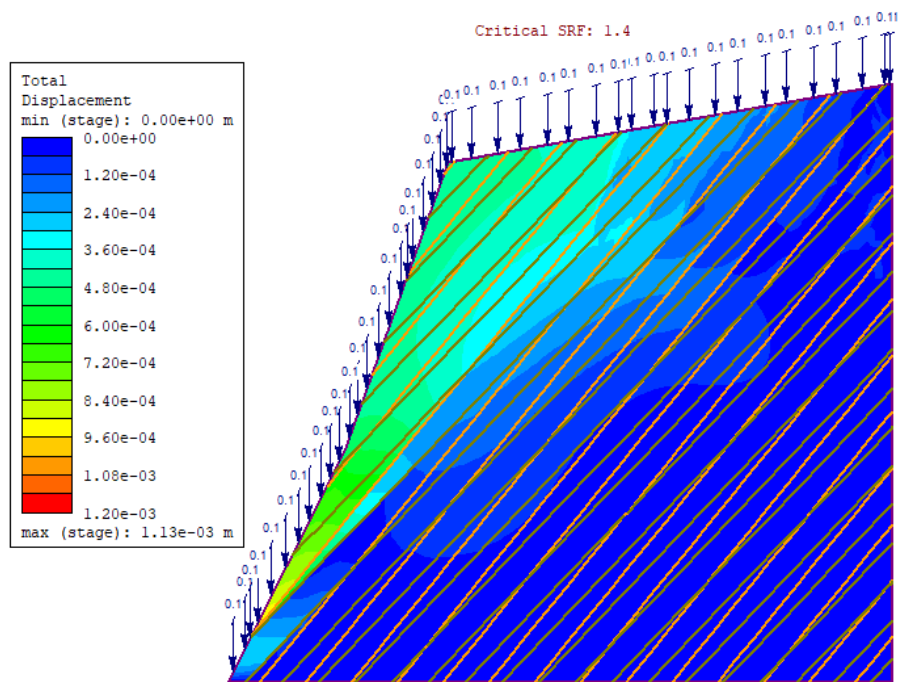
Figure 62: JS 2 and JS 3 (rainfall intensity 0.103 mm/day)

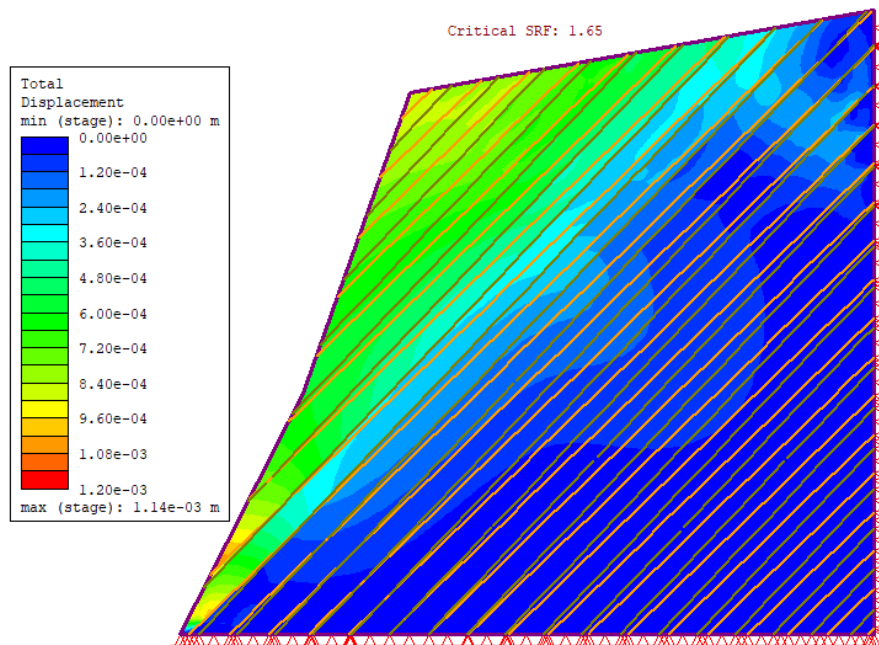
Figure 66: JS 2 and JS 4 (dry conditions)

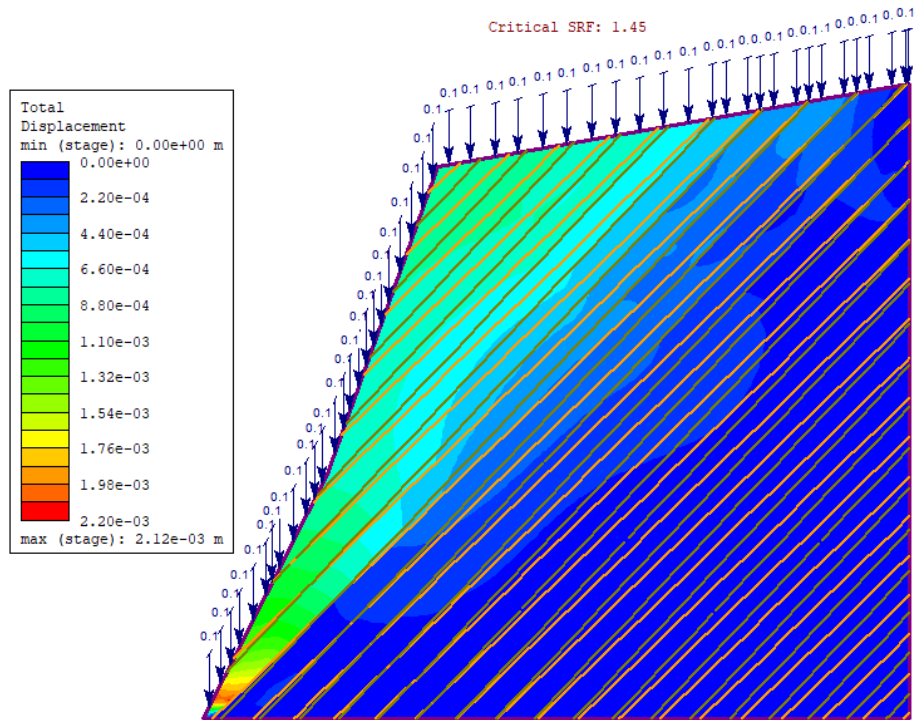
Figure 67: JS 2 and JS 4 (rainfall intensity 0.103 mm/day)

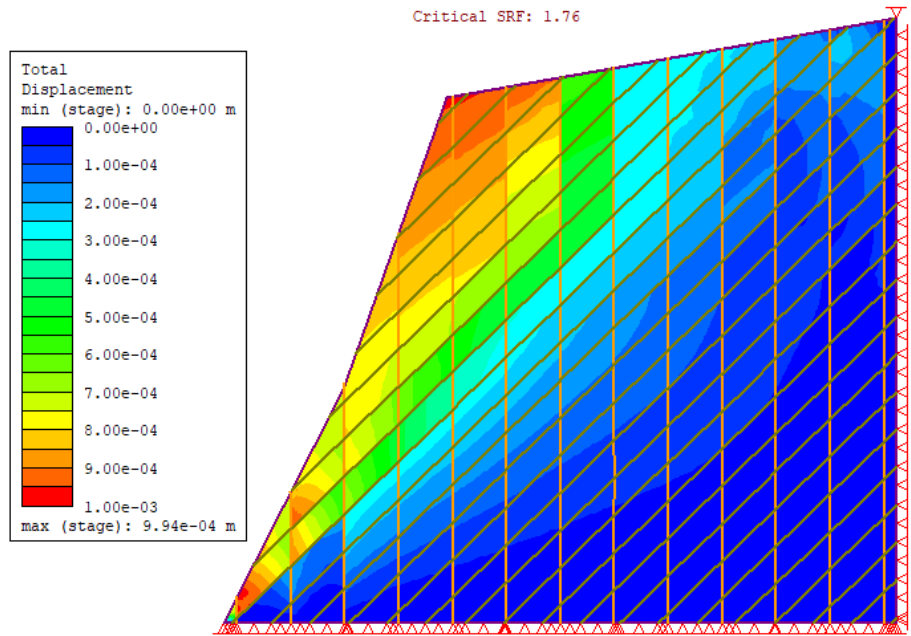
Figure 69: JS 8 and JS 4 (dry conditions)
