Landslide Hazard and Risk Level Assessment of  
Quarried Slopes in Lebanon using Drone Imagery

A thesis

for the degree of Master of Science in Civil and Environmental Engineering

August 2020

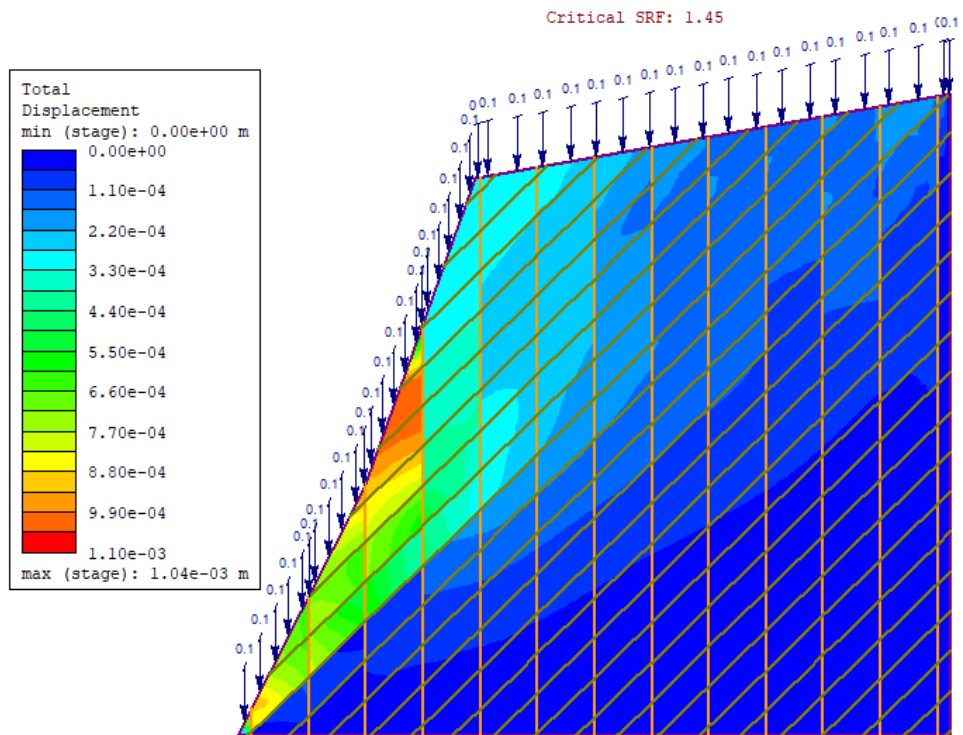
Figure 70: JS 8 and JS 4 (rainfall intensity 0.103 mm/day)

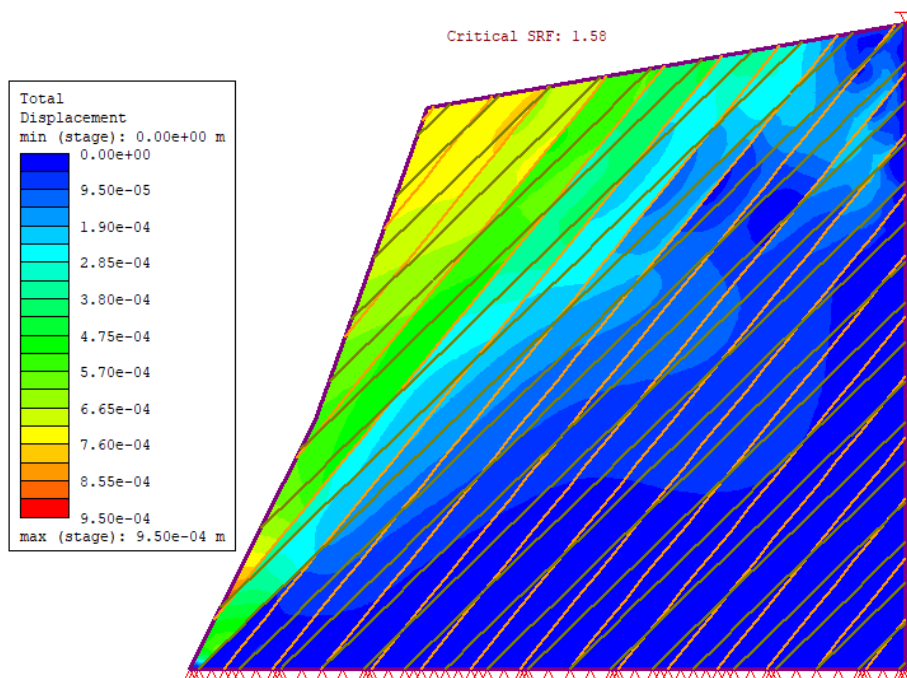
Figure 72: JS 3 and JS 4 (dry conditions)

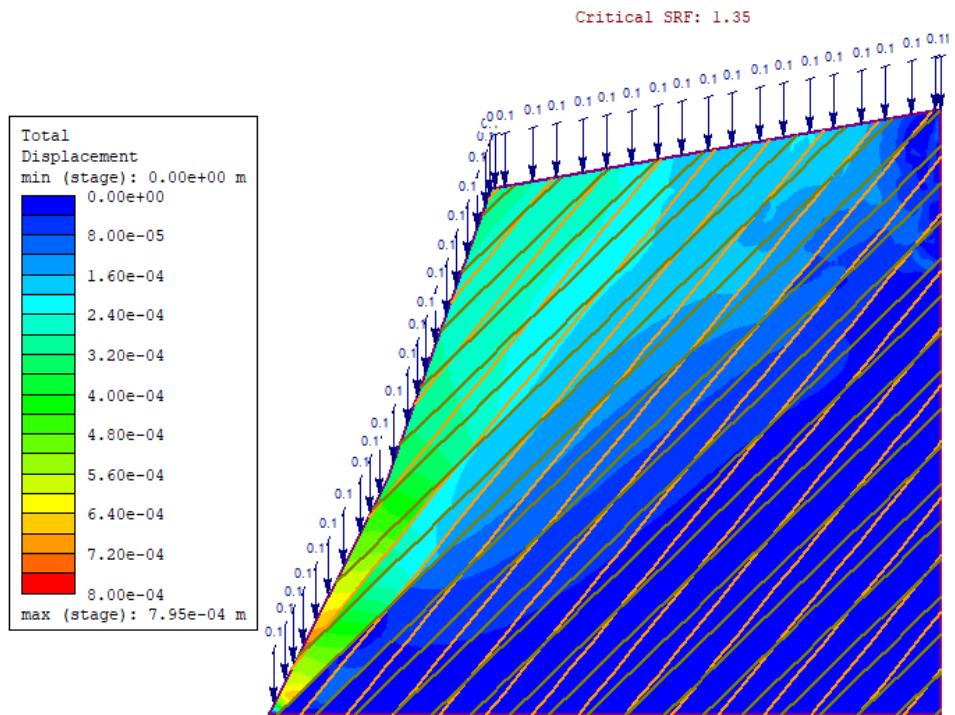
Figure 73: JS 3 and JS 4 (rainfall intensity 0.103 mm/day)

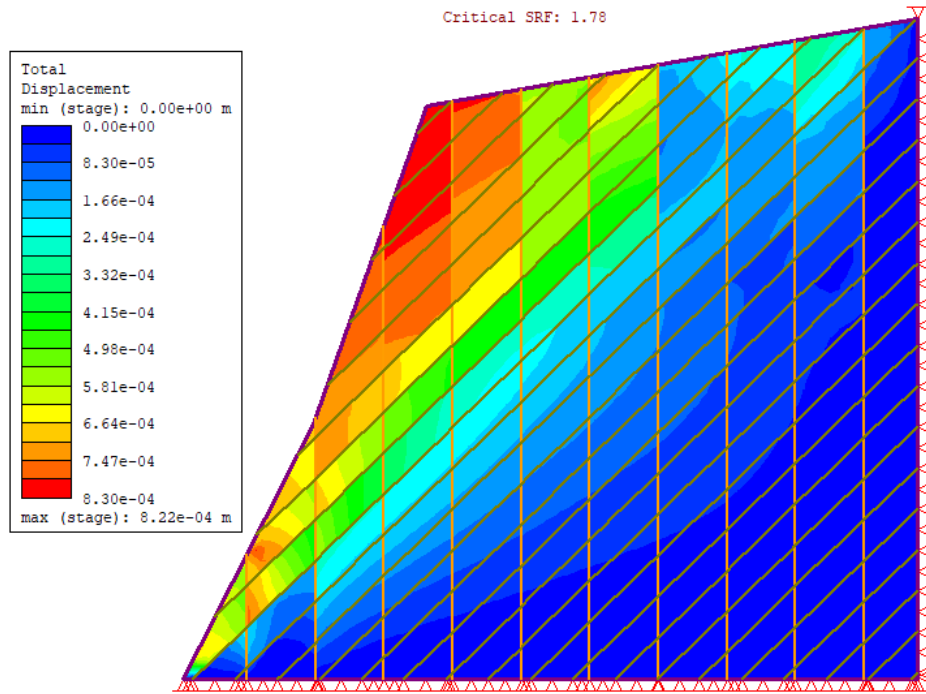
Figure 75: JS 9 and JS 4 (dry conditions)

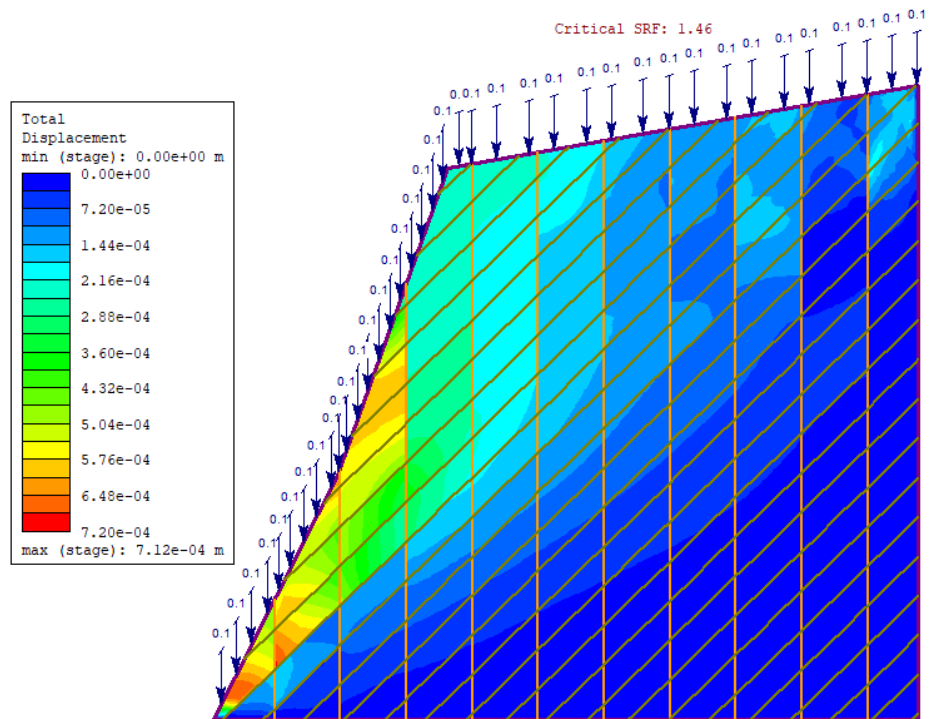
Figure 76: JS 9 and JS 4 (rainfall intensity 0.103 mm/day)

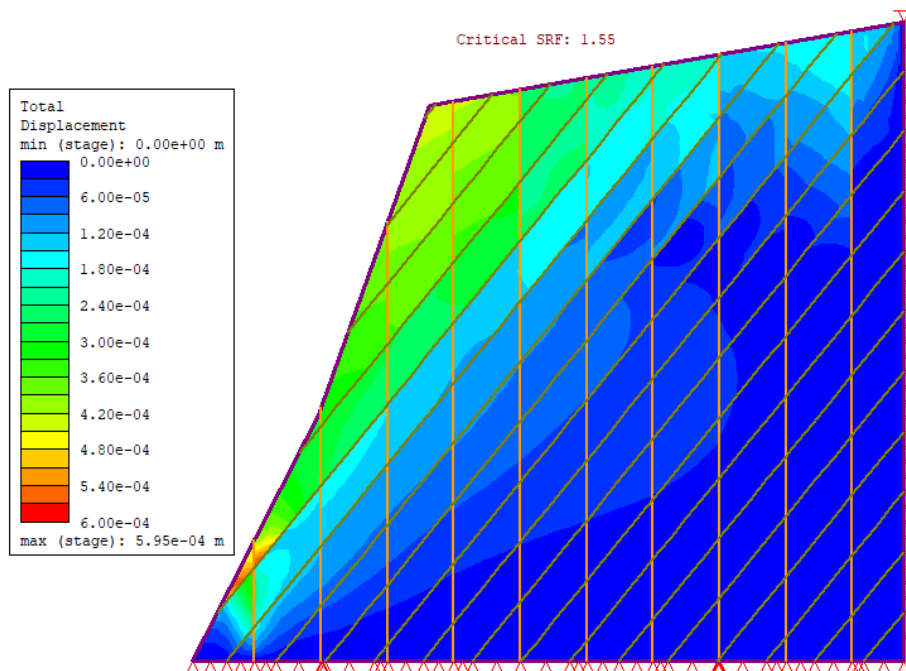
Figure 78: JS 9 and JS 3 (dry conditions)

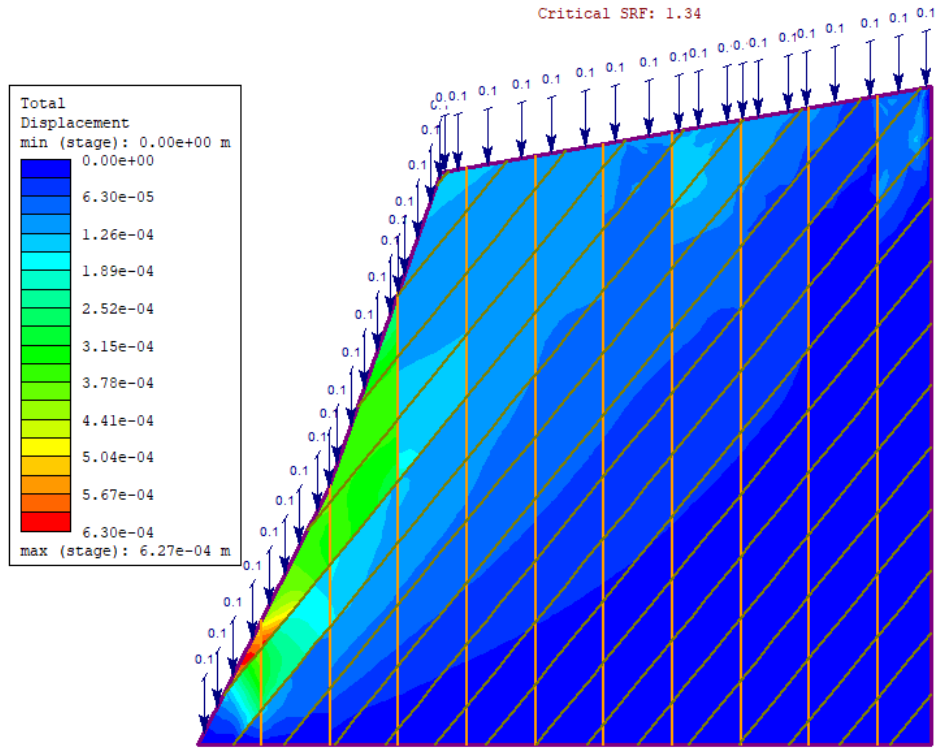
Figure 79: JS 9 and JS 3 (rainfall intensity 0.103 mm/day)

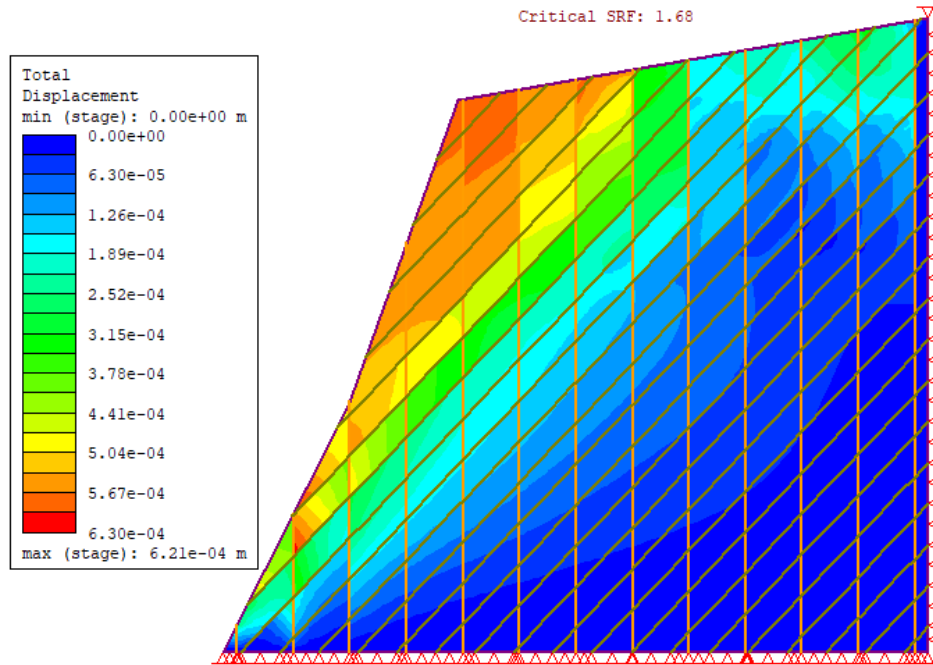
Figure 81: JS 2 and JS 8 (dry conditions)

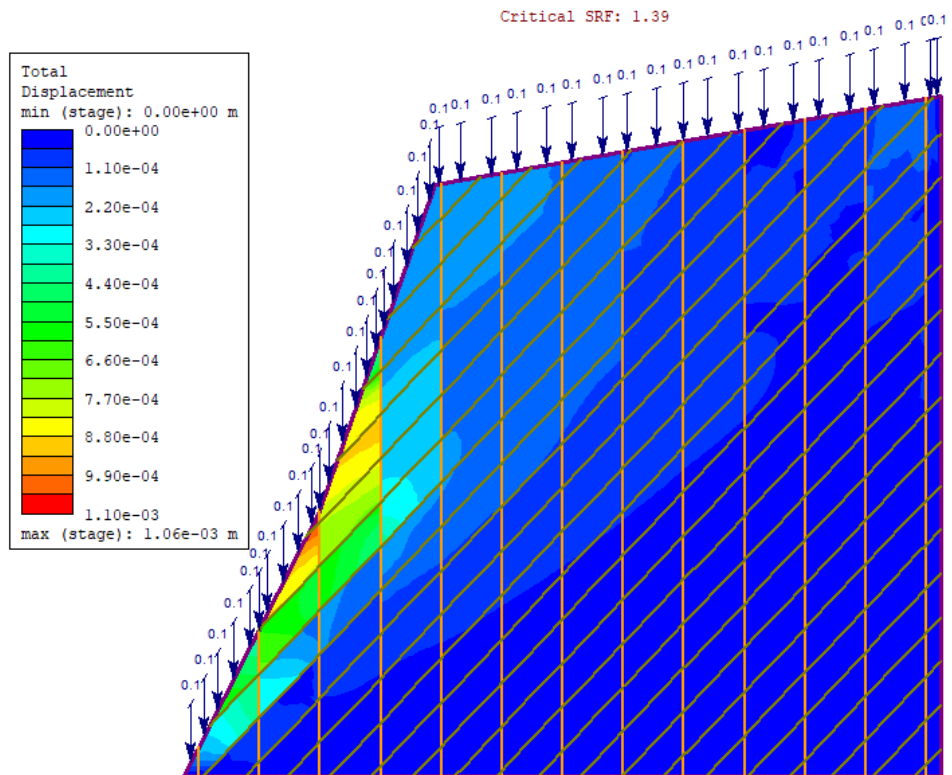
Figure 82: JS 2 and JS 8 (rainfall intensity 0.103 mm/day)

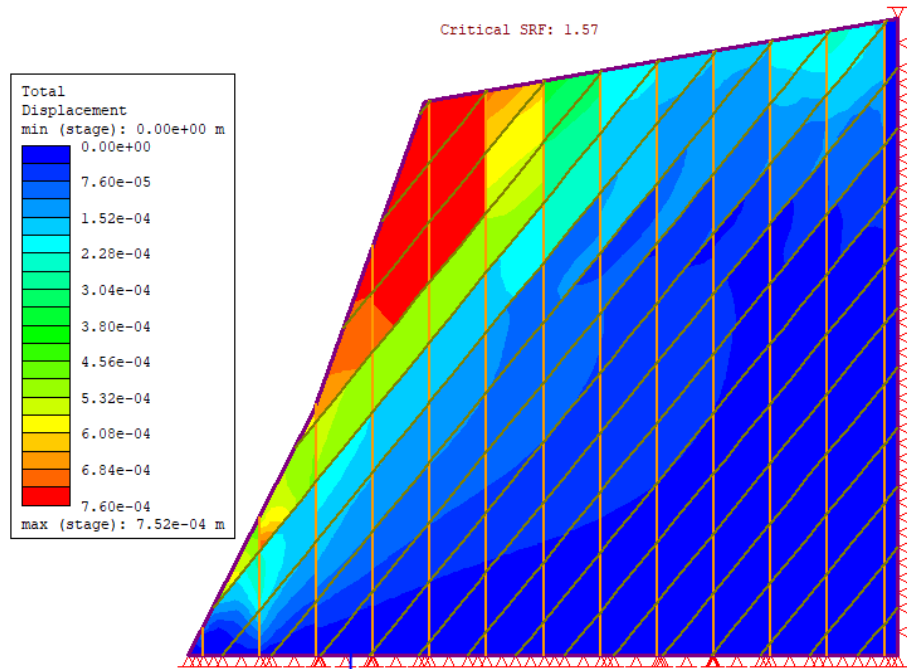
Figure 84: JS 3 and JS 8 (dry conditions)

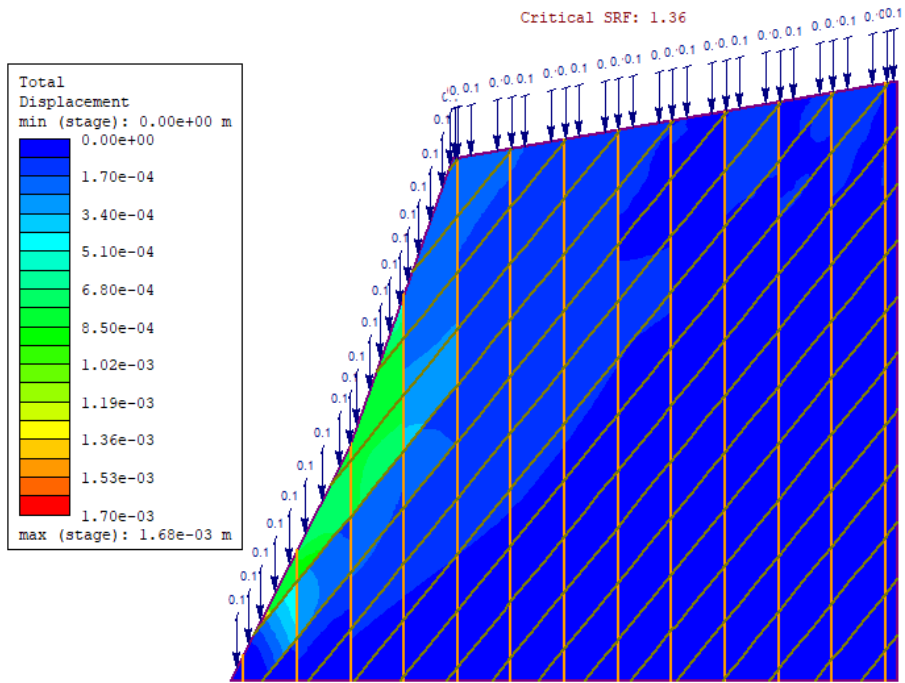
Figure 85: JS 3 and JS 8 (rainfall intensity 0.103 mm/day)

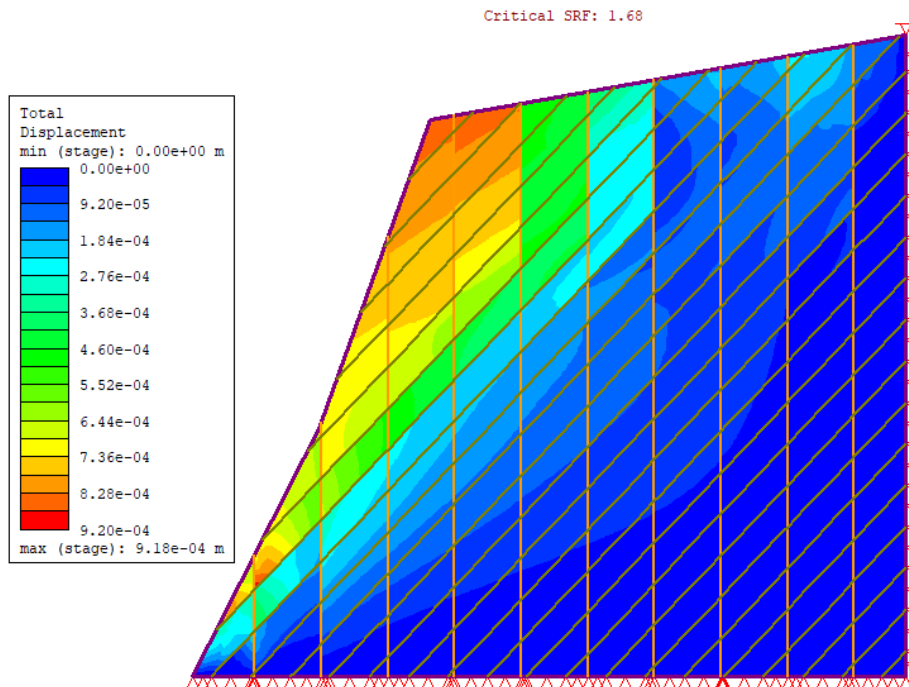
Figure 87: JS 2 and JS 9 (dry conditions)

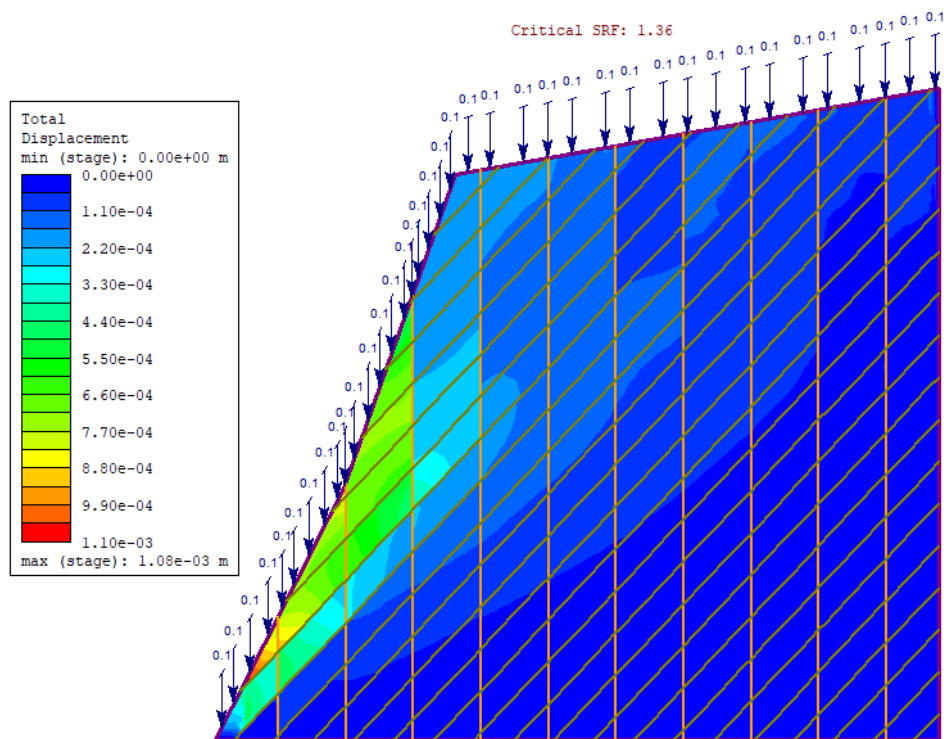
Figure 88: JS 2 and JS 9 (rainfall intensity 0.103 mm/day)

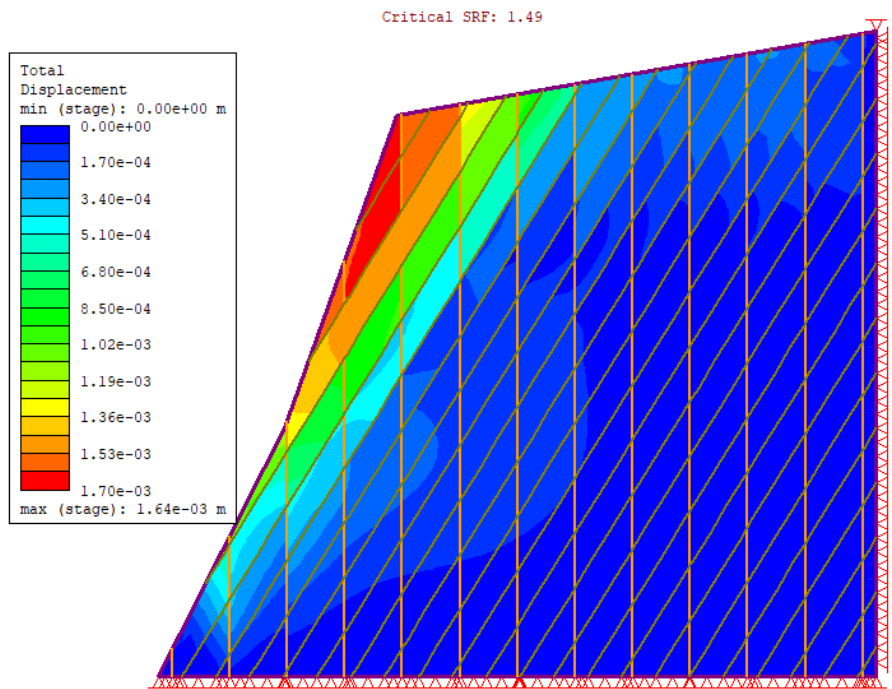
Figure 90: JS 8 and JS 5 (dry conditions)

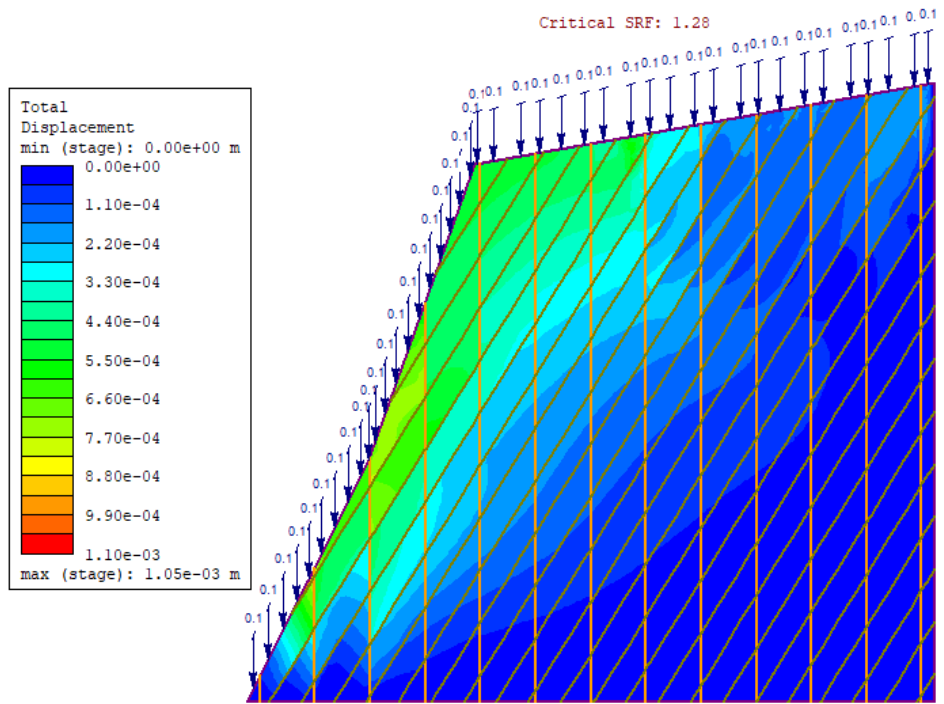
Figure 91: JS 8 and JS 5 (rainfall intensity 0.103 mm/day)

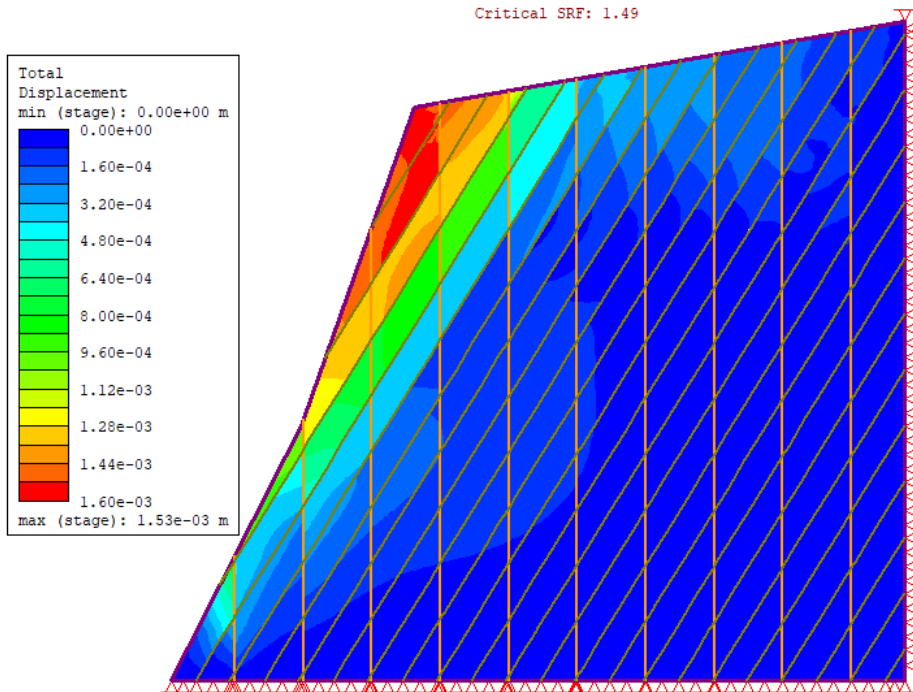
Figure 93: JS 9 and JS 5 (dry conditions)

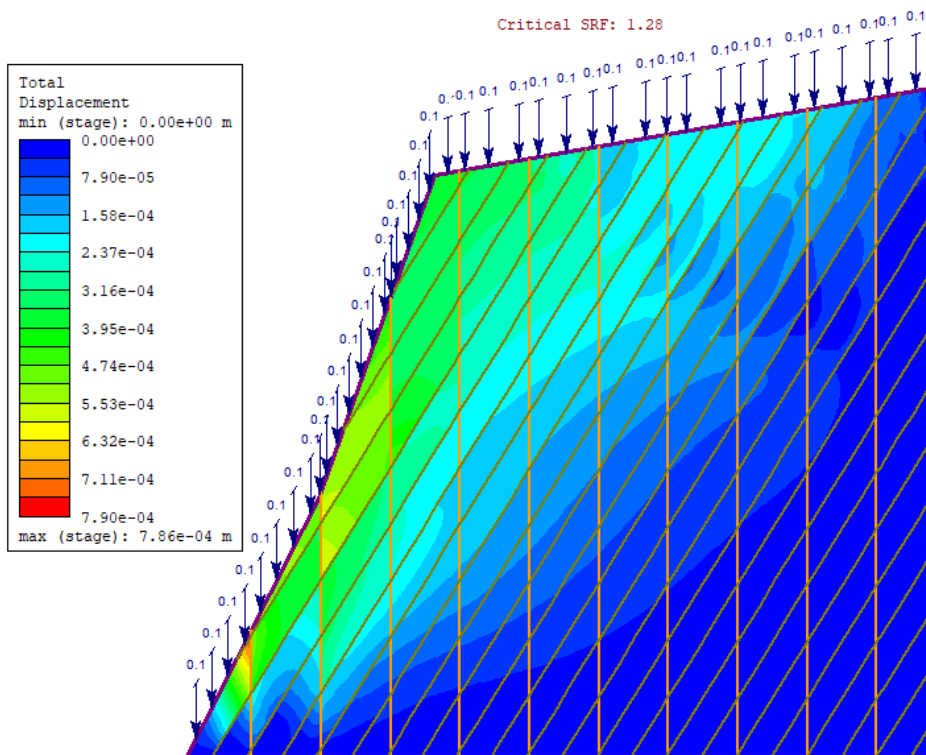
Figure 94: JS 9 and JS 5 (rainfall intensity 0.103 mm/day)

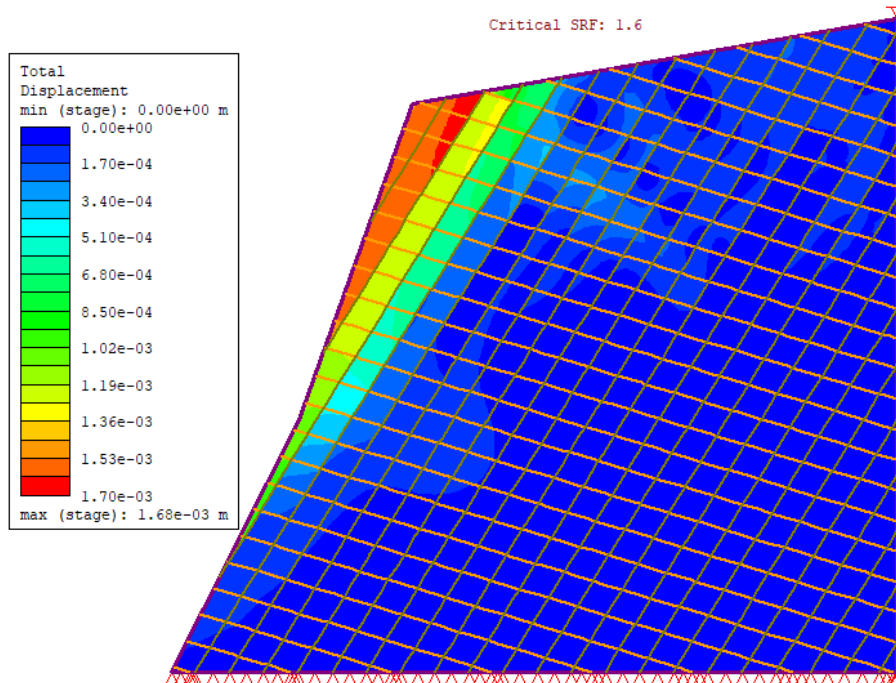
Figure 96: JS 2 and JS 5 (dry conditions)

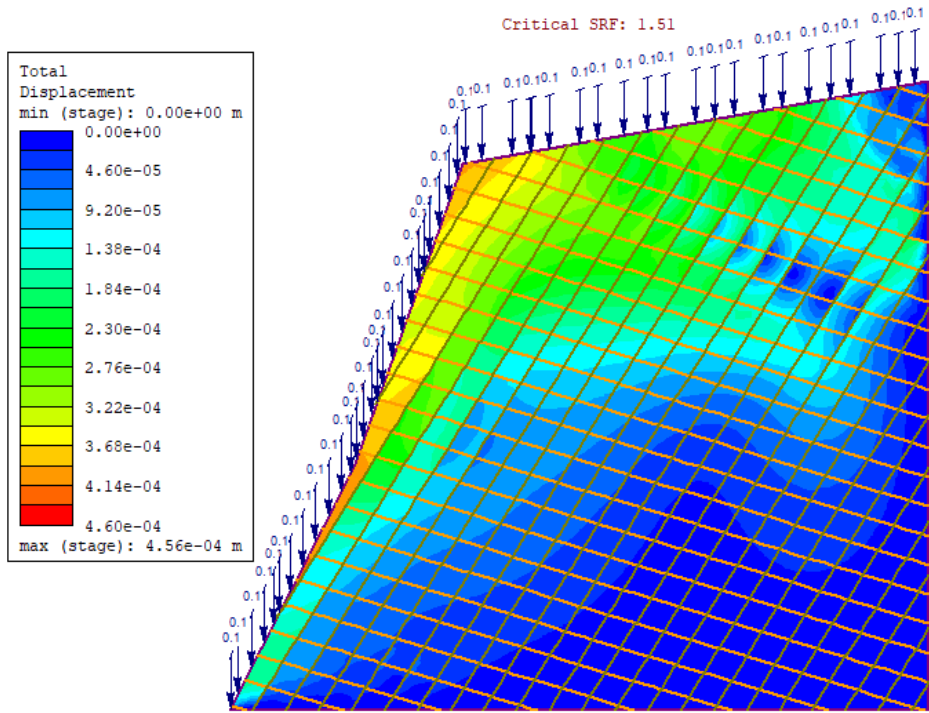
Figure 97: JS 2 and JS 5 (rainfall intensity 0.103 mm/day)

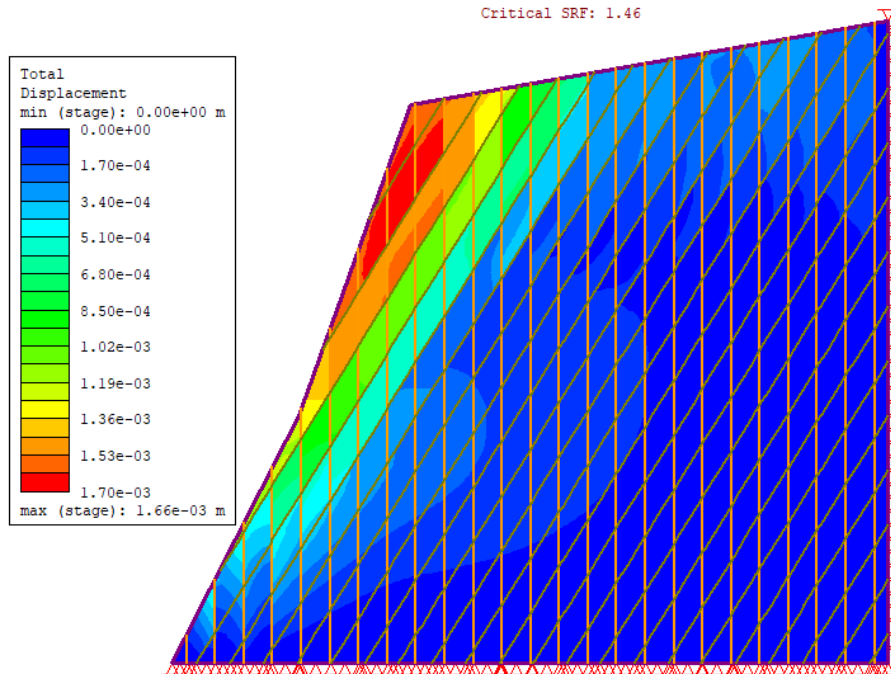
Figure 99: JS 7 and JS 5 (dry conditions)

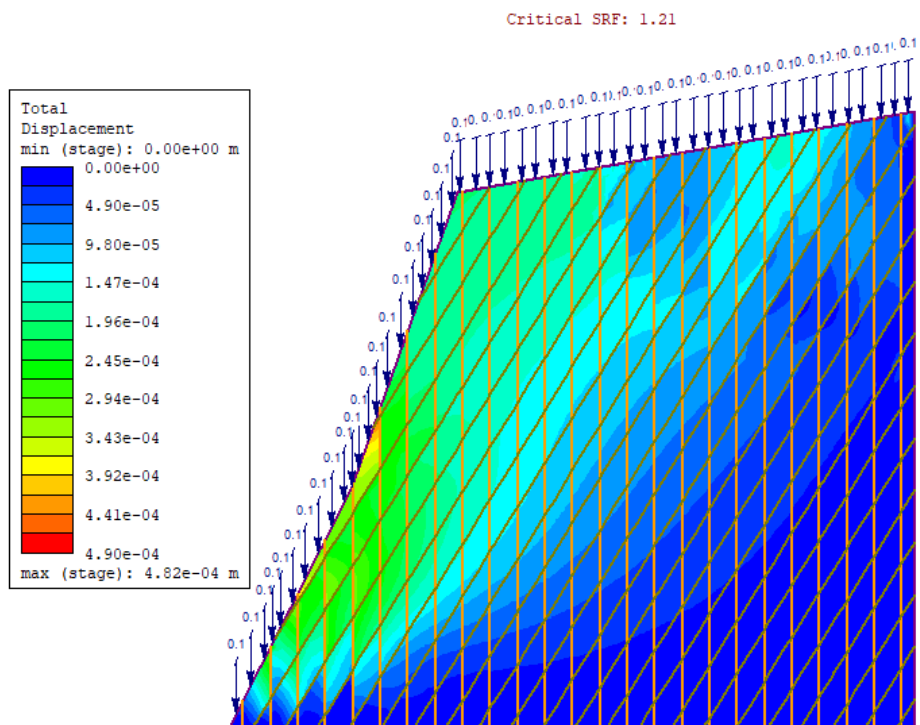
Figure 100: JS 7 and JS 5 (rainfall intensity 0.103 mm/day)

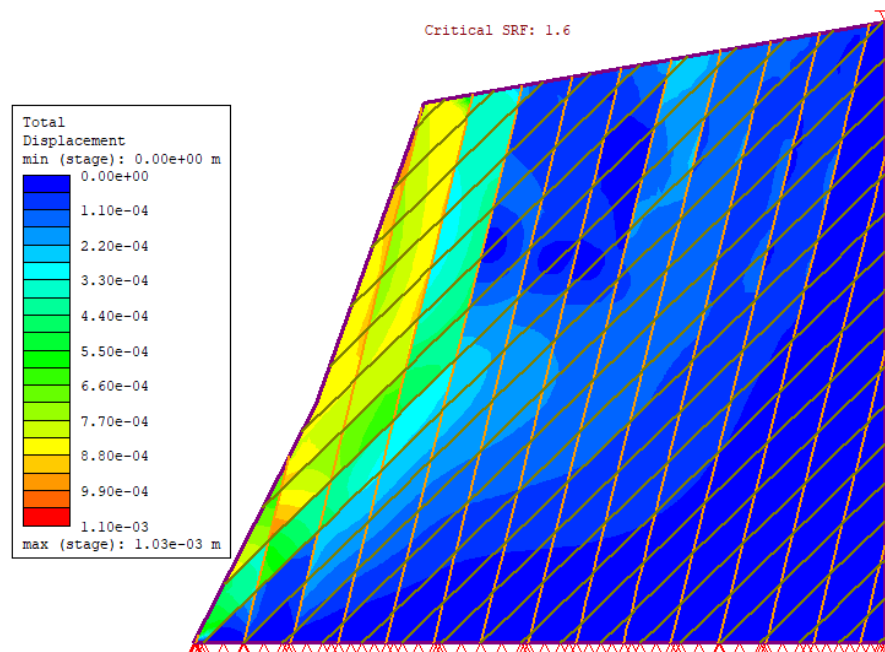
Figure 102: JS 6 and JS 4 (dry conditions)

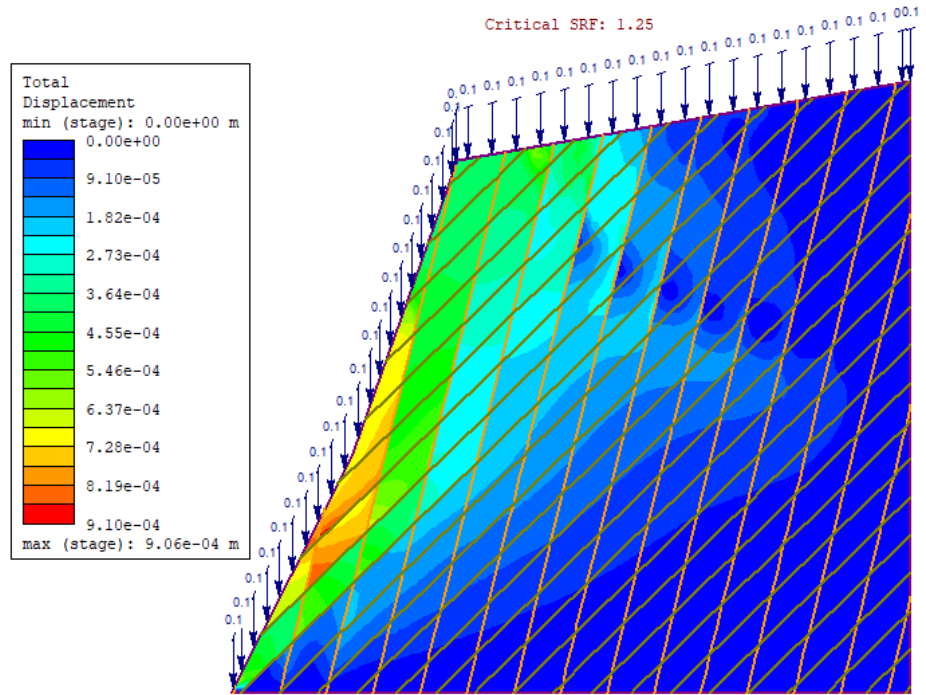
Figure 103: JS 6 and JS 4 (rainfall intensity 0.103 mm/day)

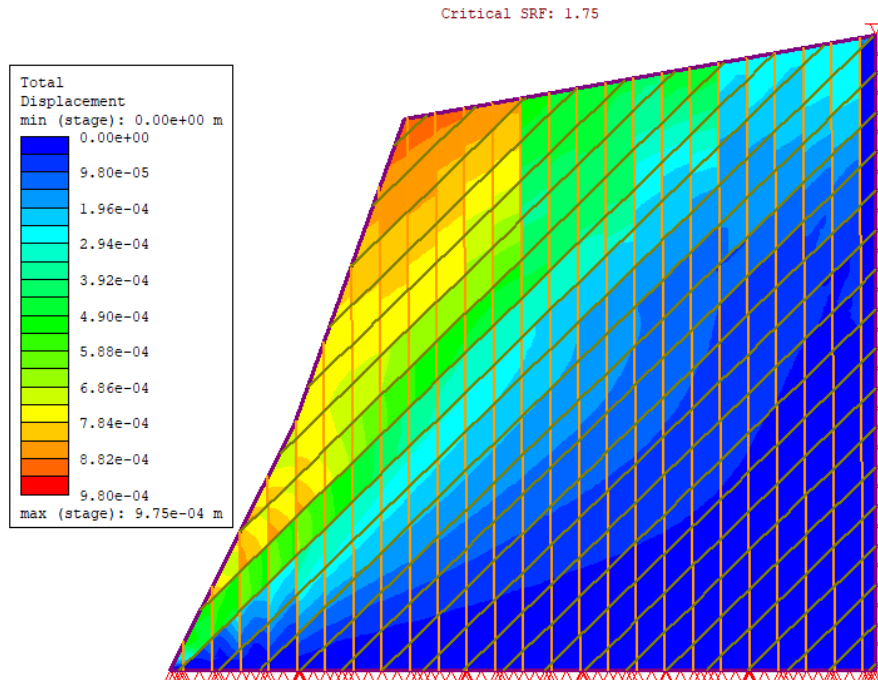
Figure 107: JS 10 and JS 4 (dry conditions)

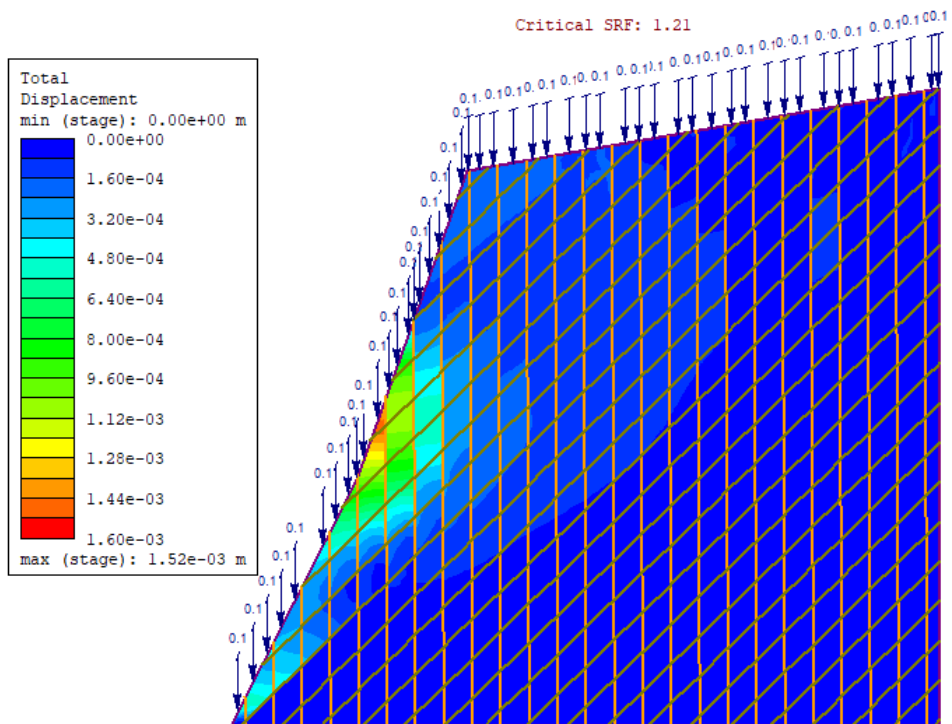
Figure 108: JS 10 and JS 4 (rainfall intensity 0.103 mm/day)

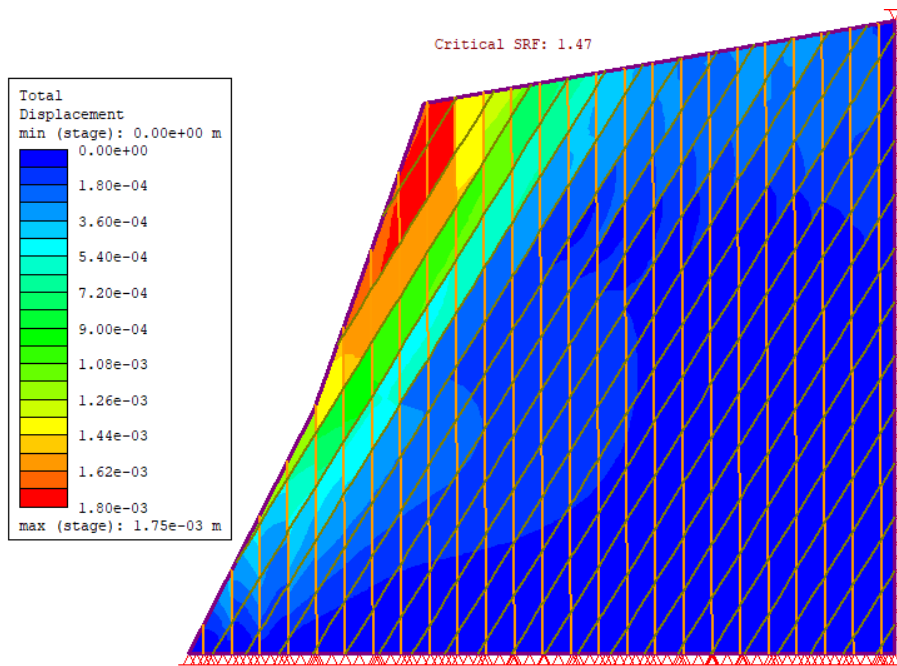
Figure 109: JS 10 and JS 5 (dry conditions)

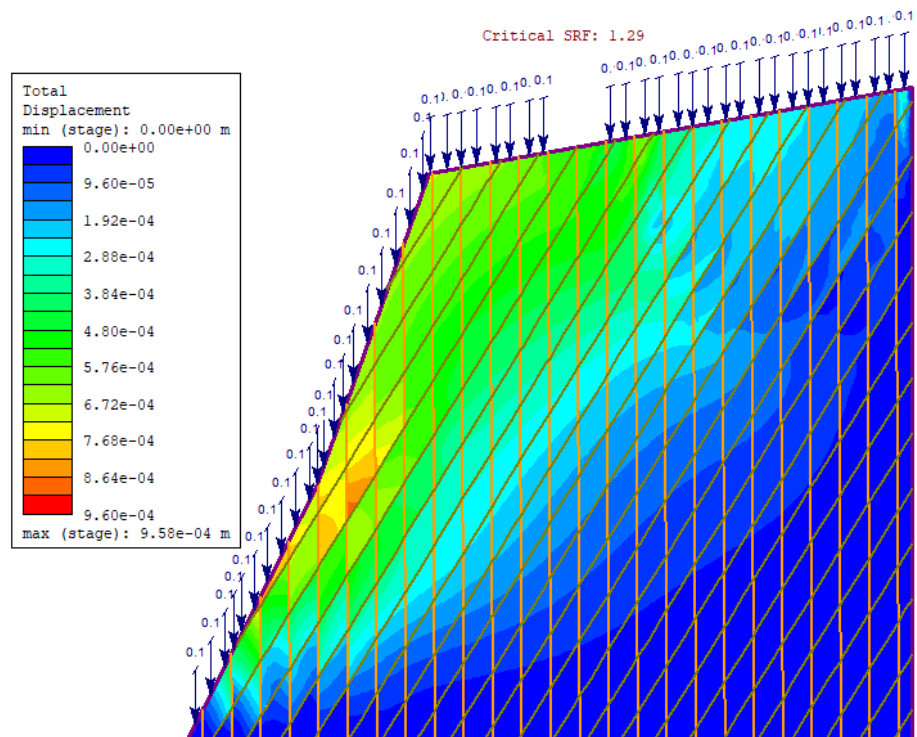
Figure 110: JS 10 and JS 5 (rainfall intensity 0.103 mm/day)
