Multiple Site-Specific Analyses of the Stability of Quarried Slopes in
Lebanon Based on Unmanned Aerial Vehicle Photogrammetry

A thesis

for the degree of Master of Science in Civil and Environmental Engineering

April 2022

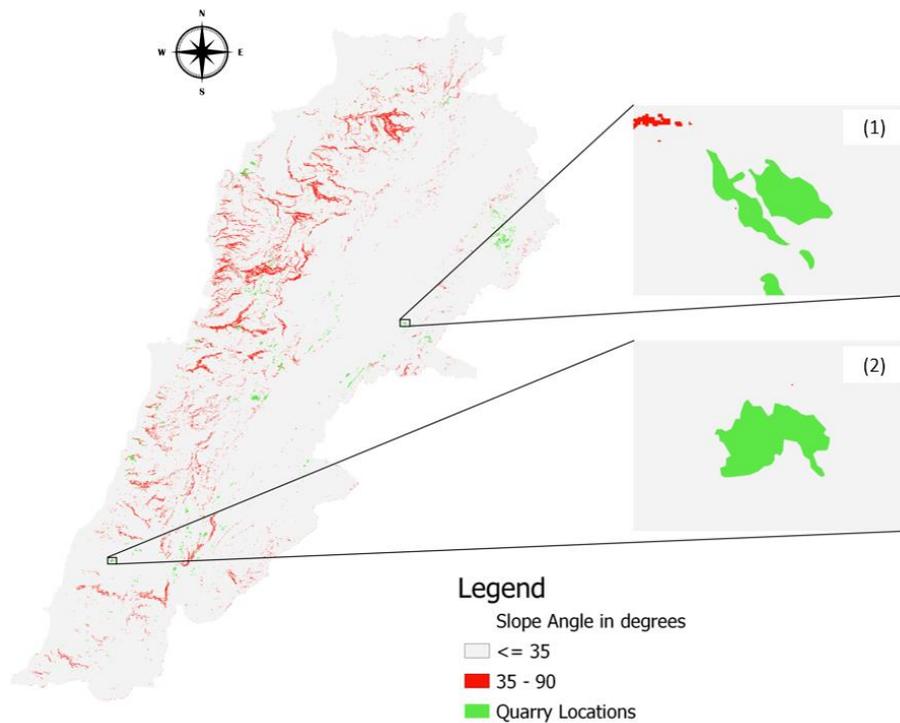
Figure 2: Overlay quarry site map with slope map. Two examples of quarry sites (1) and (2) with a slope face angle of less than 35° based on 15-m DEM

A quick assessment was performed using QGIS by superimposing the slope angle map (based on the 15-m DEM) over the quarry sites map (Atallah, 2018). It was found that more than 90% of the quarries were not captured properly and that their slope angles were less than 35° . Thus, almost all “rock” quarries had been evaluated as coherent rotational failures. Figure 2 shows an example of two quarries with an angle of inclination of less than 35° according to the 15-m DEM, but when these sites were examined in Google Earth, it was clear that these slopes are quite steep, as shown in Figure 3. For the reasons mentioned above, and given that most quarries in Lebanon have steep faces exceeding 45° (El-Fadel et al., 2001), these regional-scale maps are less reliable for use in quarrying risk assessment. This simple exercise shows that the hazard and risk predictions for quarry sites must be improved and updated based on site-specific analysis with a more accurate and refined digital elevation map.

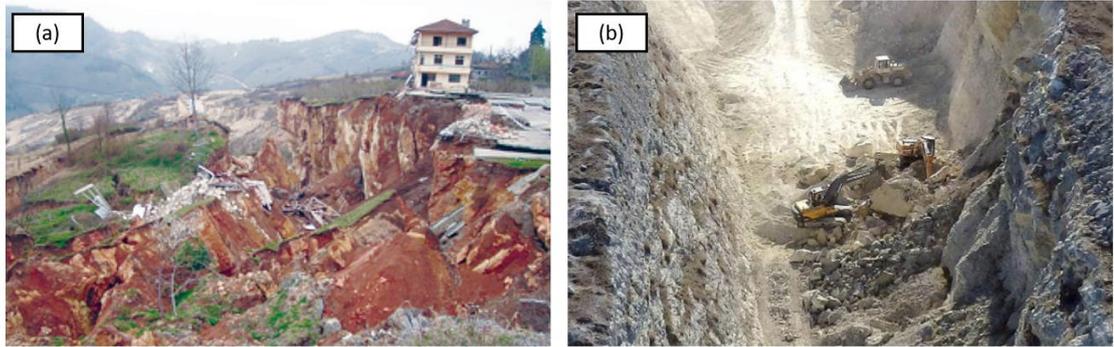
Figure 6: Quarry failure in a) Trabzon, Turkey and b) Waikari, New Zealand

Between 2005 and 2006, due to uncontrolled blasting activities and heavy rainfall, a very steep limestone quarry in Trabzon, north-eastern Turkey, experienced three separate planar failures. The failures resulted in the demolition of houses, a mosque and a school, and also adversely affected the road and farm fields surrounding the quarry (Figure 6a) (Karaman et al., 2013).

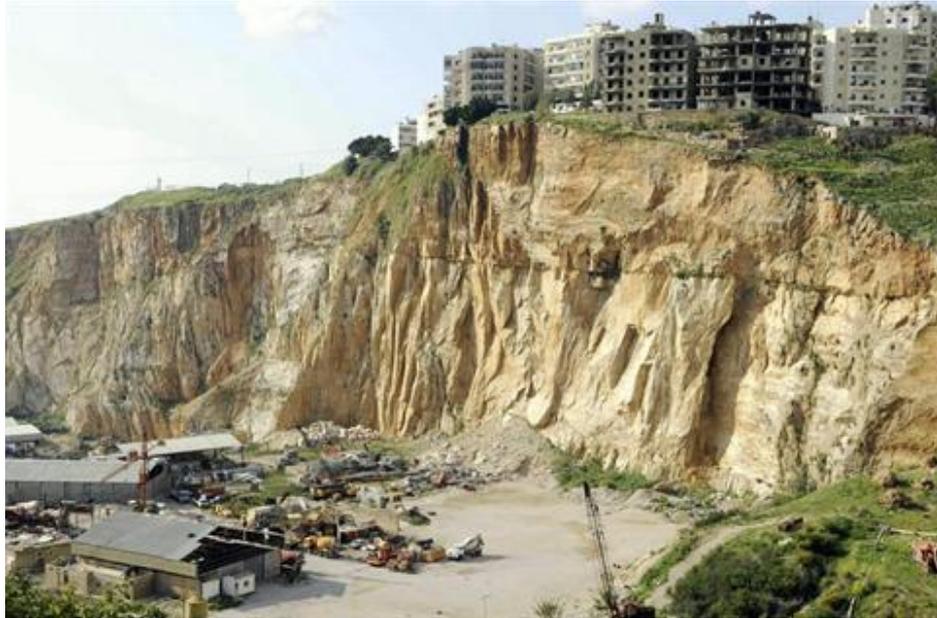
Figure 7: Residential areas threatened by quarry near Nahr El Mott, North of Beirut

In Lebanon, some examples of failures in quarries include the failure in Bjaout, Mount Lebanon (Figure 7) that occurred on February 16, 2000. The open and abandoned quarry collapsed beneath the newly constructed residential buildings. This landslide completely destroyed two buildings and the structural integrity of a third building was compromised (Abdallah, 2011; Shaban et al., 2011).

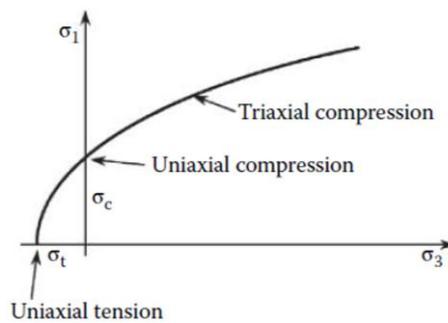
Figure 8: Hoek–Brown failure criterion

where σ_1 and σ_3 are the major and minor principal stresses, respectively; σ_{ci} is the unconfined compressive strength of the intact rock; and m_i is a material constant for a specific rock type.

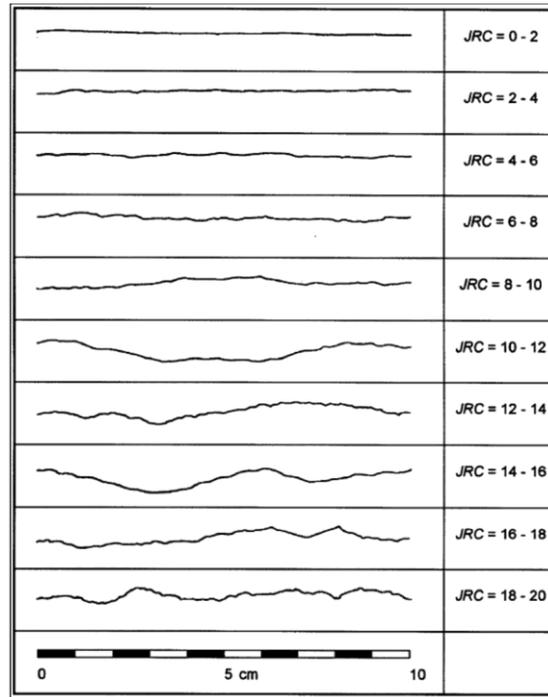
Figure 10: Roughness profiles and corresponding JRC values (After Barton and Choubey 1977)

where JRC is the joint roughness coefficient, JCS is the compressive strength of the rock at the fracture surface and σ' is the effective normal stress. The joint roughness coefficient JRC is a number used to quantitatively describe the irregular morphology of joints. It can be estimated by comparing visually the appearance of a discontinuity surface with standard profiles. One of the most useful of these profile sets was published by Barton and Choubey (1977) and is reproduced in Figure 10 (Karakas, 2008). As for the joint compressive strength JRC, it can be estimated based on the compressive strength of the intact rock and the degree of weathering of rock mass that forms the joint wall.

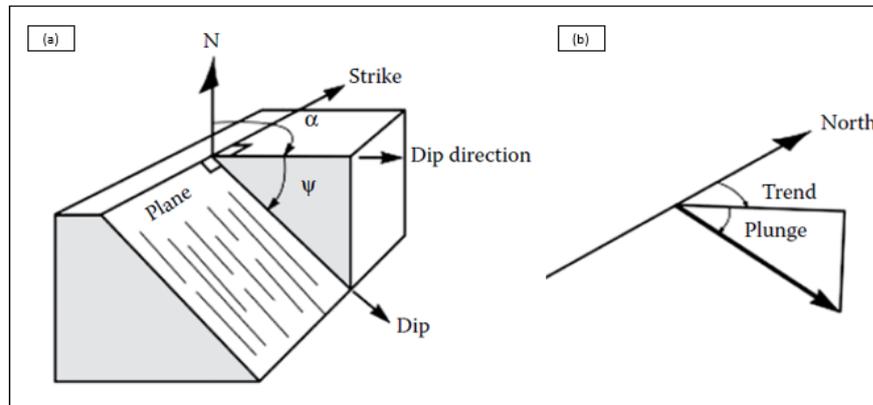
Figure 11: Terminology defining discontinuity orientation: (a) isometric view of plane (dip and dip direction); (b) isometric view of line (plunge and trend).

2. Trend (α) (similar to dip direction) is the direction of the horizontal projection of the line, measured clockwise from the north.

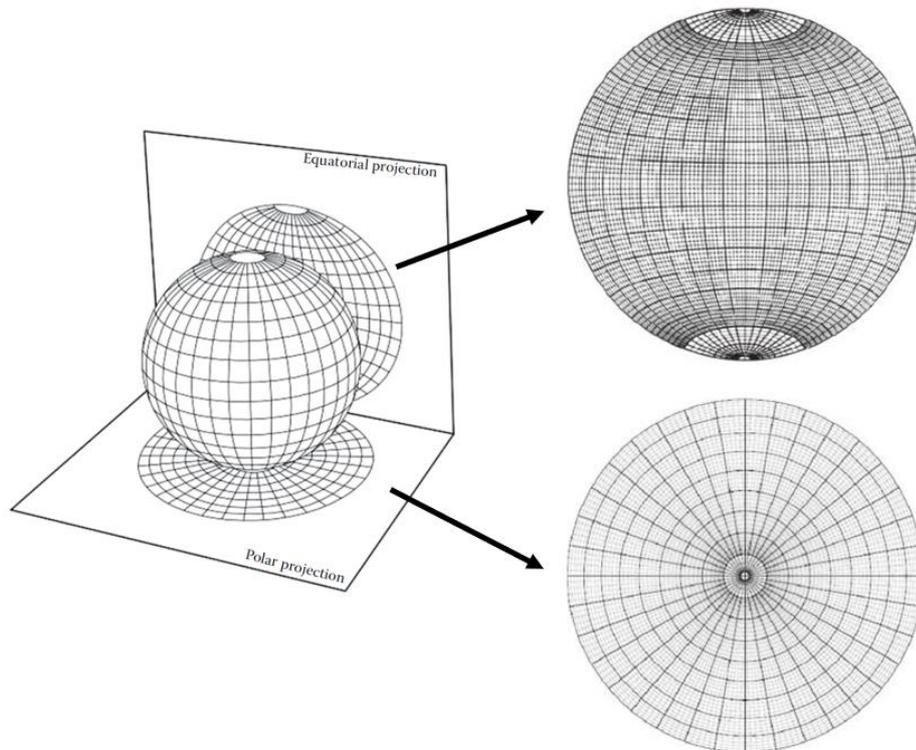
Figure 13: Polar and equatorial projections of a sphere.

The two types of stereographic projections used in structural geology are the polar and equatorial projections as shown in Figure 13. The equatorial stereonet is used to present the projection of a great circle and a pole while the polar stereonet is used to plot only poles.

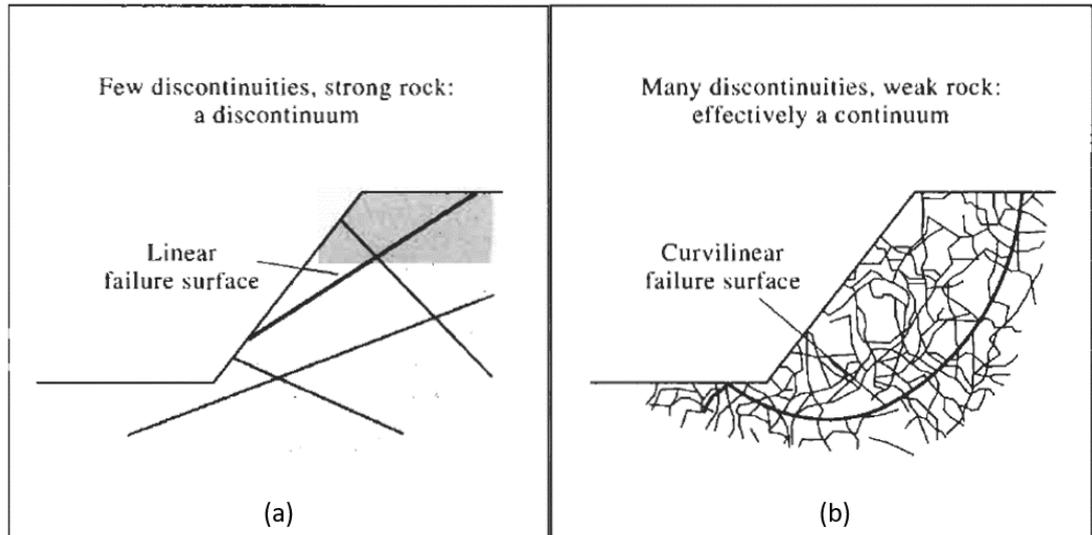
Figure 16: Slope failure mechanisms: a) structurally controlled failure b) non-structurally controlled failure.
Source: (Hudson & Harrison, 1997)

The modes of rock slope failure depend mainly on the geometric interaction of existing discontinuities and the strength of the rock material between them (intact rock strength) (Hudson & Harrison, 1997; Sivakugan et al., 2013). These modes can be basically grouped into two categories, i.e., “structurally controlled failure” and “non-structurally controlled failure”. Structurally controlled failure often occurs along specific pre-existing discontinuities (Figure 16a) typically in hard rock with large discontinuity spacing (Hudson & Harrison, 1997; Goodman, 1989). Non-structurally controlled failure occurs along a surface that approaches a circular shape (Figure 16b) in weak, highly weathered and/or closely fractured rock (Wyllie, 2015). Although most rock slope instabilities are controlled by the geological structures (Hudson & Harrison, 1997), it is always necessary to assess overall slope stability, especially if the strength of the intact rock is low and/or the spacing between discontinuities is small which makes the rock mass highly fracturing.

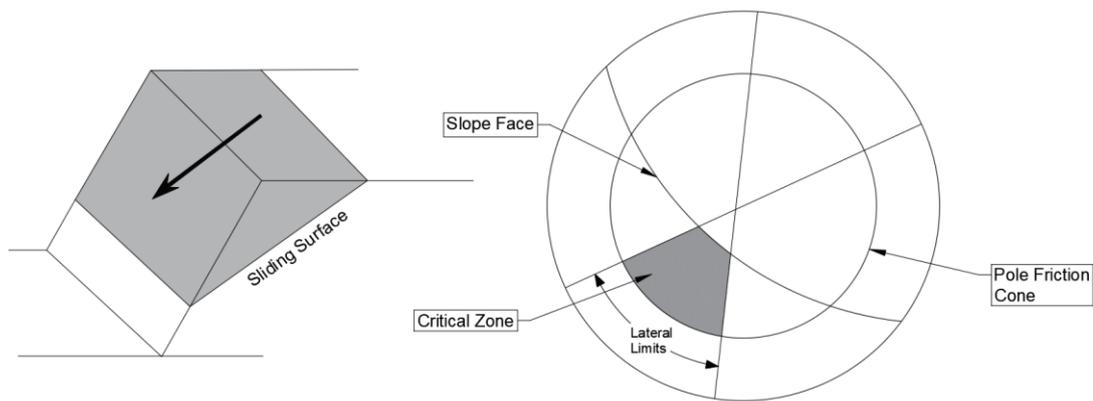
Figure 17: Planar sliding kinematic analysis

Planar sliding occurs on a discontinuity plane dipping out of the slope face at an angle smaller than the slope angle and greater than the friction angle of the discontinuity surface and striking parallel or nearly parallel to the slope face. These conditions can be checked by using spherical projections. For plane failure to occur along a certain discontinuity, its pole must fall within the critical zone for planar sliding as shown in Figure 17. This zone is enclosed between the friction cone, representing the residual friction angle along the discontinuity, the slope plane representing the orientation of the slope face, and the lateral limits to ensure that the dip direction of the discontinuity is within a certain angular range of the slope face dip direction.

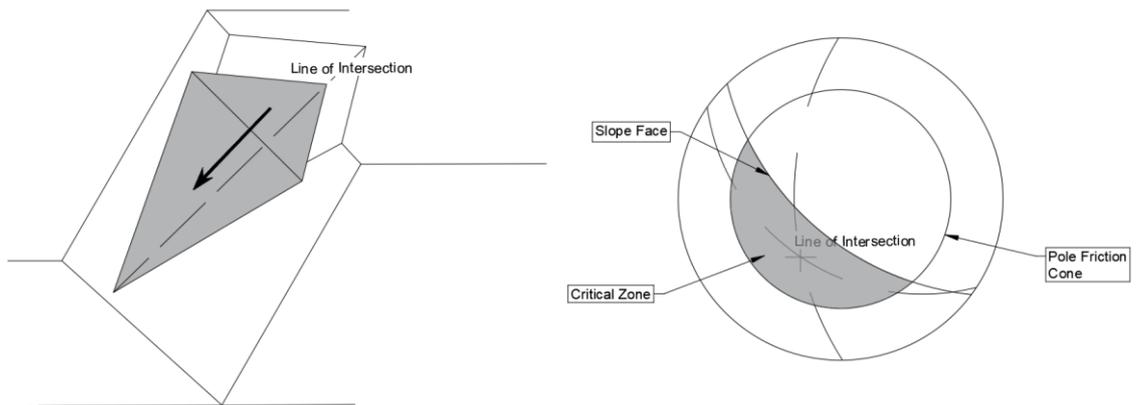
Figure 18: Wedge sliding kinematic analysis

Wedge sliding occurs when the line of intersection of two discontinuities is daylighting into the slope face at an inclination significantly greater than the average angle of internal friction of the two joint/bedding materials. These conditions can be also checked by using spherical projections. For wedge failure to occur along two discontinuities, the pole of the line representing the intersection of these two planes must lie within the critical zone for wedge sliding as shown in Figure 18. This zone is enclosed between the friction cone and the slope plane.

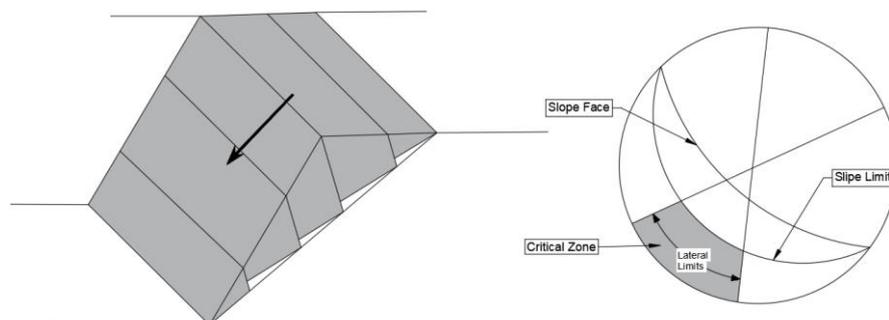
Figure 19: Kinematic analysis toppling failure

Toppling failure occurs when multiple rock columns or layers (depending on their dimensions) are steeply dipping into the slope face causing them to rotate about their bases into the free excavation (Fig. 20c) (Hudson & Harrison, 1997; Sivakugan et al., 2013). For toppling failure to occur over a certain discontinuity, its pole must lie within the critical zone for toppling failure as shown in Figure 19. This zone is defined by the region outside the slip limit plane and inside the lateral limits. The slip limit plane is not an actual physical plane although it is derived from the slope angle and friction angle. The dip angle of the slip limit plane is equal to the difference between the slope dip and the friction angle, and its dip direction is equal to that of the slope face.

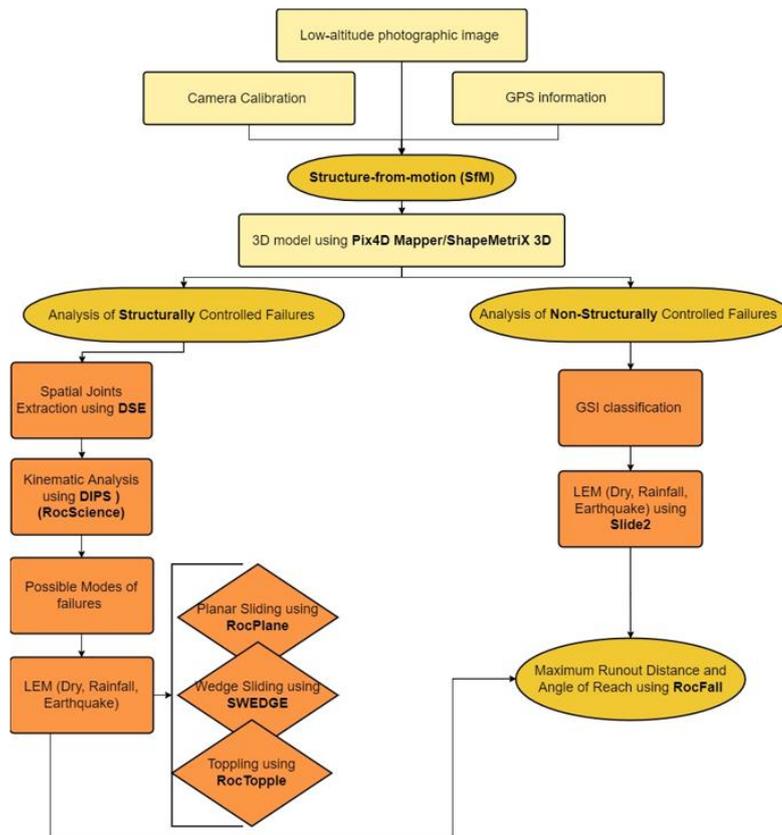
Figure 21: Methodology Flowchart

This chapter outlines the methodology that was adopted to assess the stability of four limestone quarries located in the Anti-Lebanon mountain range under dry, rainfall, and seismic conditions. The flowchart in Figure 21 sets out the methodology of this research. The first step was to visit the quarry sites where photogrammetric surveys were carried out using UAV technology to create 3D models of the rock faces for rock mass characterization, slope stability analysis, and feature extraction. The stability of the studied quarries controlled by geometry and strength of the discontinuities was evaluated kinematically and then analyzed using limit equilibrium methods under dry, rainfall, and seismic conditions. The overall stability of the quarries was also assessed based on the geological strength index (GIS) classification and the rock mass geomechanical properties were based on the generalized Hoek- Brown constants. The maximum runout distance and the corresponding angle of reach were determined wherever the quarry face was found unstable.

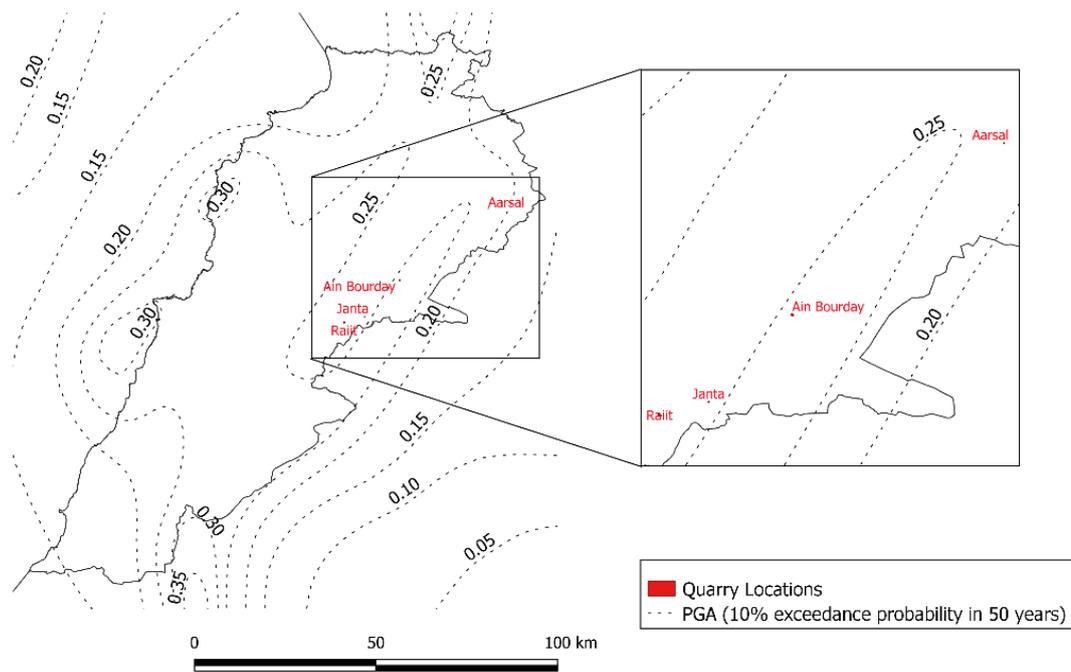
Figure 22: Contour maps of peak ground acceleration (PGA) with a 10% exceedance probability in 50 years (Huijer et al., 2011)

between occurrences) for most areas within Lebanon varies between 15 and 35 percent of the gravitational acceleration (Figure 22).

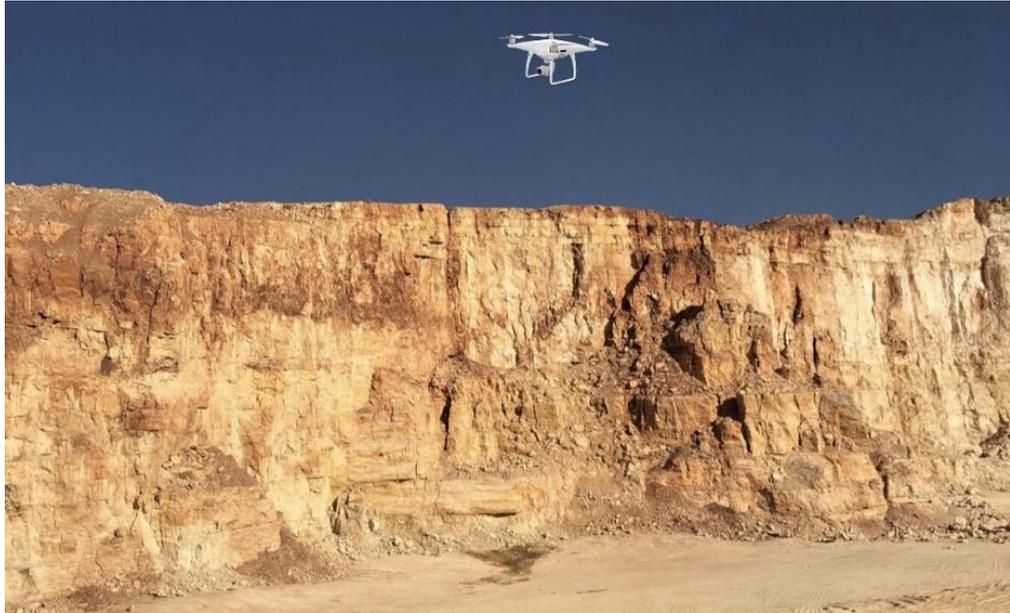
Figure 24: UAV operation in Quarry 2 mapping.

The DJI Phantom 4 Pro was used to capture the digital images (Figure 24). This drone has a high-quality camera allows it to take sharp, 1080-pixel photos. It can take off and land in small areas due to its small size. One battery allows a maximum flight time of 30 minutes. When more time was required to complete the mission in progress or to start a new mission on the same visit, the battery was sequentially replaced on site with two fully charged batteries.

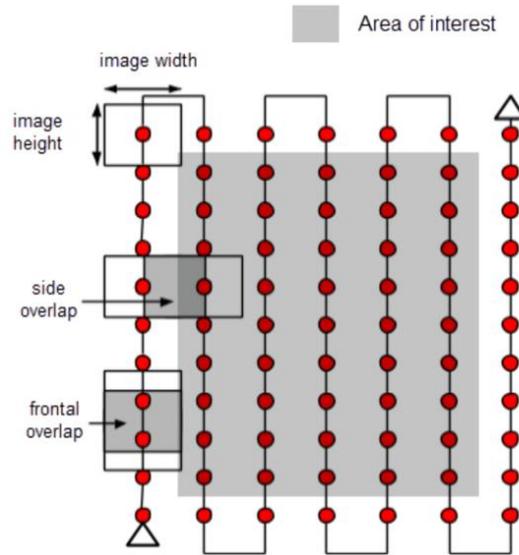
Figure 25: Image Acquisition Plan

The UAV-based remote sensing survey consists of creating a 3D point cloud data that is defined by overlapping at least two images taken from different positions. A point cloud is a digital 3D representation of a physical object or space. It's made of a huge collection of tiny individual georeferenced points plotted in 3D space. When there is a high overlap between the images, the common area captured will be larger and thus the 3D points can be computed more accurately. The drone flight was planned using the Pix4Dcapture mobile app with a double grid mission and maximum overlap. The overlap of the side and front images was set to 90% and the camera angle was set to 60° from the horizontal based on the recommendations developed by Pix4D company for steep slope mapping (Figure 25).

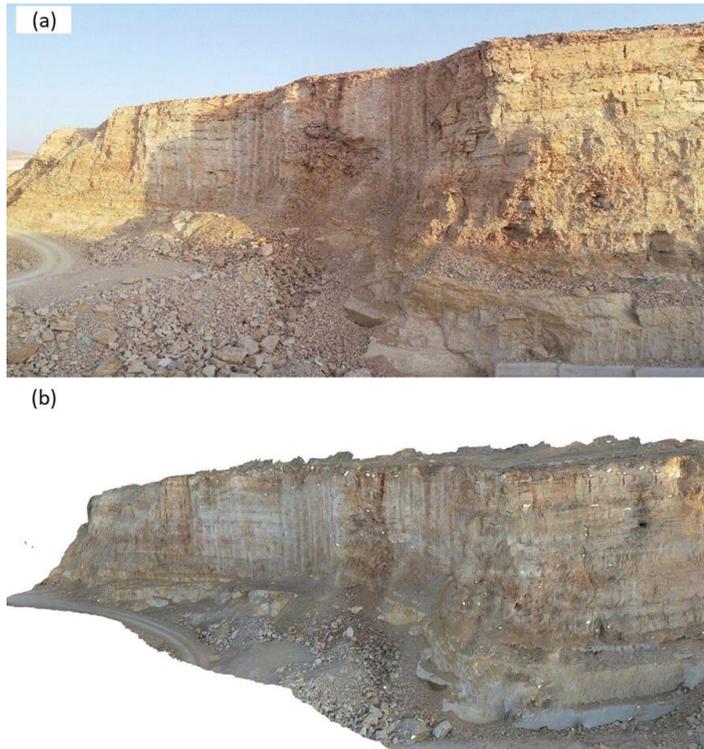
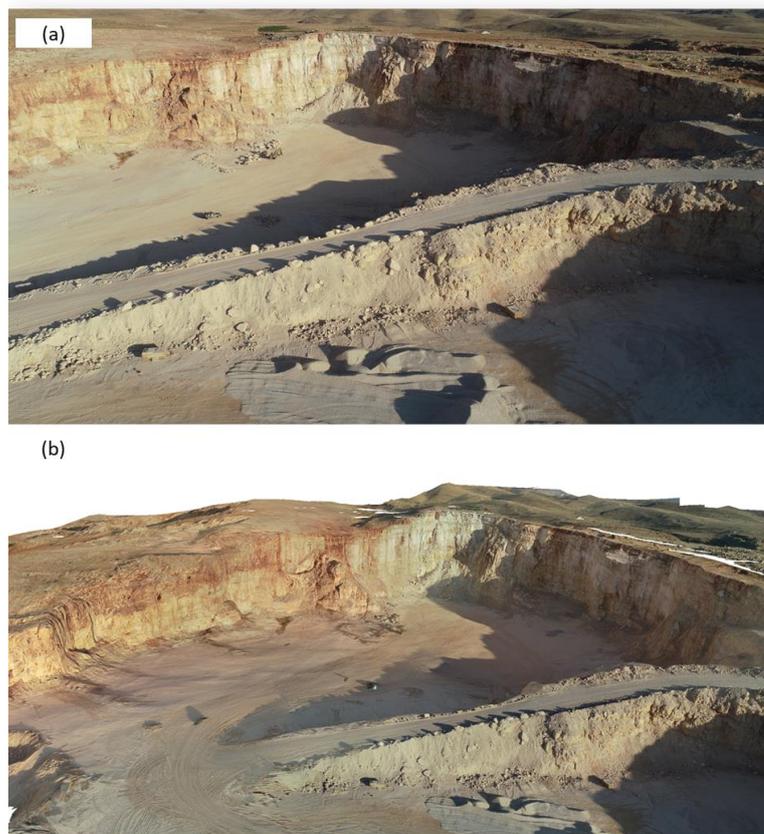
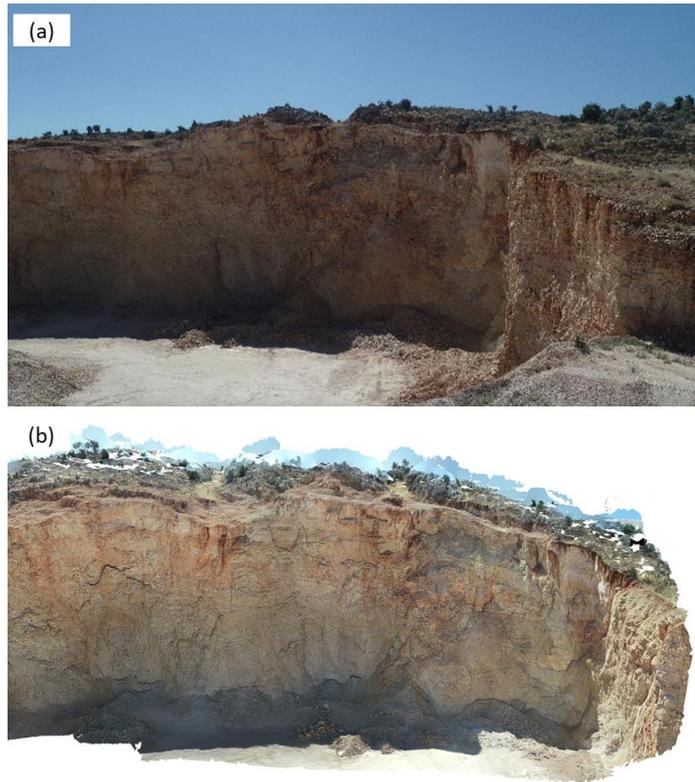
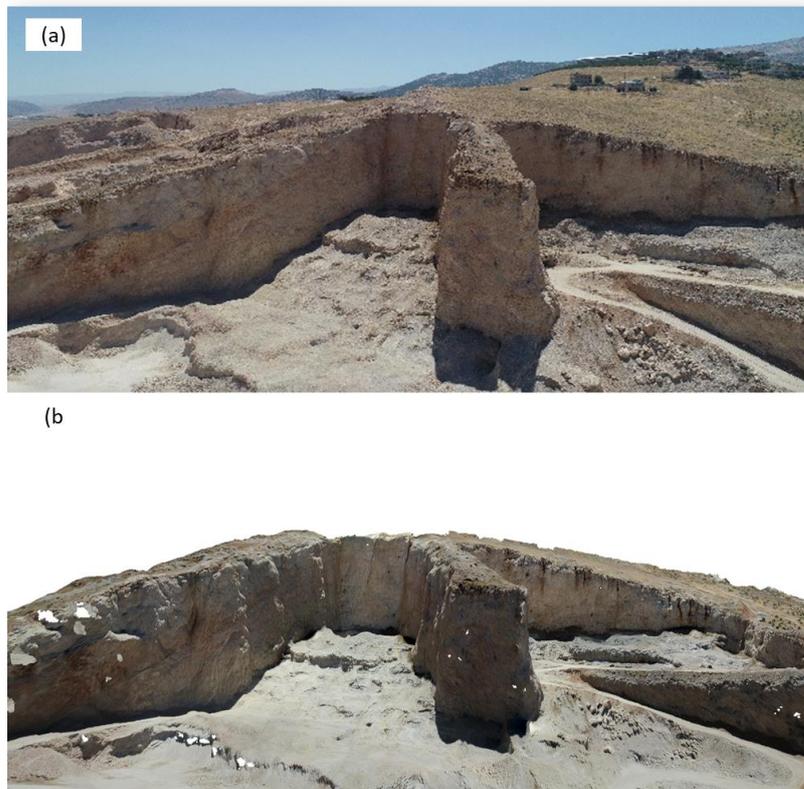
Figure 26: Aarsal Quarry: a) Image by the DJI Phantom 4 Pro drone and b) 3D Model created using the SfM technique

Figure 27: Ain Bourday Quarry: a) Image by the DJI Phantom 4 Pro drone and b) 3D Model created using the SfM technique

Figure 28: Raiti Quarry: a) Image by the DJI Phantom 4 Pro drone and b) 3D Model created using the SfM technique

Figure 29: Janta Quarry: a) Image by the DJI Phantom 4 Pro drone and b) 3D Model created using the SfM technique.

By comparing the on-site images of the four quarries to their corresponding three-dimensional models as shown in figures below (Figure 26 to Figure 29), it is evident that the generated 3D scenes match exactly the actual quarry faces.

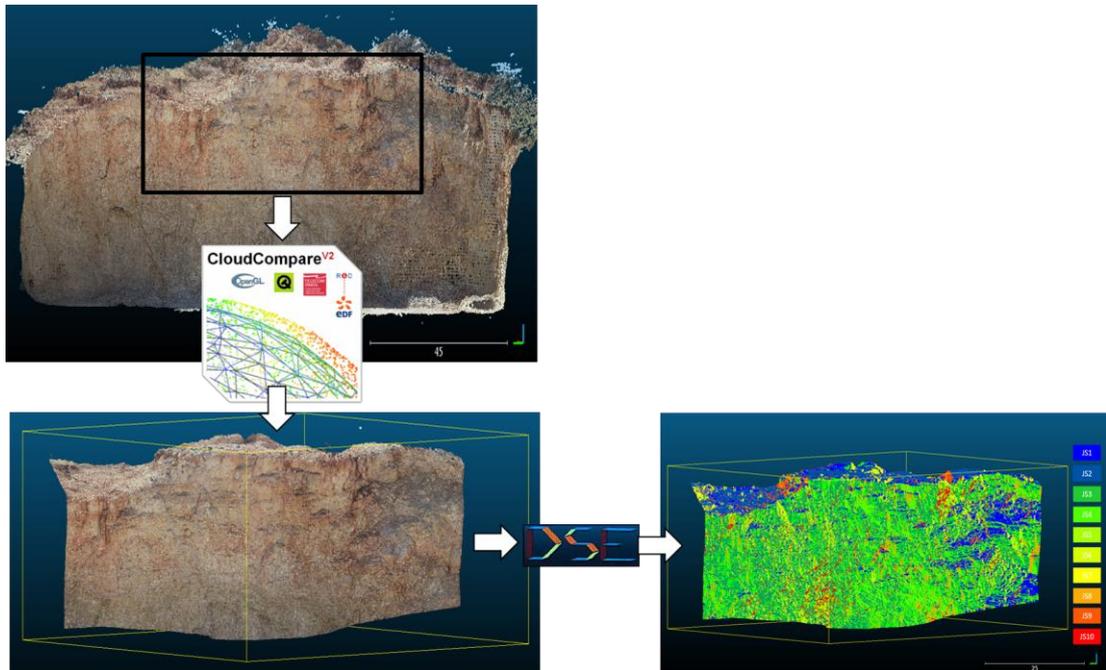
Figure 30: Critical Section of Quarry 3 clipped in CloudCompare

This file was then used as an input data for an open-source software programmed in MATLAB, Discontinuity Set Extractor (DSE) to extract discontinuity sets from the rock masses. DSE follows the method outlined by Riquelme et al. (2014) which defines the equations of the different planes of the rock slope surface by first applying a coplanarity test for the neighbouring points, followed by finding principal orientations and identifying clusters. Figure 30 shows an illustration of the above steps for Quarry 3 as an example.

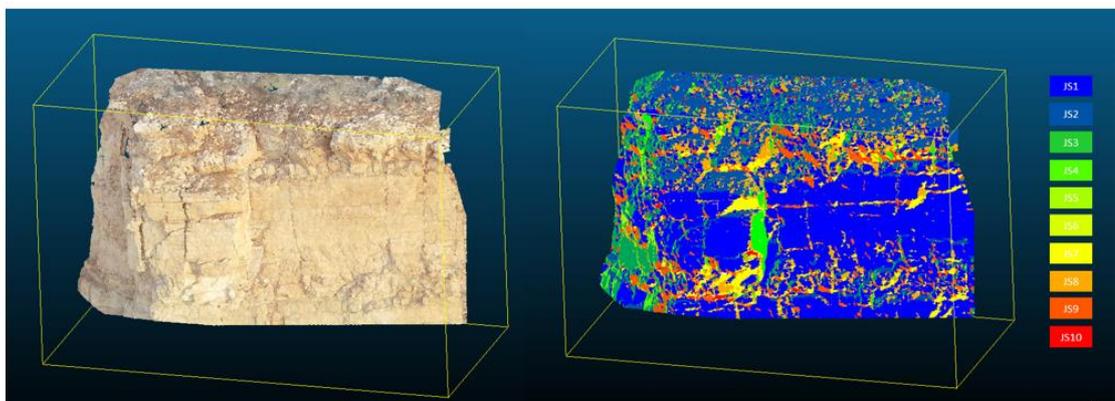
Figure 31: Overlaying DSE-detected joint sets on the quarry face in Quarry 1 using ClouCompare

This method is not fully automated. It remains necessary for the operator to visually verify the detected discontinuity sets by placing them on the quarry face in CloudCompare. Figure 31 shows how the discontinuities in quarry face of Quarry 1 were extracted using DSE and viewed in CloudCompare to validate that the detected planes perfectly trace actual discontinuities. The length and spacing of the discontinuities were determined from either CloudCompare or ShapeMetriX software.

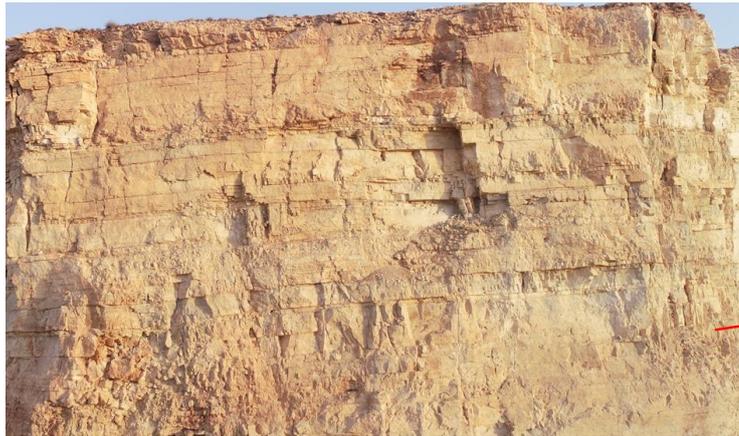
Figure 20: Geological Strength Index Chart for Jointed Rocks.

GEOLOGICAL STRENGTH INDEX FOR JOINTED ROCKS (Hoek and Martin, 2000)
 From the lithology, structure and surface conditions of the discontinuities, estimate the average value of GSI. Do not try to be too precise. Quoting a range from 31 to 37 is more realistic than stating that GSI = 35. Note that the table does not apply to structurally controlled failures. Where weak planar structural planes are present in an unfavourable orientation with respect to the excavation face, these will dominate the rock mass behavior. The shear strength of surfaces in rocks that are prone to deterioration as a result of changes in moisture content will be reduced if water is present. When working with rocks in the field in very poor conditions, a shift to the right may be made for wet conditions. Where pressure is dealt with by effective stress analysis.

The GSI value is assigned using Figure 20 and the disturbance factor D is estimated based on the degree of disturbance to which the rock mass has been subjected to blast damage and stress relaxation. The value of D varies in the range of 0–1; 0 for undisturbed and 1 for highly disturbed rock mass.

For the general stability analysis, the rock mass was first classified based on the GSI classification system. The GSI value for each quarry was estimated by comparing the structure and surface conditions of the discontinuities with the chart shown in Figure 20. GSI was estimated as 55, 40, 45, and 65 for Quarry 1, 2, 3 and 4, respectively. Figure 32 shows a comparison of the GSI chart for jointed rocks and the slope face of Quarry 1. The comparison reveals that the slope surface appears to be “VERY BLOCKY” with “GOOD” quality due to the fact that the surface is rough and slightly weathered. Therefore, GSI 55 was assigned to Quarry 1.

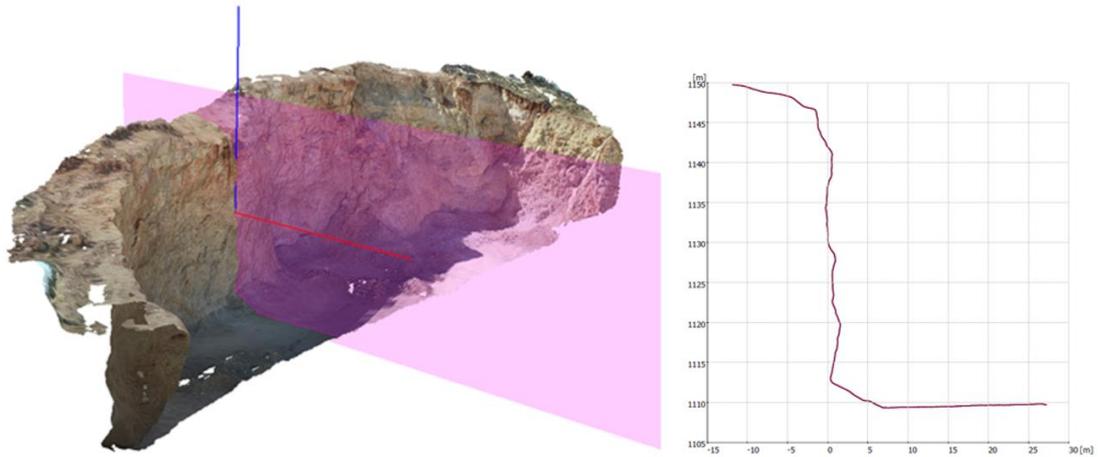
Figure 34: 2D cross-section extraction from 3D Model of Quarry 3

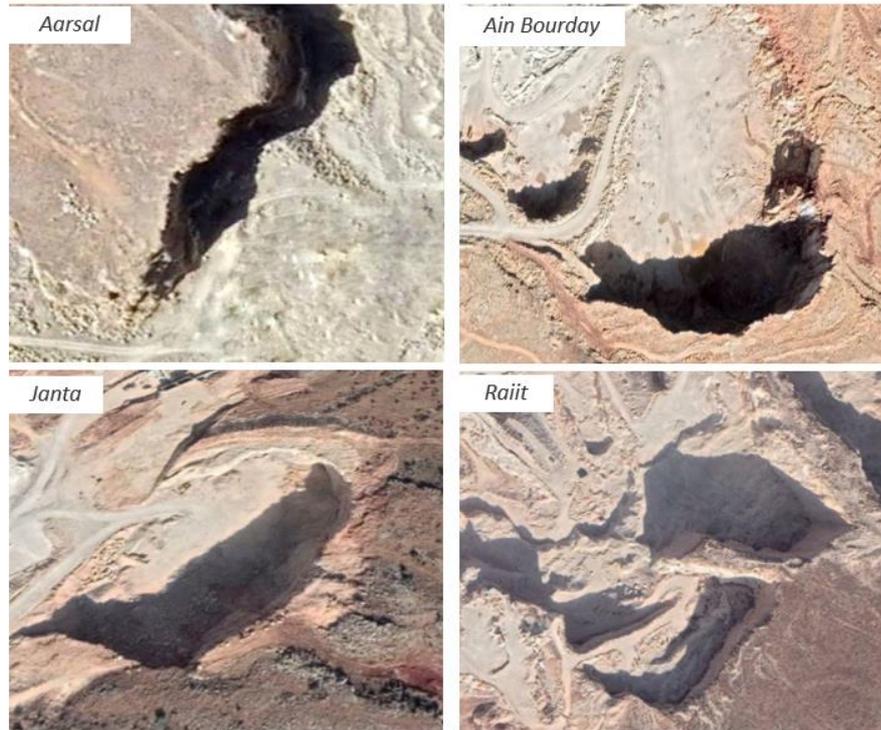
Figure 36: Satellite Image of the four quarry sites reproduced using Google Earth

Figure 35 shows the DEMs of the four quarries created in CloudCompare using the generated 3D point cloud file. It is clear that the slope face in all these quarries is very steep through the change of colours, indicating a significant decrease in height along a short horizontal distance. This is consistent with what was observed during the site visits, and from the satellite images produced using Google Earth (Figure 36). All quarry faces have near vertical cuts.

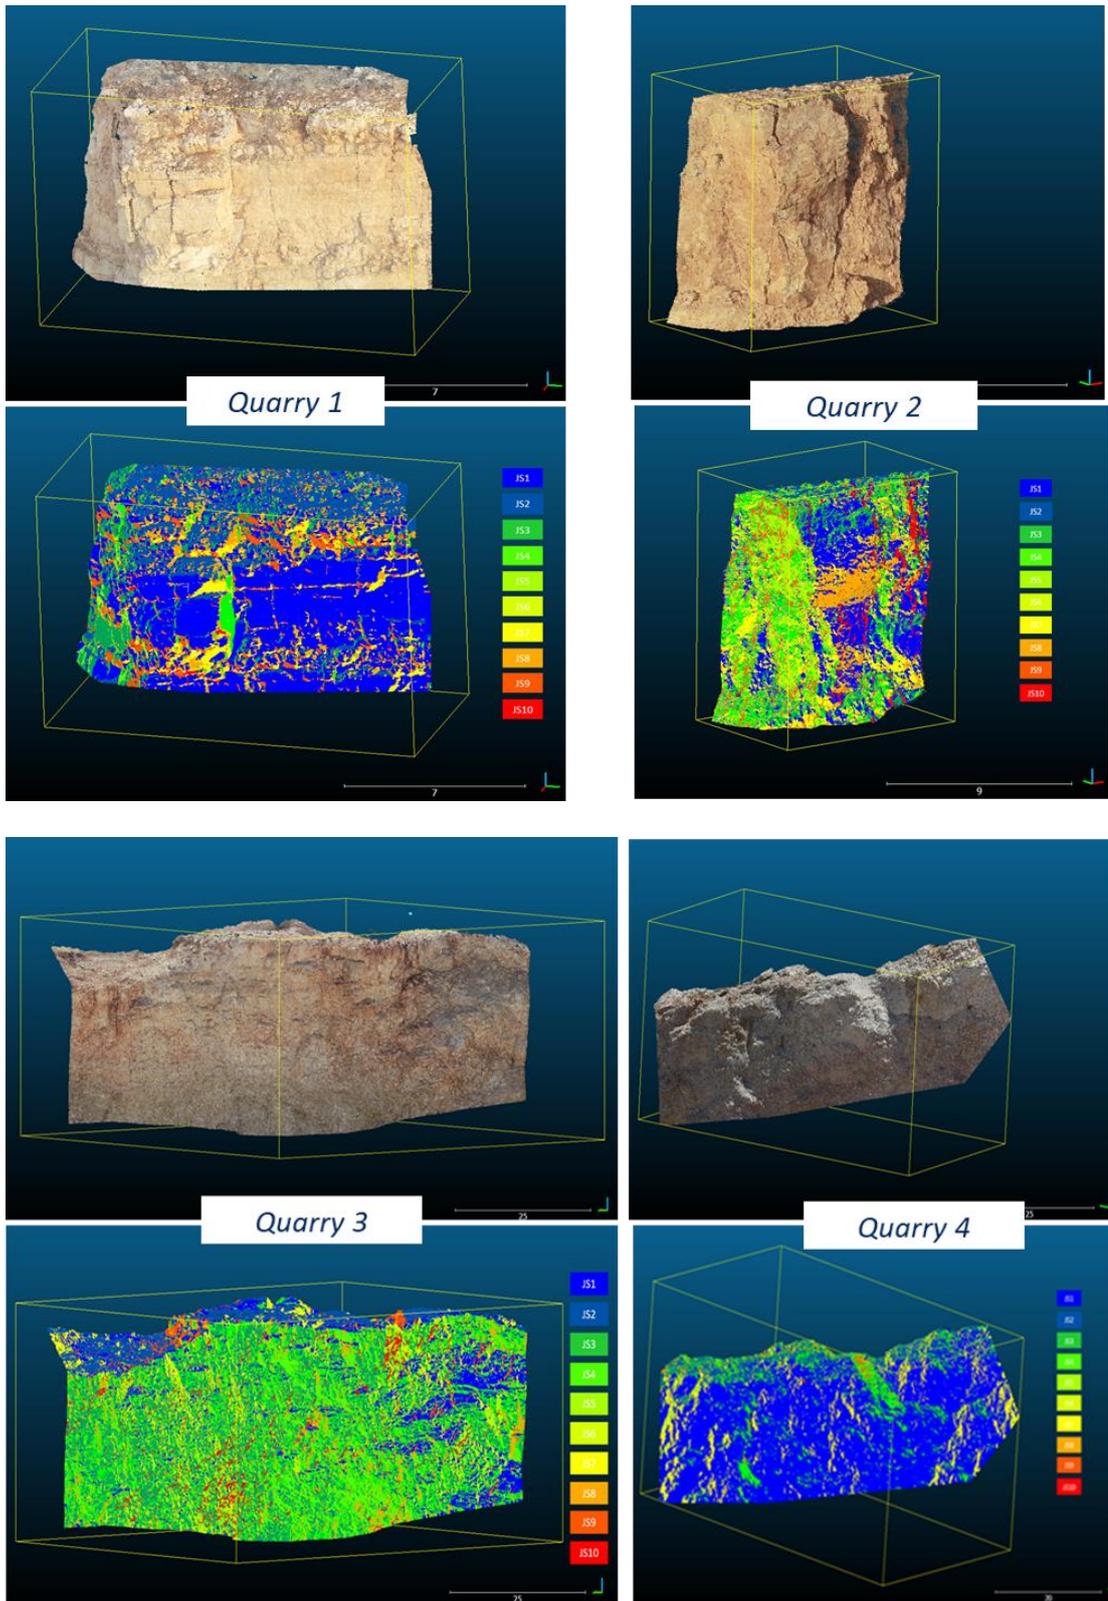
Figure 37: The color scale represents the discontinuity sets assigned to each point of the critical face that was cropped from each quarry face.

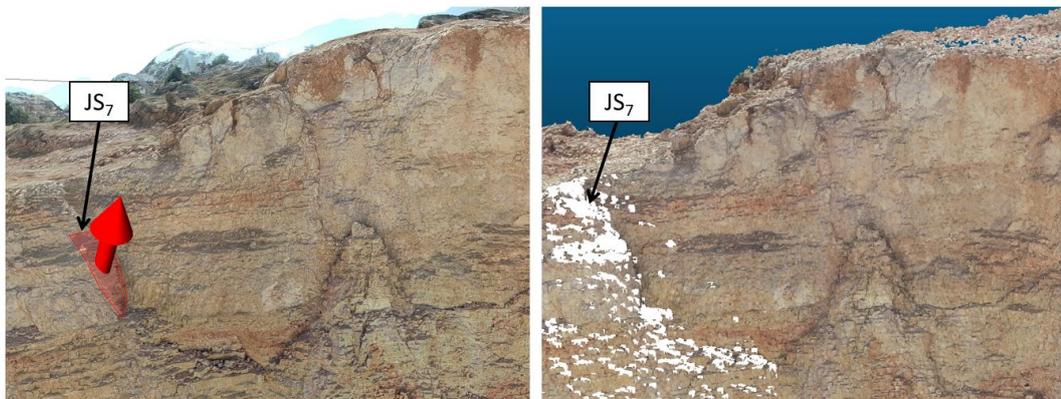
Figure 38: The orientation of JS7 (from Quarry 3) obtained with b) DSE, was verified using a) ShapeMetrix software.

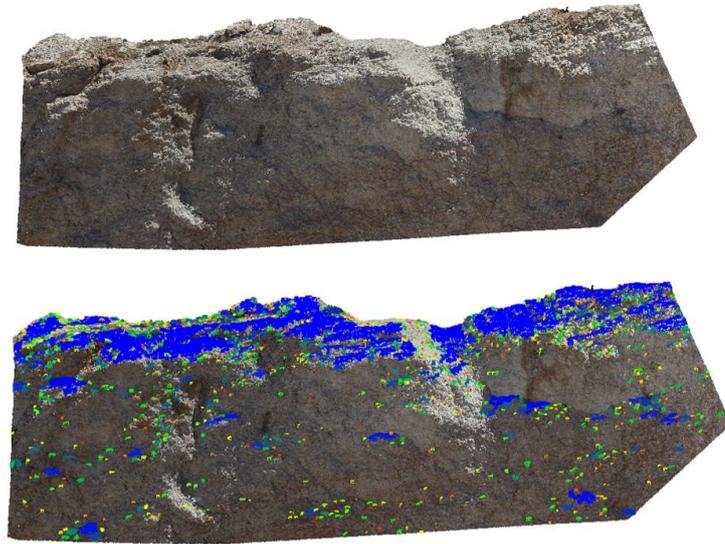
Figure 39: JS2 in Quarry 4 shows a risk of planar sliding

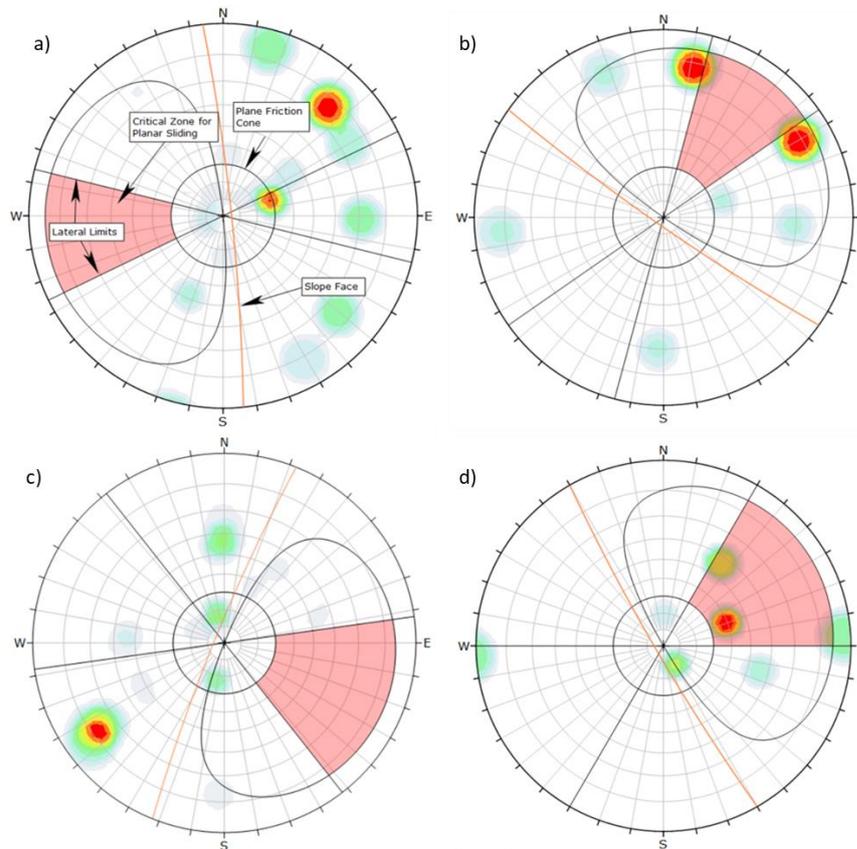
Figure 40: Kinematic analysis of planar failure using DIPS on a) Quarry 1, b) Quarry 2, c) Quarry 3, and d) Quarry 4

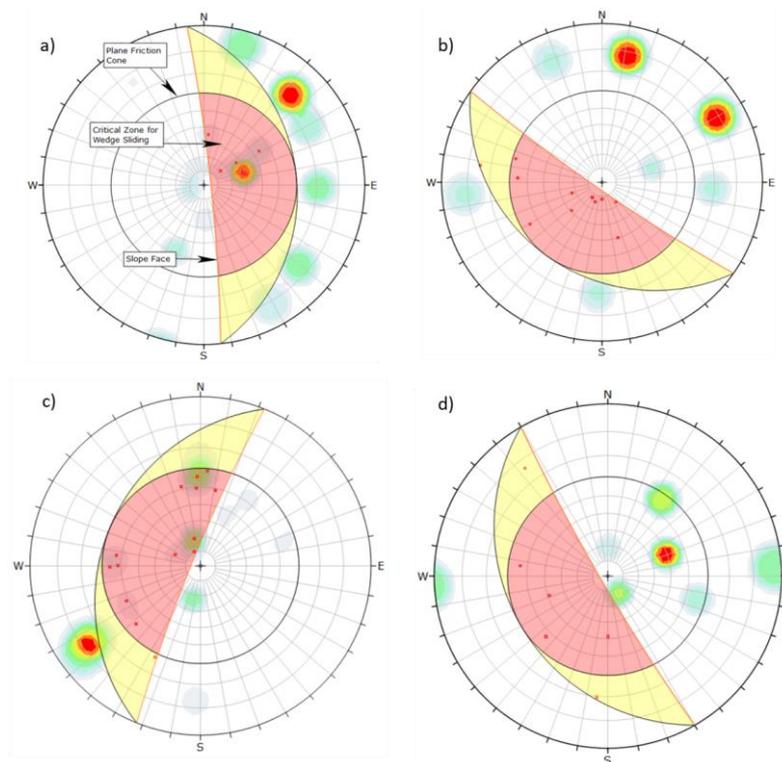
Figure 41: Kinematic analysis of wedge failure using DIPS on a) Quarry 1, b) Quarry 2, c) Quarry 3, and d) Quarry 4

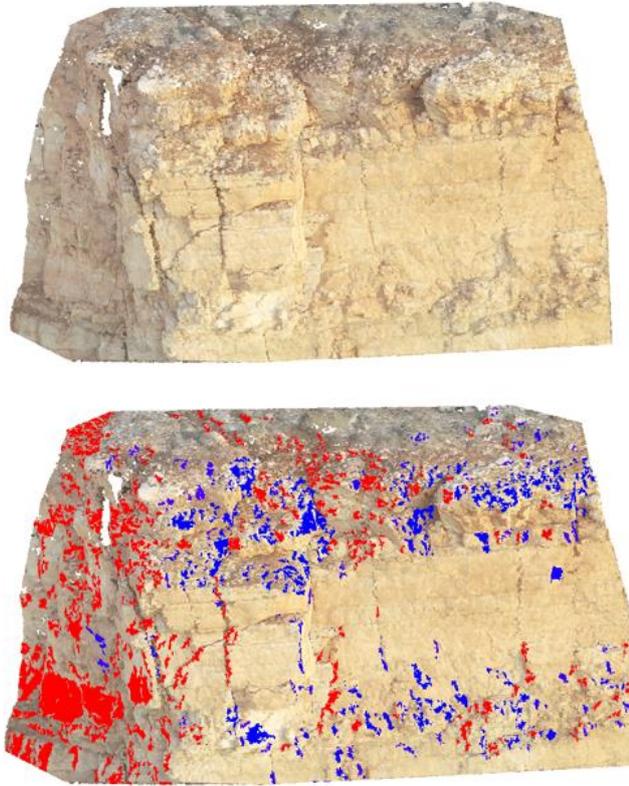
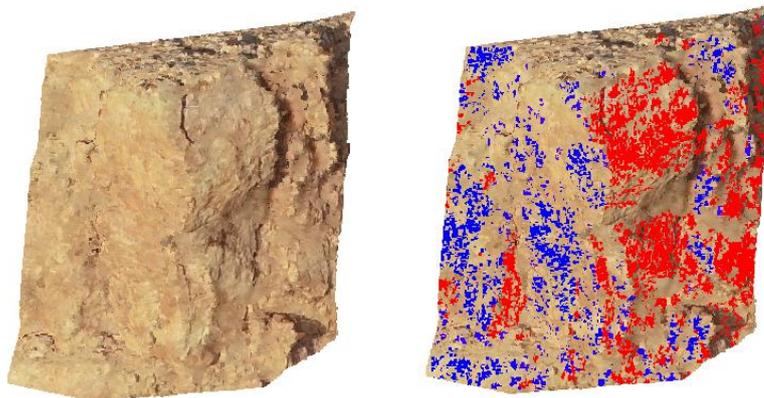
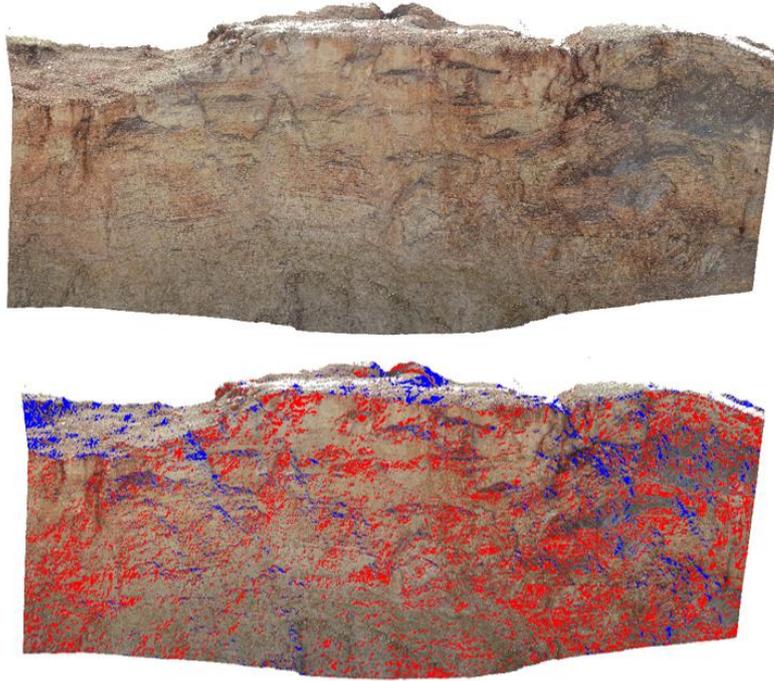
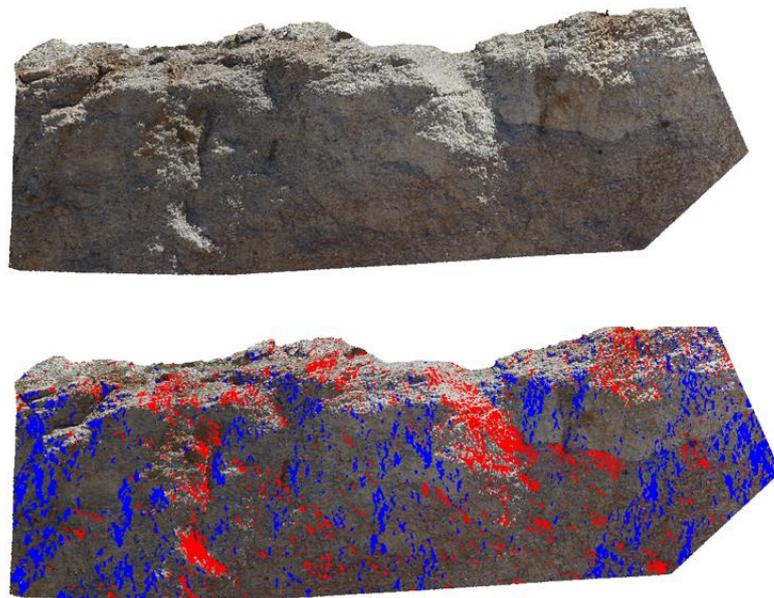
Figure 42: JS3 and JS8 showing a risk of wedge sliding (Quarry 1)

Figure 43: JS1 and JS4 showing a risk of wedge sliding (Quarry 2)

Figure 44: JS4 and JS7 showing a risk of wedge sliding (Quarry 3)

Figure 45: JS4 and JS7 showing a risk of wedge sliding (Quarry 4)
