Multiple Site-Specific Analyses of the Stability of Quarried Slopes in
Lebanon Based on Unmanned Aerial Vehicle Photogrammetry

A thesis

for the degree of Master of Science in Civil and Environmental Engineering

April 2022

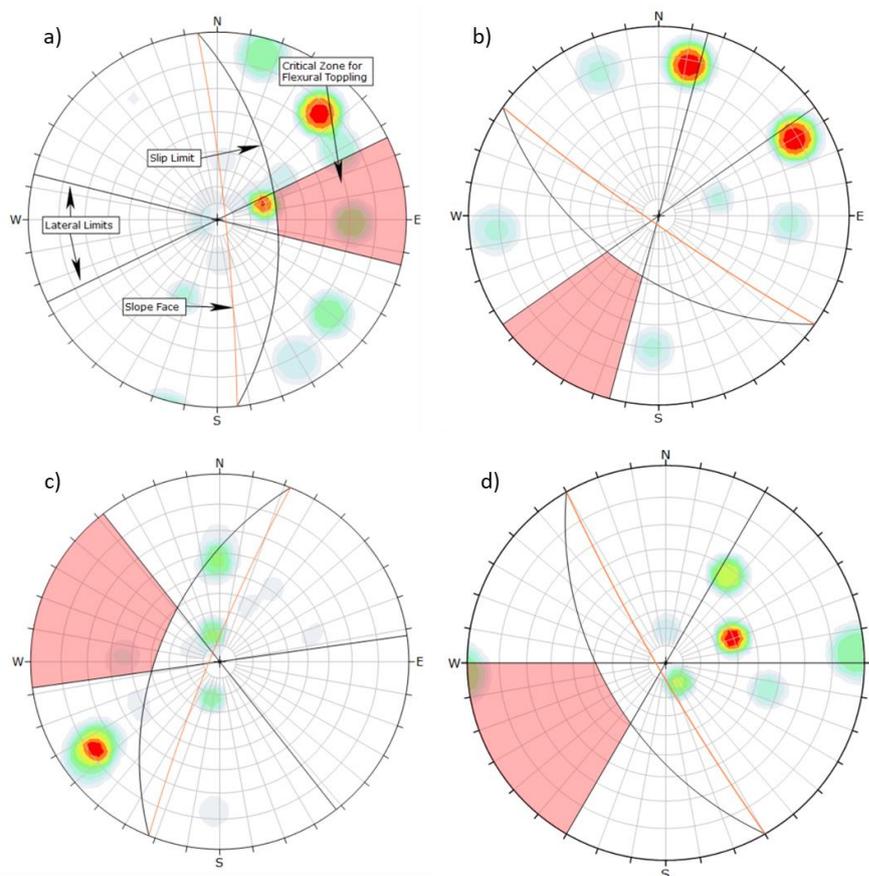
Figure 46: Kinematic analysis of flexural toppling using DIPS on a) Quarry 1, b) Quarry 2, c) Quarry 3, and d) Quarry 4

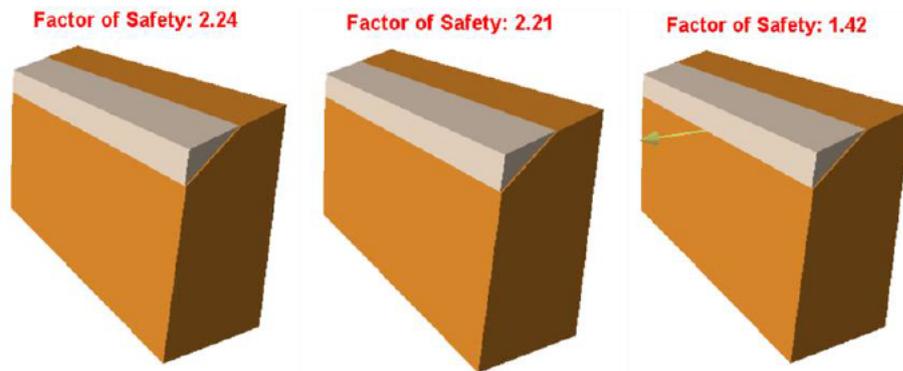
Figure 47: Factor of safety of JS2 of Quarry 4 under (a) Dry conditions (b) Wet conditions (c) Seismic loading

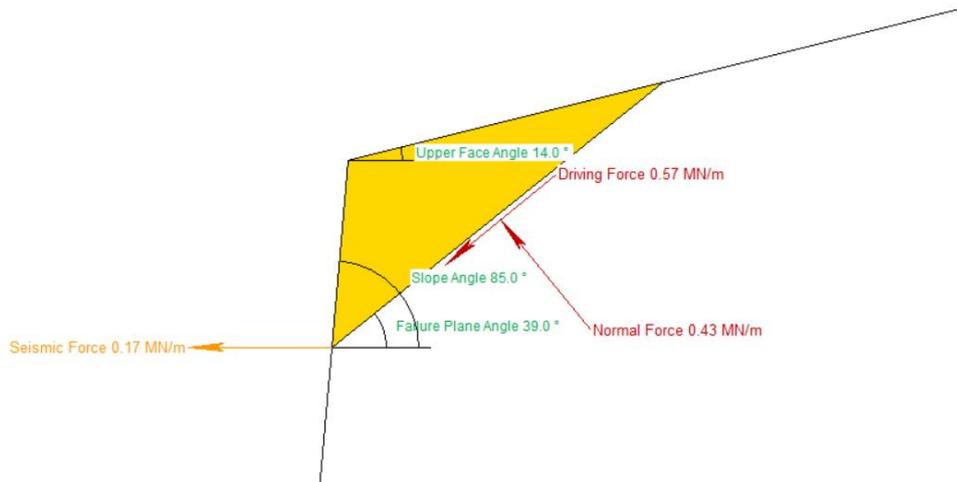
Figure 48: 2D view of the JS2 model showing the applied and resultant forces under seismic event.

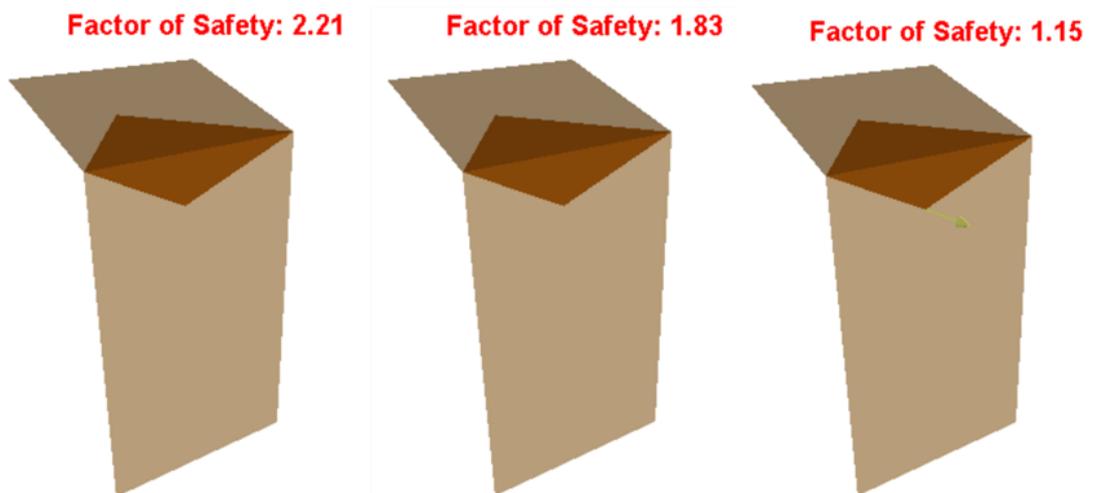
Figure 49: Factor of safety of wedge formed by JS1 and JS7 in Quarry 3 under (a) Dry conditions (b) Wet conditions (c) Seismic loading

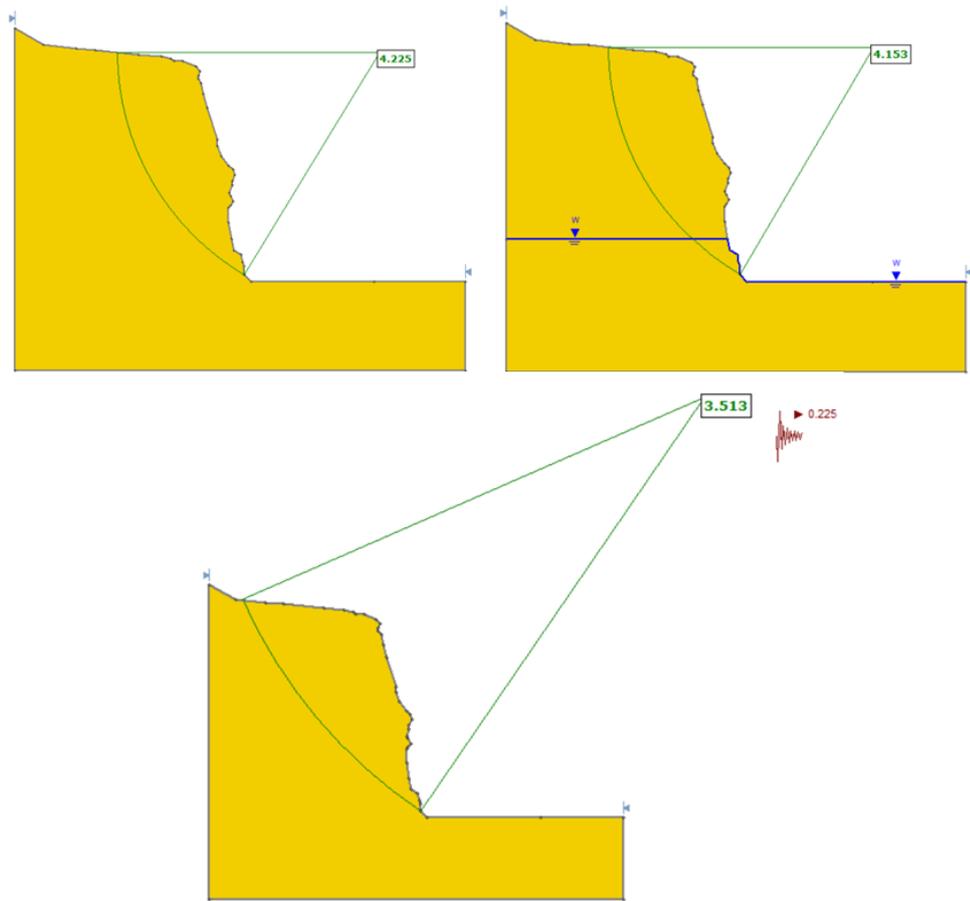
Figure 50: Factor of safety of the overall slope in Quarry 1 under (a) Dry conditions (b) Wet conditions (c) Seismic loading

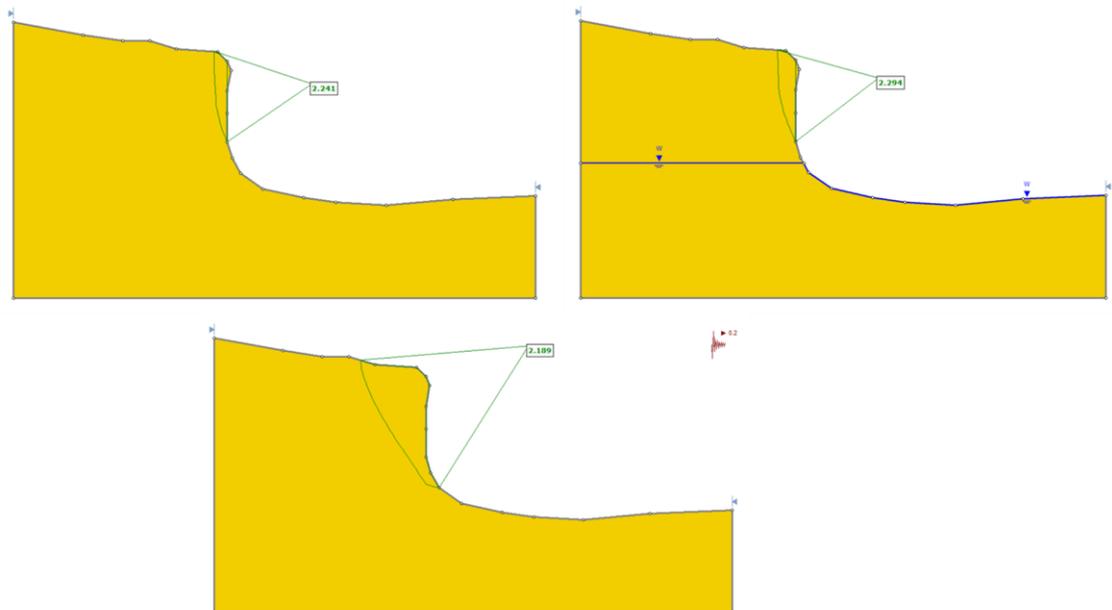
Figure 51: Overall Slope Stability Results for Quarry 2 under (a) Dry conditions (b) Wet conditions (c) Seismic loading

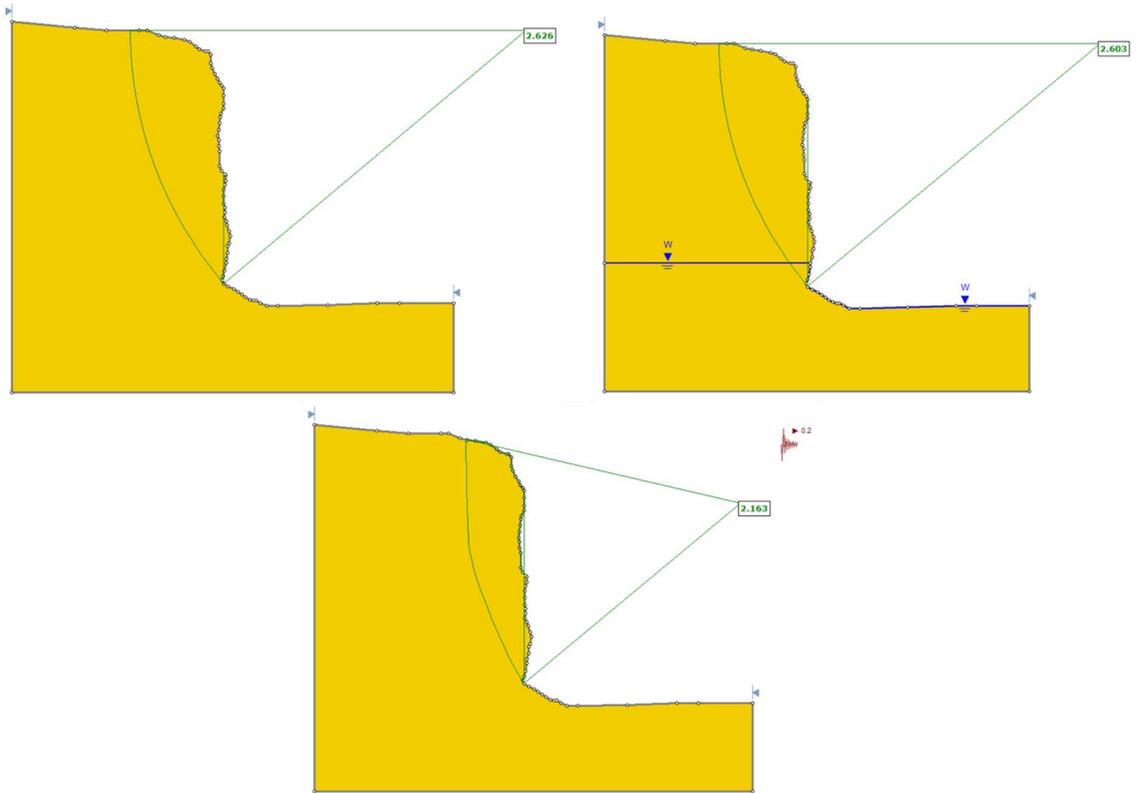
Figure 52: Overall Slope Stability Results for Quarry 3 under (a) Dry conditions (b) Wet conditions (c) Seismic loading

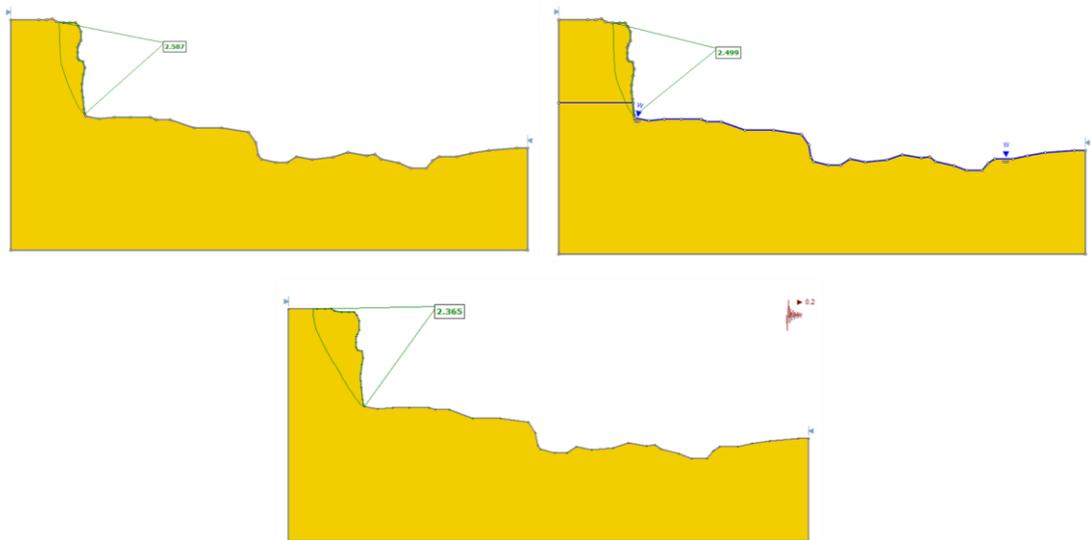
Figure 53: Overall Slope Stability Results for Quarry 4 under (a) Dry conditions (b) Wet conditions (c) Seismic loading

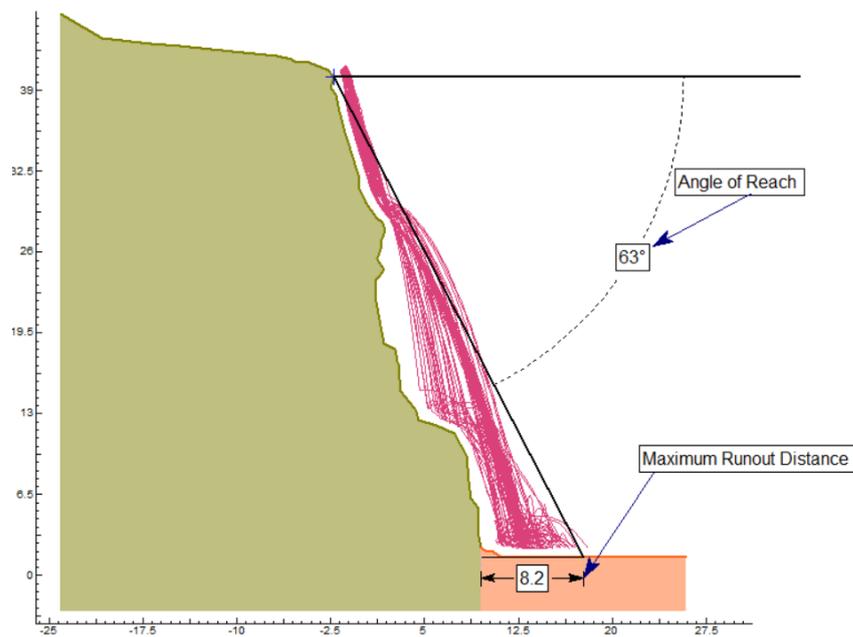
Figure 54: RocFall analysis of the wedge formed by JS3 & JS4 for Quarry 1.

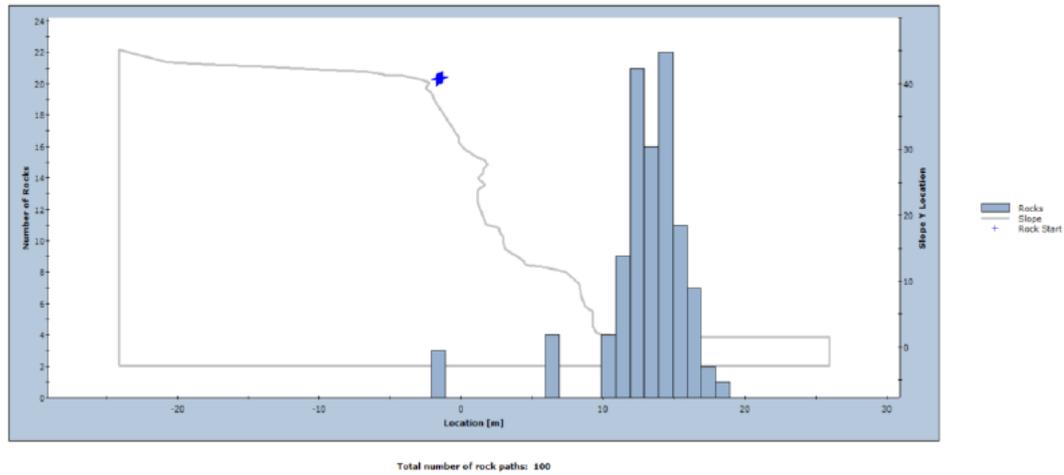
Figure 55: Distribution of rock fall path end locations of the wedge formed by JS3 & JS4 for Quarry 1.

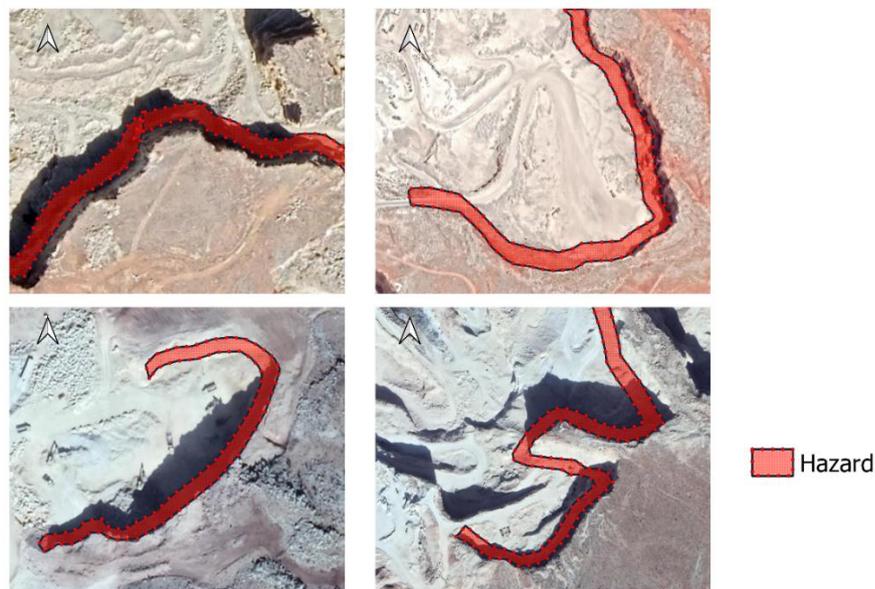
Figure 56: Rockfall Hazard shown in QGIS for a) Quarry 1, b) Quarry 2, c) Quarry 3, and d) Quarry 4

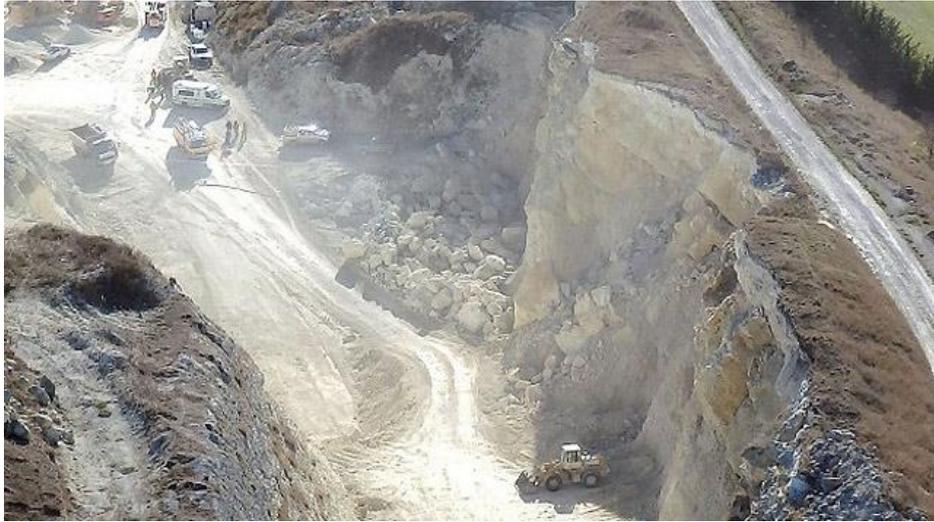
Figure 57: Limestone Quarry Failure in New Zealand

One limitation of the 2D rockfall simulation is the lack of the lateral trajectory dispersion modeling. Therefore, the hazard associated with rockfalls for each quarry was assumed to be in the area created by offsetting the slope face a distance equal to the maximum runout distance for each site. This was done using QGIS software and the generated hazard map is shown in Figure 56. By examining the landslide hazardous areas of each quarry, it can be seen that the hazard is limited to the quarry site only and any potential rock fall threatens the quarry workers and equipment since the exposure appears to be low. This can be confirmed by reviewing the landslide discussed earlier in Chapter 2 where a limestone quarry failure occurred in New Zealand and resulted in the death of the quarry owner. The quarry face is very similar to the quarries analyzed in this study as they all have a steep slope with a slope height of 40 to 60 m. Looking at the rock blocks that have fallen (Figure 57), we notice that these blocks have reached a small runout distance (no more than 10 meters).

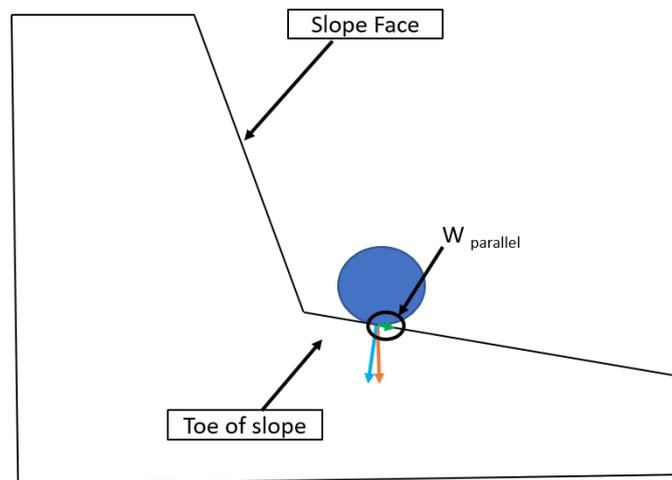
Figure 58: Sketch showing the toe of slope and the parallel component of the weight
