**LEBANESE AMERICAN UNIVERSITY**

Seismic Performance of Slender Concrete Shear Walls with and  
without Carbon Fiber Reinforced Polymers Laminates

For the degree of Master of Science in Civil and Environmental Engineering

December 2022

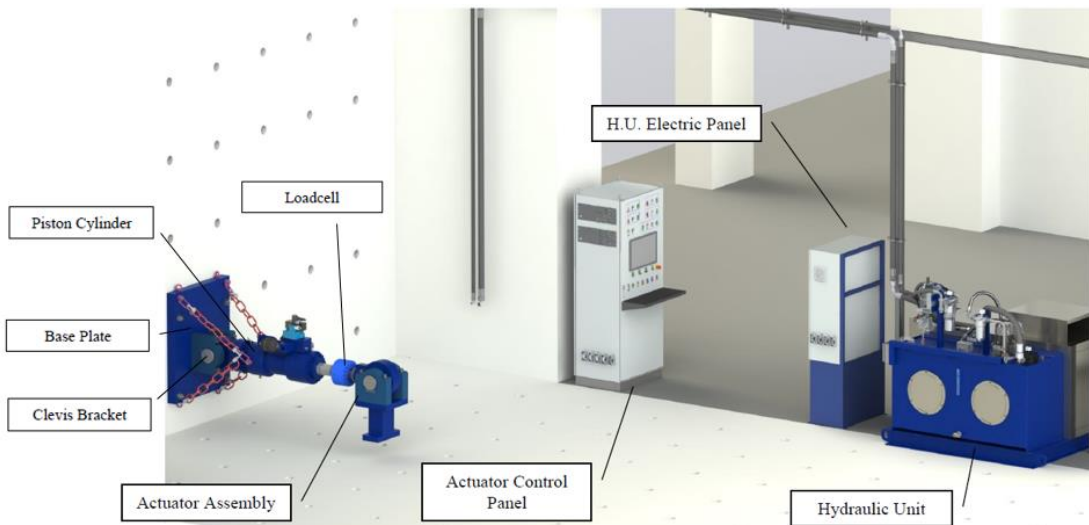
*Fig. 1 Description of the RWSF Machine*

The experiment was conducted using a Reaction Wall and Strong Floor (RWSF) testing setup in the Engineering Laboratories and Research Center (ELRC) at the Lebanese American University (LAU). This equipment can perform quasi-static and pseudo-dynamic two-dimensional earthquake simulations on full-scale structural concrete members and building components such as girders, piers, and shear walls. It can also handle a variety of axial and lateral loading scenarios. The RWSF system consists of the hydraulic power unit, where the hydraulic energy is produced to the system, with its electric panel and the actuator assembly, and an electric actuator control panel as illustrated in Fig. 1. The hydraulic unit and actuator assembly are controlled by the electric

panels that contain switches and a built-in PC. The actuator assembly is made up of a base plate fixed to the wall by four M24 tie rods. Two hydraulic actuators procured by Bosch have a maximum capacity of 1200 kN and a maximum frequency of 10 Hz. A piston-cylinder is capable of producing 900 kN push force and 565 kN pull force. The actuator is connected to the base plate by a clevis bracket that ensures the alignment of the force during the test. In addition, a load cell that can read loads in compression and tension up to 120 kN. Moreover, experiments are applied and monitored from the control panel where the progress and results are displayed on the software installed on the built-in PC.

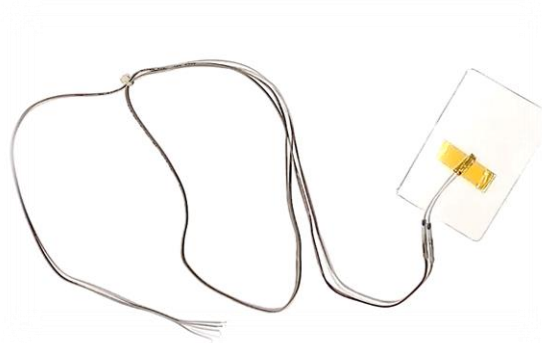
*Fig. 2 Pre-wired strain gauges*

To measure the strain vs applied load, sixty two pre-wired strain gauges are used for the measurement of the strain with respect to the applied load. The pre-wired strain gauges are manufactured by Omega. The chosen model is KFH-10-120-C1-11L1M2R that have a linear 10 mm grid with two 1-meter leads and 120  $\Omega$  resistance. The strain gauges were connected to the data acquisition using extension cables. Figure 2 shows a sample of the used pre-wired strain gauge.

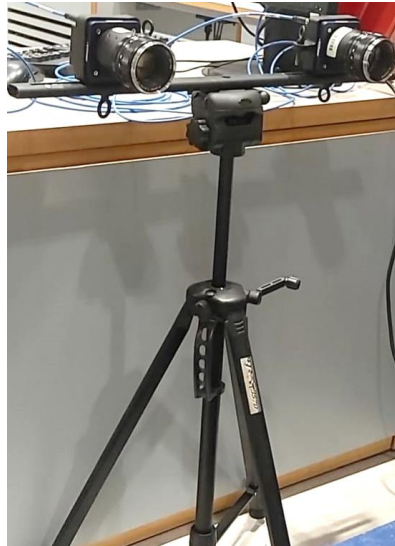
*Fig. 3 Two Imperx cameras*

In order to monitor the displacement of the shear wall specimens in 3D, two cameras were placed parallel to each other on the same tripod and had a center-to-center distance of 27 cm, as shown in Figure 3. Both cameras were placed facing toward the wall. The cameras are manufactured by Imperx. The chosen model is IMPERX CXP-C5190C where the cameras have a 4-channel C5190 CXP-6 CoaXPress output interface and a resolution of 25 MP. The cameras were connected to the PC using a Kaya Komodo 8-channel frame grabber. This frame grabber was manufactured by kaya Instruments and it was fully compatible with our cameras. Using the Vision Point software, both cameras can be triggered at the same time. Some parameters were modified in the settings of the cameras and frame grabber. For example, the maximum exposure time was changed to 10,000micro-seconds, the f-stop was changed to 5.6, and the frame rate was set to be 1 frame per second. The acquired images are monochrome because this type has better resolution and these images are stored in (.raw) format for later processing. This setup allows the research team to measure all the movement happening in the plane of the sensor. In fact, we are able to measure the wall displacement and trace the progression of cracking. In addition, the out-of-plane displacement can be obtained by doing 3D measurements where both cameras are used to triangulate the out-of-plane movement.

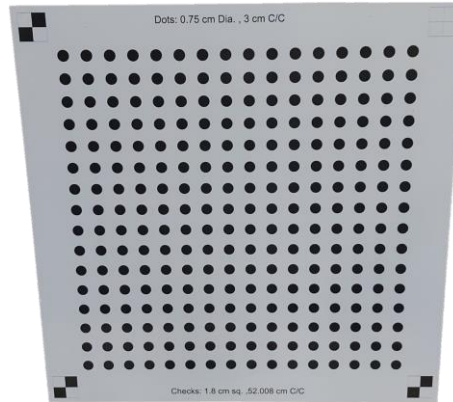
*Fig. 4 Calibration Board*

A stiff planar rectangular board was used for calibrating our cameras. The calibration board had a white matte background and black circular dots printed in a square grid array where their center-to-center distance was equal to 3 cm, as depicted in Figure 4. The calibration process requires that the calibration board be positioned in multiple orientations. For example, the board should be positioned straight such that it faces normal to the line of sight and should be positioned inclined at different inclinations such as being inclined to the left, right, down, and up. For each orientation, 9 images were acquired where the calibration board position was moved over the entire camera's field of view to have full coverage of the field of view. Once the process of capturing images was complete, a calibration procedure is performed using special software.

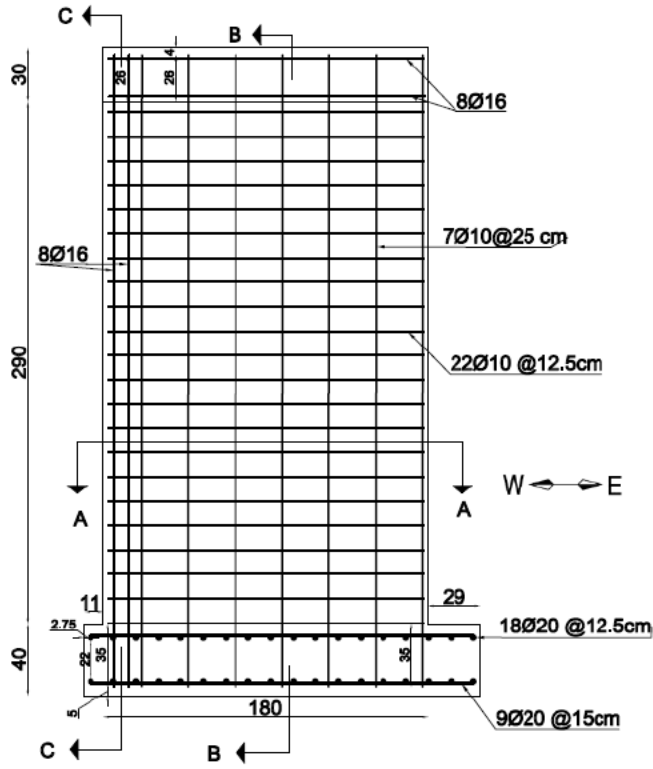
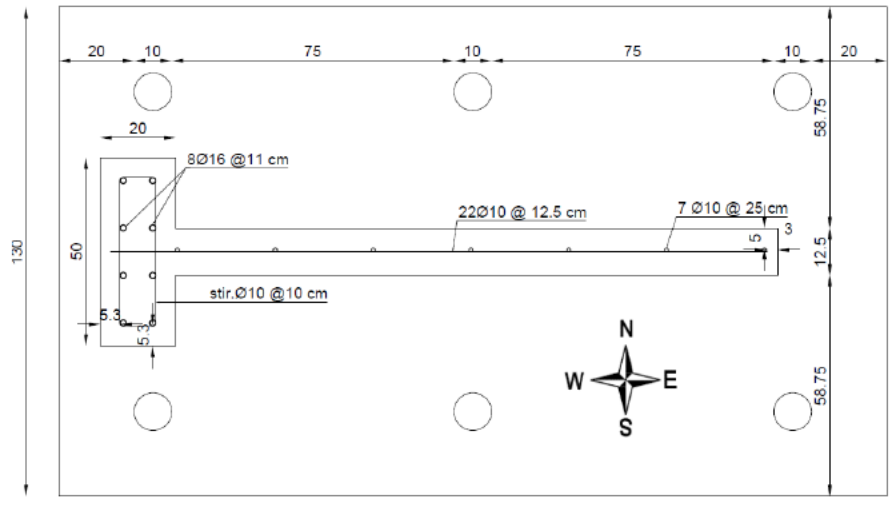
Fig. 5 Wall Specimen Dimensions and Reinforcement Details (all dimensions in mm)

The test specimens consist of two walls that represent typical shear walls of old buildings in the Beirut area, which are not designed up to building codes—specifically minimum wall thickness, minimum steel layers, minimum bar diameters, and detailing of boundary elements. The two walls have identical dimensions: The height from the top of the foundation to the top of the wall is 2900 mm, the wall thickness is 125 mm, and are wall length is 1600 mm. The walls are T-shaped, having a 200 mm thick and 500 mm long flange at the west end. The longitudinal reinforcement consisted of a single layer of seven 10 mm diameter bars spaced at 250 mm in the web, and eight 16 mm diameter bars in the flange. The transverse reinforcement consists of twenty-two 10 mm diameter bars spaced at 125 mm. The deformed steel bars used for the reinforcement of the shear wall specimens had a yield strength of 608 MPa and the concrete had a compressive strength of 20 MPa. The dimensions and detailing of the walls are shown in Fig. 5. Since the wall has only one layer of steel, the vertical bars were placed on the centerline of the section, while the horizontal ones had a 10 mm eccentricity to the right from the flange side as shown in Fig. 5 (b).

PLAN VIEW  
(a)

Section A-A  
(b)

In addition, the foundation which is 2200 mm long, 1300mm wide, and 400mm thick was connected to the strong floor through six prestressed rods. The foundation was designed for maximum rigidity to provide proper anchorage in the wall in order to avoid the reduction of energy dissipation, as indicated by Greifenhagen et al. (2005) and was heavily reinforced to represent a fixed boundary to the slender shear wall specimens and to minimize its damage when the walls are subjected to cyclic loading.

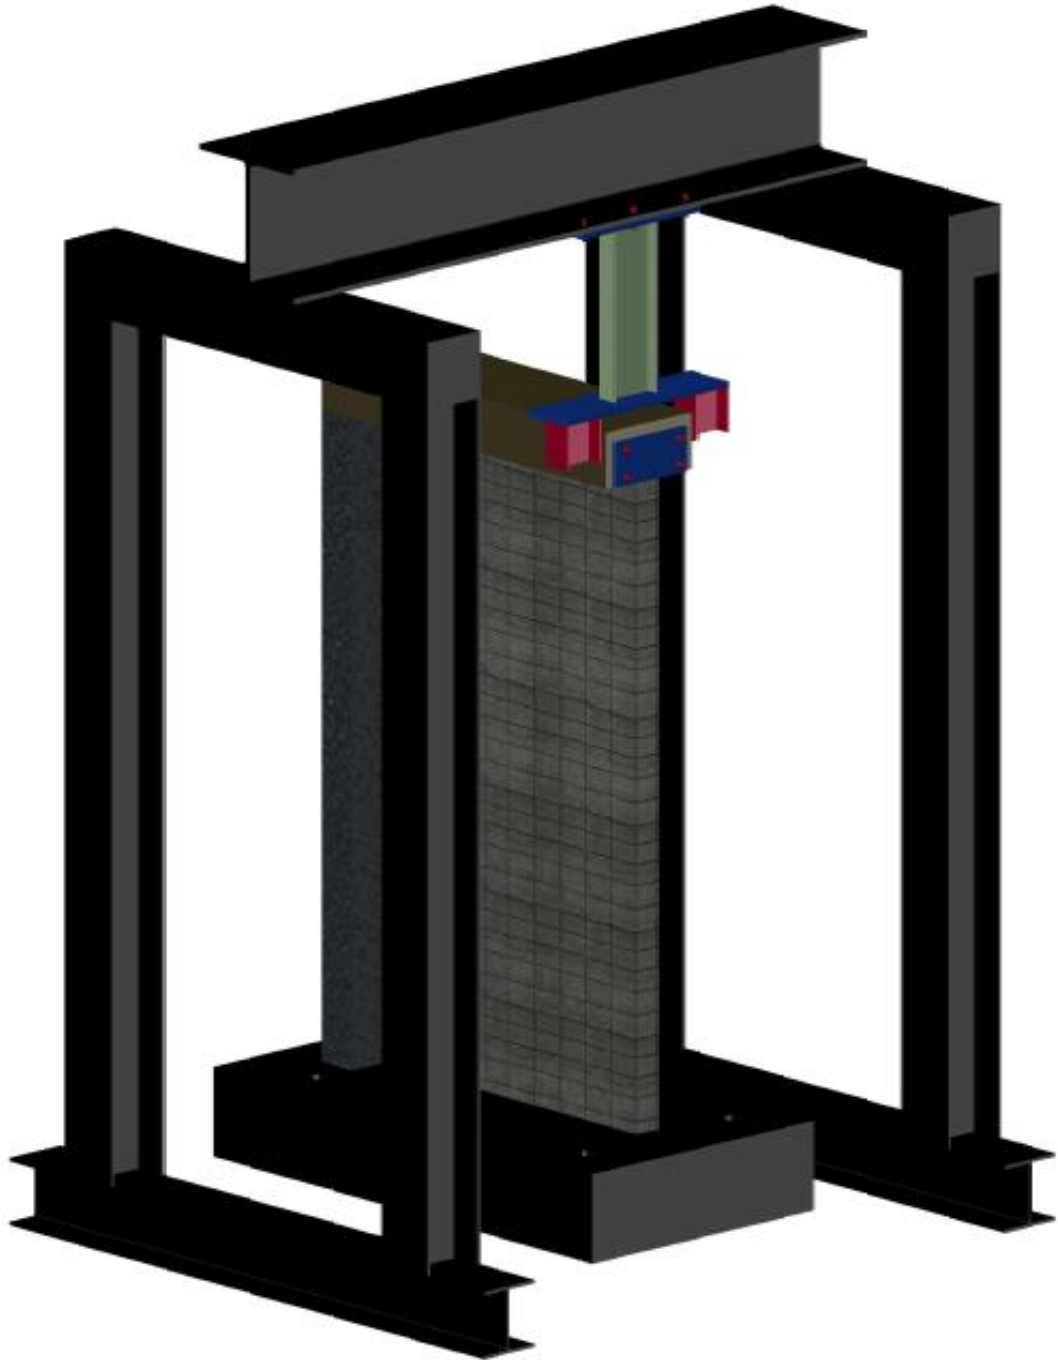
*Fig. 6 3D representation of the test setup*

The experimental testing program on reinforced concrete shear walls was carried out at the LAU ELRC structures lab. A horizontal actuator was used to subject the wall to cyclic in-plane loading. At the top of the wall a rigid 50 x 30 cm beam provides the needed integrity to the brittle wall top while testing and to ensure that the whole wall section is resisting the cyclic loads. The actuator is connected to the top beam at 3050 mm from the top of the foundation using 4 prestressed rods and two steel plates sandwiching the beam from both sides. Fig. 6 illustrates the general test setup used in the experiment.

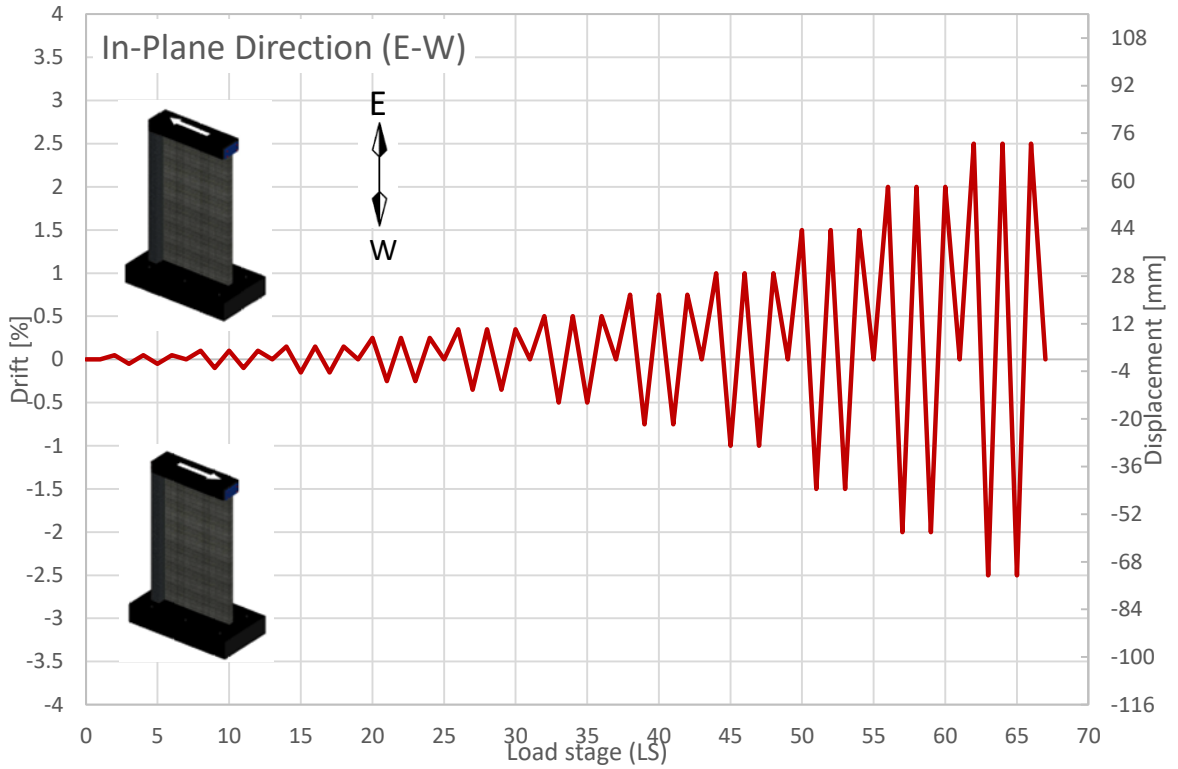
Fig. 7 Drift Protocols of the reversed cyclic load tests including load stages

The loading protocol consisted of a reversed cyclic loading, imposed by the horizontal actuator in displacement control. Two fully-reversed cycles were applied at each target drift, according to the following incremental drifts:  $\pm 0.05\%$   $\rightarrow$   $\pm 0.1\%$   $\rightarrow$   $\pm 0.15\%$   $\rightarrow$   $\pm 0.25\%$   $\rightarrow$   $\pm 0.35\%$   $\rightarrow$   $\pm 0.5\%$   $\rightarrow$   $\pm 0.75\%$   $\rightarrow$   $\pm 1\%$   $\rightarrow$   $\pm 1.5\%$   $\rightarrow$   $\pm 2\%$   $\rightarrow$   $\pm 2.5$  for the as-built wall (W). A full description of the drift protocols including load stages (LS) is represented in Fig. 7 and Fig. 8.

During the loading phases, the applied forces were recorded by load cells in the actuators, and data were collected from the strain gauges on the reinforcing bars. Out of the 31 strain gauges, 14 strain gauges, which are the 1/B, 1/C, 1/D, 1/E, 2/A, 2/B, 2/C, 2/E, 3/C, 3/D, 3/E, 4/D, 6/C, 7/B, were properly functioning in the as-built wall. The reason behind that is that the strain gauges wires were cut during the concrete pouring process, especially the gauges at the wall base. Figure 9 illustrates the location of the strain gauges on the reinforcing bars and the highlighted ones indicate the working strain gauges. The two cameras, which were connected to a data acquisition software, recorded 3-dimensional displacements of high contrast targets placed along the face of the wall to monitor in-plane and out-of-plane displacements and to trace the progression of cracking. Moreover, at the end of each drift cycle, photos of the wall were taken from eight different angles to match new observations to their respective drift value.

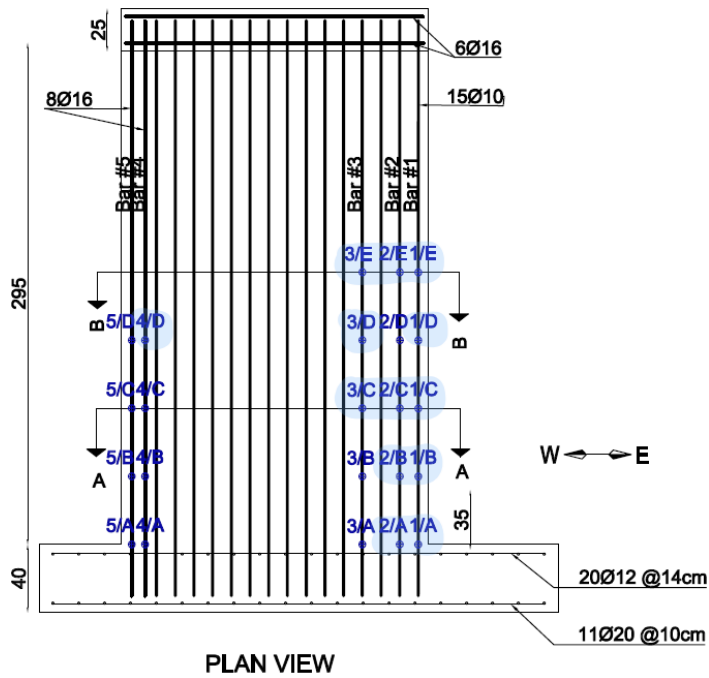
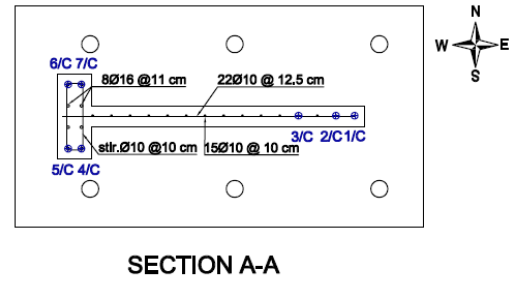
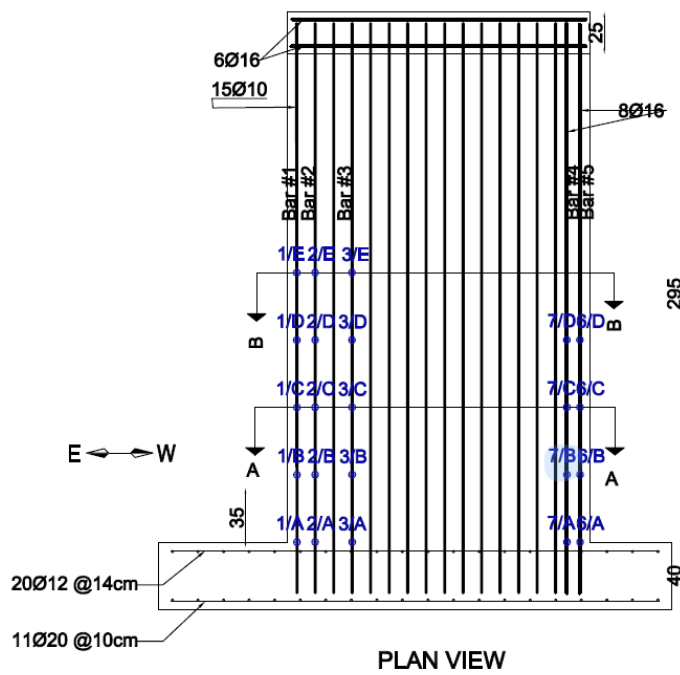
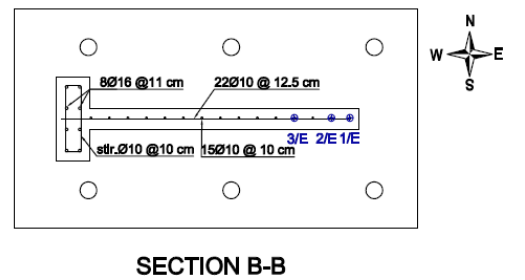
Fig. 9 Strain Gauges layout

Figure 9 shows the placement of the strain gauges on the longitudinal steel bars. **Error! Reference source not found.** through Fig. 24 show the forces versus strain plots that were recorded by the data acquisition system for the as-built wall (W).

The strain measurements obtained from the data acquisition for the strain gauges placed on longitudinal bar #1, 2, and 3, which are located in the web (see Fig. 9), are presented in (c)

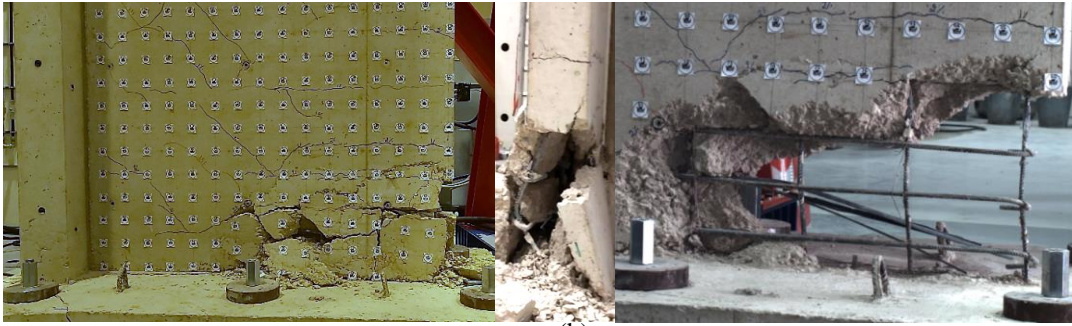
Starting with the first cycles, horizontal and diagonal cracks started forming in the as-built wall (W), and these cracks started propagating with the increase of displacement. During loading LS 50→LS 51 (in-plane drift amplitude: drift =  $\pm 1.5\%$ ), the lateral buckling of wall (W) started where it was observed the opening of the crack at the wall base along with its closure during the loading cycle LS 51→LS 52. Moreover, at the end of the in-plane drift amplitude of  $\pm 2\%$ , the crack at the base of the wall was clearly visible as well as the small chunks of concrete that were fallen down. Finally, during loading LS 63→LS 64 (in-plane drift amplitude: drift =  $\pm 2.5\%$ ), concrete crushing was observed at the free web edge of the wall. Following the progression of concrete crushing, the longitudinal rebars buckled towards the South at the web end of the wall during loading LS 65→LS 66; thus, leading to buckling failure, see Fig. 10(a) and Fig. 10(b). As shown in Fig. 10(c), the wall failure involved concrete crushing and buckling of the vertical rebars at the web edge.

(a) (b) (c)  
*Fig. 10 As-built wall (W) at the end of the test, after failure*

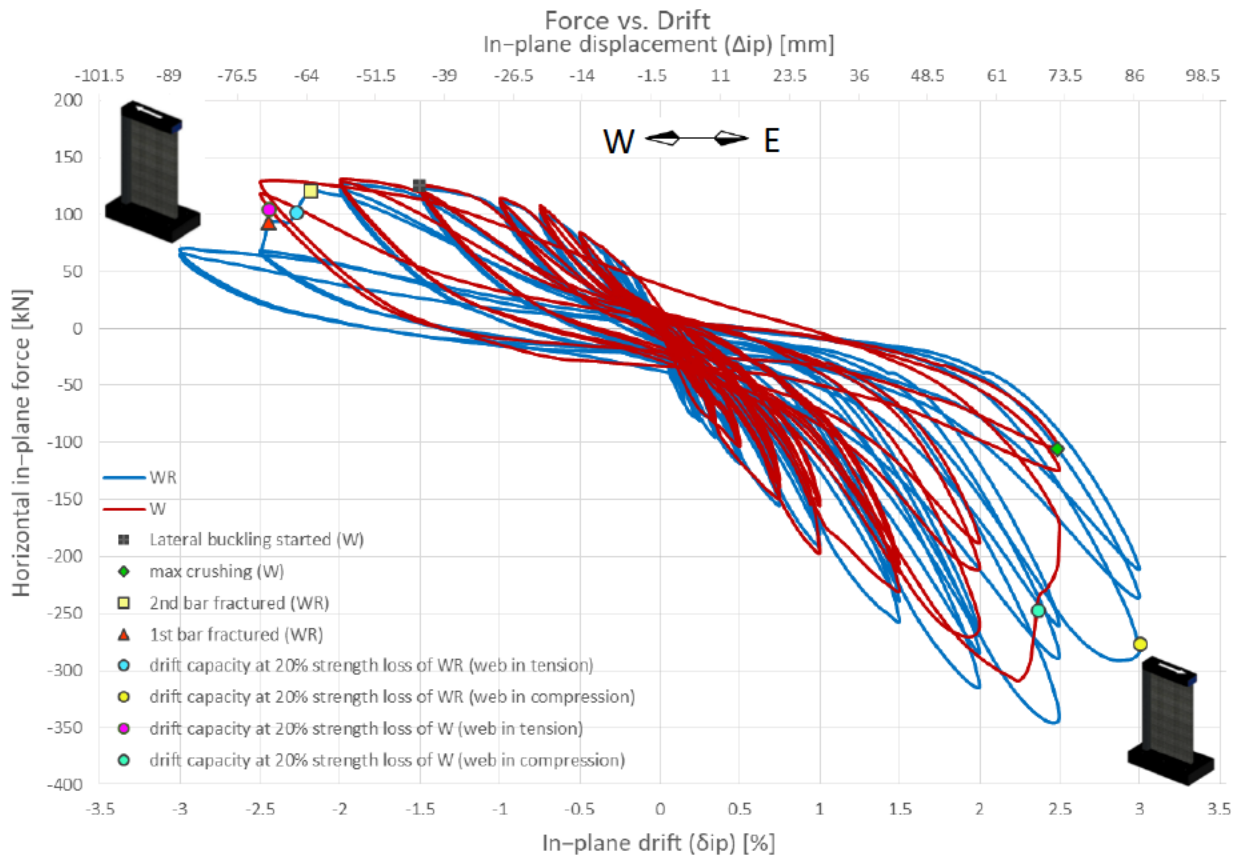
Fig. 11 In-plane force-displacement response of the as-built wall (W) and the retrofitted wall (WR)

Fig. 11 describes the in-plane force-displacement responses of the as-built wall (W) and the retrofitted wall (WR), where it was shown that the blue curve went farther than the red curve. This means that the retrofitted wall maintained its strength for a longer period before it became unstable and started losing strength. However, the retrofitted wall did not gain much of a deformation capacity increase because the longitudinal bars started fracturing early and the retrofitted wall started losing strength at 2.5% drift. As can be seen in Fig. 11, during loading the web in tension for an in-plane drift amplitude of  $\pm 2.5\%$ , it can be observed that the wall lost the first bar when the forces started dropping at  $-2.2\%$  drift. Then, when the forces dropped at around  $-2.4\%$  drift, the second bar was fractured. However, we can not define from the graph at which drift the third bar was

fractured. Maybe two bars were fractured at the same time or maybe the third bar fractured during the compression cycles.

When looking at the right side of the in-plane force-displacement response of wall W, the force capacity peaked at -308 kN during the last loading of  $\pm 2.5$  at approximately 2.25% drift between LS61 and LS 62. Then, between LS62 and LS63, wall W reached 80% of its peak strength at about 2.36%. Therefore, the drift capacity at 20% strength loss of wall W is 2.36% when the web is in compression. Then, when loading from the flange to the web (between LS63 and LS64), it was observed that the as-built wall lost its strength because of the buckling of the web region. Hence, the wall started losing strength when it started losing its compression block. Finally, maximum concrete crushing was observed between LS65 and LS66 at 2.5% drift.

When looking at the right side of the in-plane force-displacement response of wall WR, the force capacity peaked at -346 kN at about 2.5% drift. Then, during the last loading cycle of  $\pm 3$ , it can be observed the drop of 20% of the force capacity at a 3% drift between LS68 and LS69. Therefore, the drift capacity at 20% strength loss of wall WR is 3% when the web is in compression. Besides, when loading from the flange to the web, it was observed that the retrofitted wall was losing strength between LS67 and LS68. Because the web region was in compression and was still stable (did not buckle), it was concluded that the strength loss occurred when the column was in tension. In fact, an unknown factor happened on the tension side and led the wall to lose more than half its strength.

However, when looking at the left side of the in-plane force-displacement response of wall WR, the force capacity peaked at 127 kN at -2% drift. Then, during the loading cycle of  $\pm 2.5\%$  drift, wall WR reached 80% of its peak strength at about -2.27% drift between LS62 and LS63. Therefore, the drift capacity at 20% strength loss of wall WR is -2.27% when the web is in tension. This strength loss was due to the fracture of the first bar at -2.2% drift. Then, a second bar was fractured at -2.4% drift. Then, the force capacity maintained stable levels throughout the last loading cycle of  $\pm 3$ .

It can be concluded that the retrofitted wall did not gain much deformation capacity on the left side when loading from the web to the flange. In fact, wall W lost 20% of its strength at -2.45% drift while wall WR got to the same level of strength loss at -2.27%. Therefore, the drift capacity had decreased by 7% because of the fracture of three longitudinal steel bars in the web of the retrofitted wall.

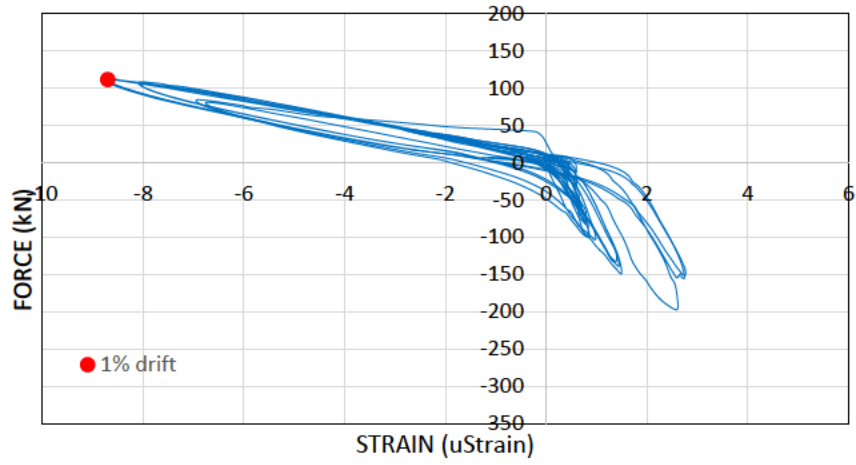
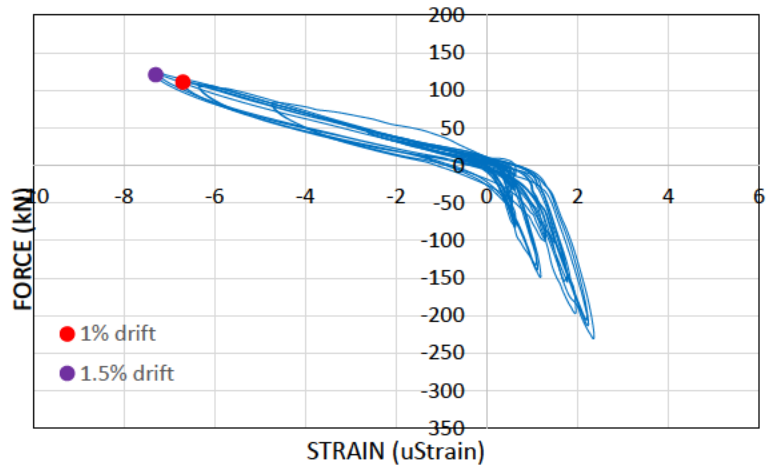
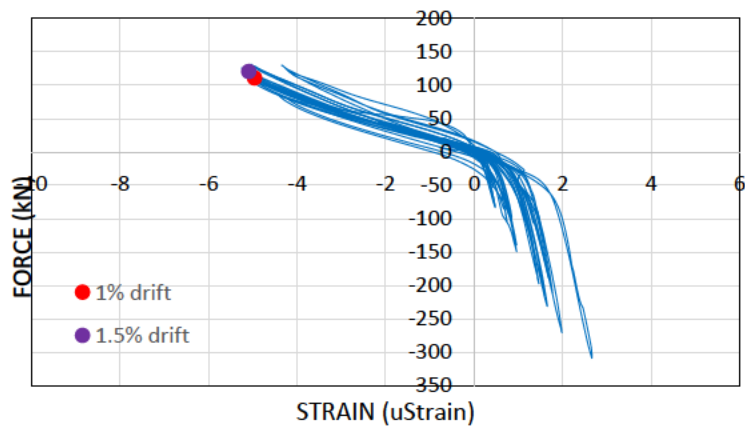
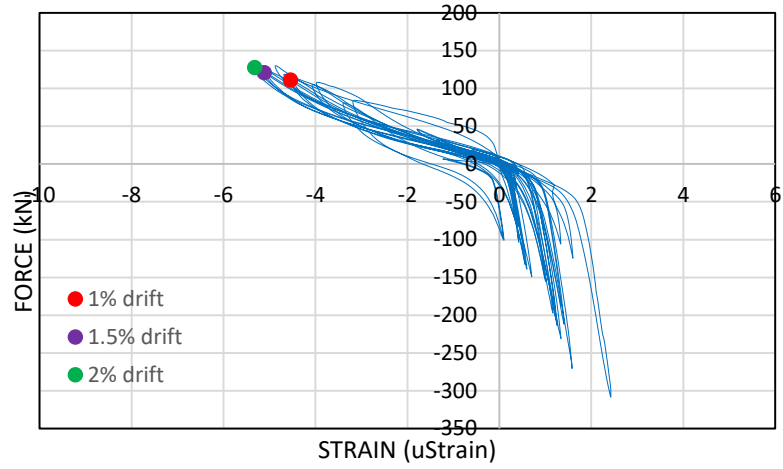
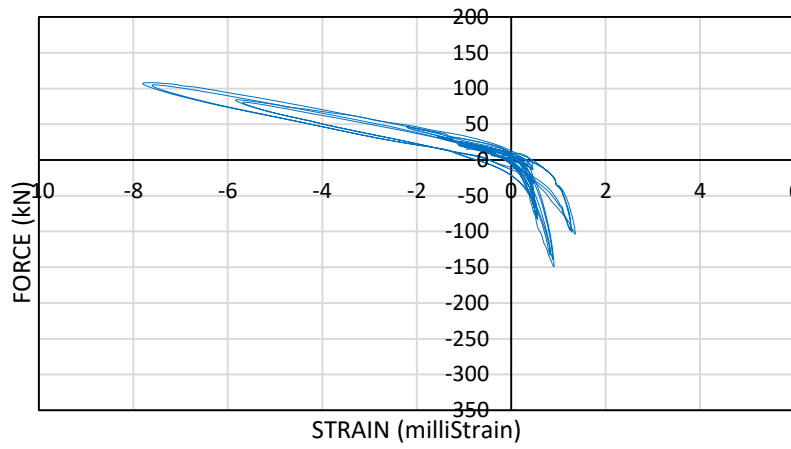
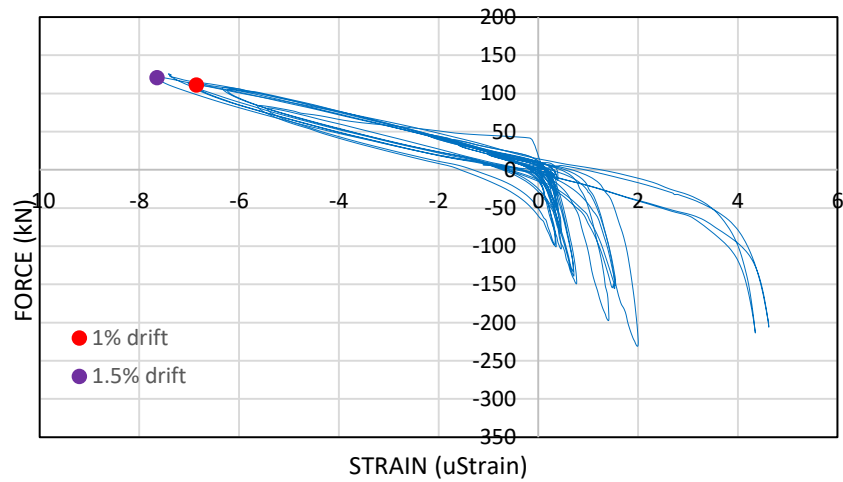
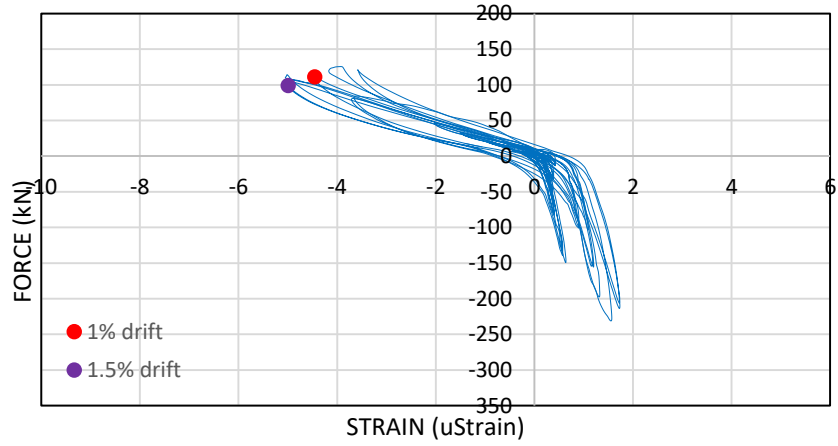
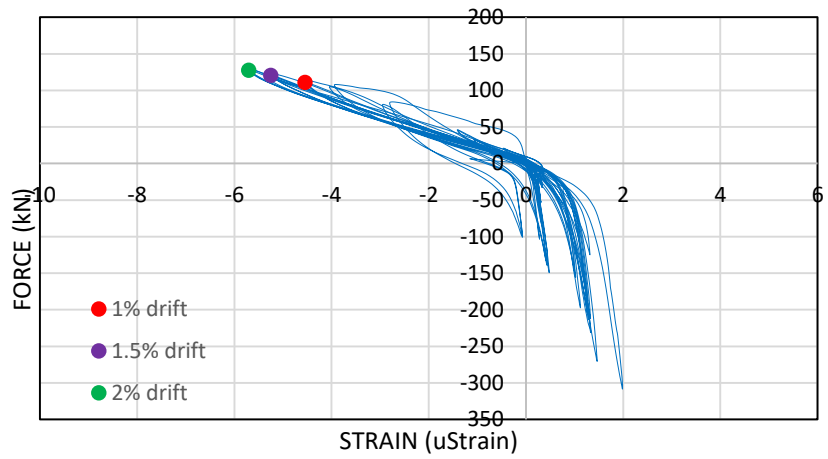
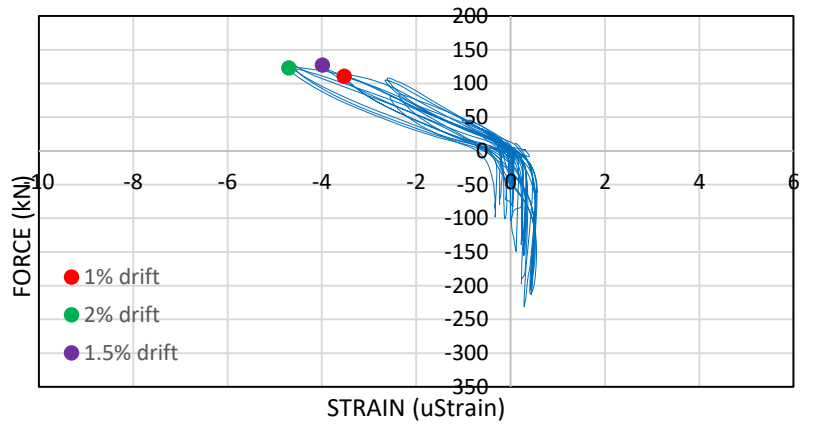
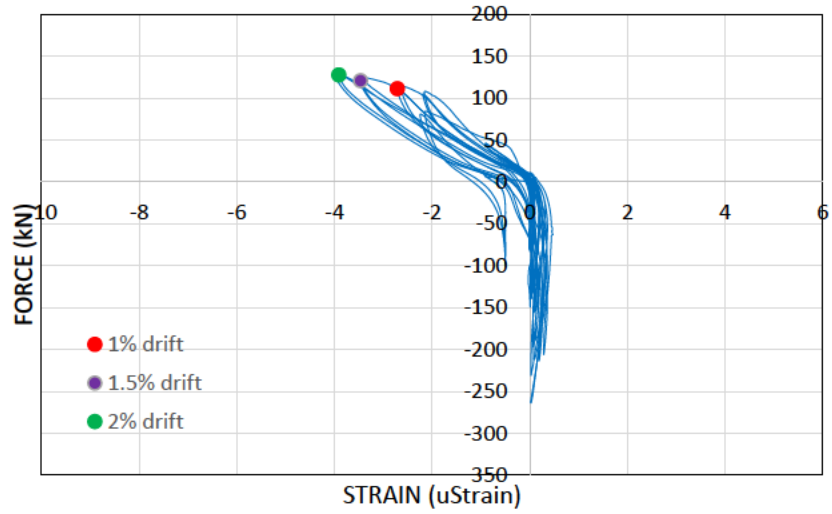
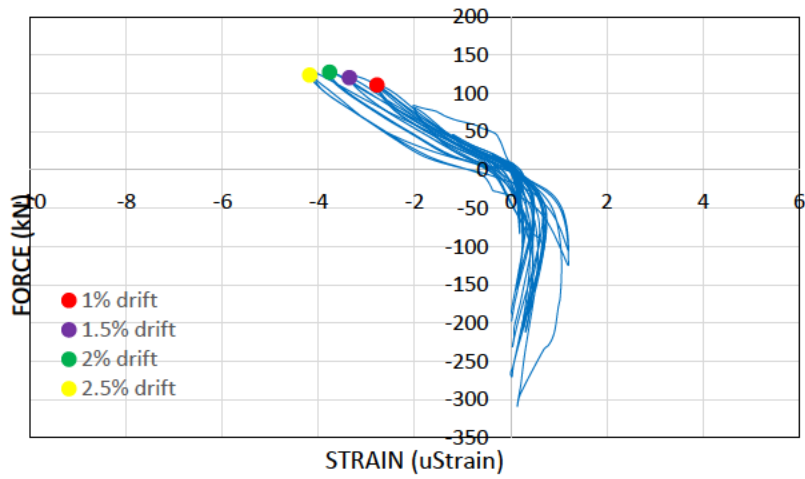
The plots of the strains located in the web of the as-built wall were illustrated in Figure 12 through Figure 22. Positive strains mean that the wall was experiencing positive displacements and the web was loaded in compression; whereas, negative strains mean that the wall was experiencing negative displacements and the web was loaded in tension. It can be concluded that the strains are higher when the web is loaded in tension than those when the web is loaded in compression. In addition, the strain values are increasing when moving toward the web end region and when moving down toward the wall base. It was also observed that the maximum tensile strain demands in the web had exceeded the yielding strain which is equal to 3 millistrain, which implies that these steel bars had yielded.

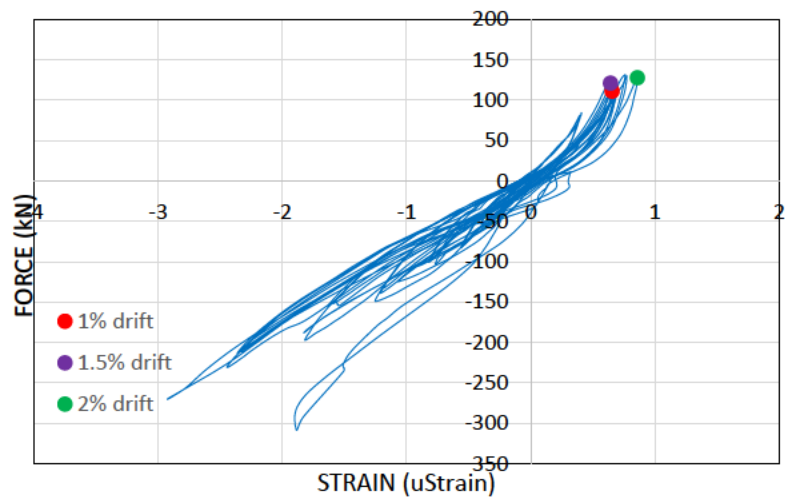
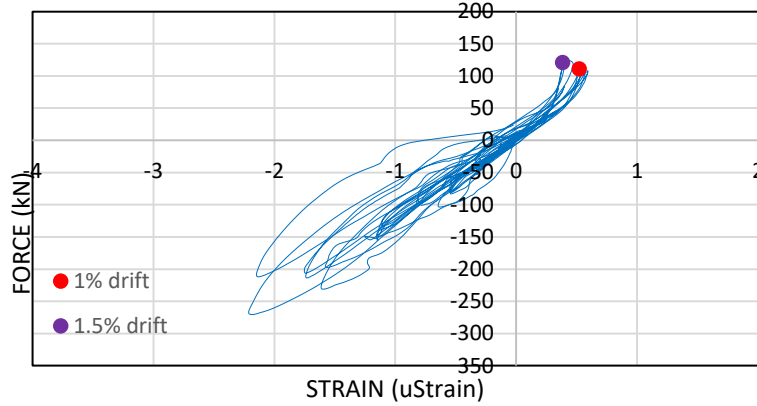
The plots of the strains located in the flange of the as-built wall were illustrated in Figure 23 and Figure 24. Negative strains mean that the wall was experiencing positive displacements where the web was loaded in compression; whereas, positive strains mean that the wall was experiencing negative displacements where the web was loaded in tension. It can be noticed that the strain values were higher in tension when the web was loaded in compression. In addition, the maximum tensile strains were lower than the yielding strain; therefore, the steel bars in the column did not yield.

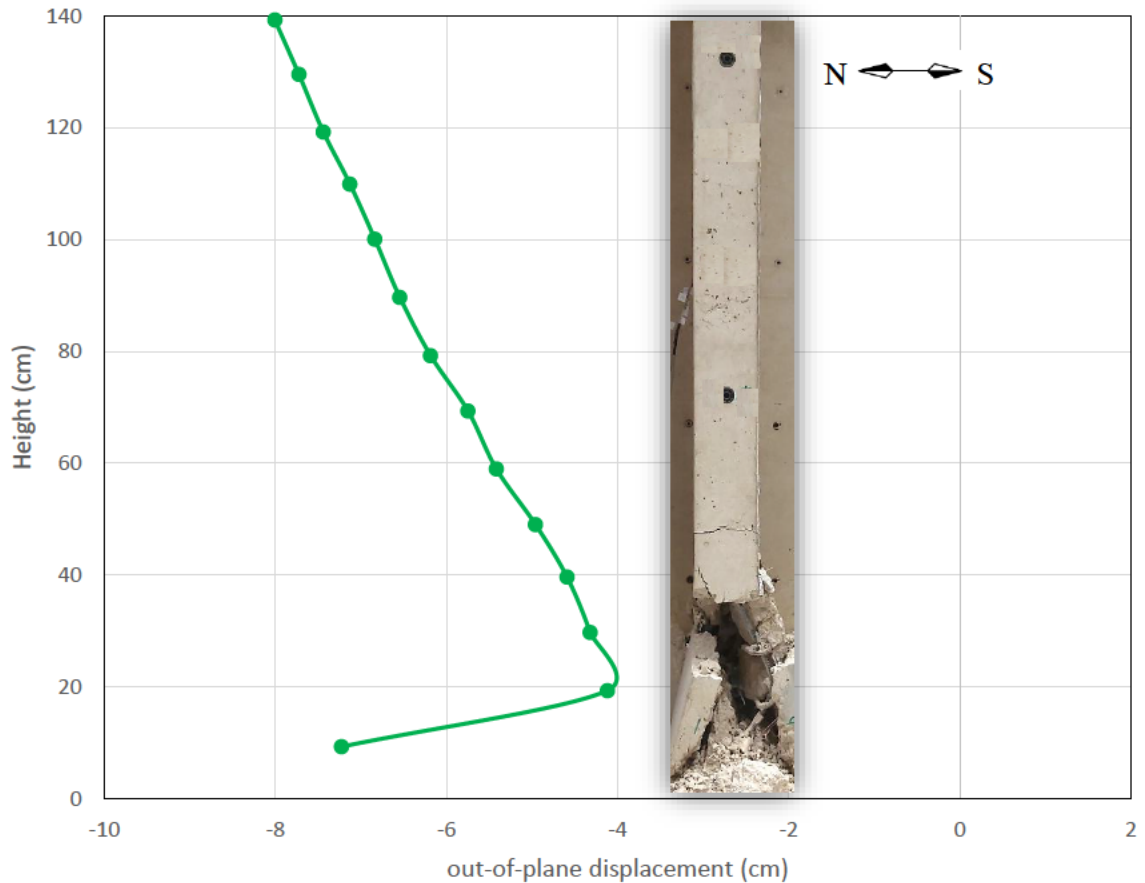
Fig. 26 Relative Out-of-plane buckling of the as-built wall (W)

Figures 26 and 27 show the relative out-of-plane buckling of the as-built wall (W) and retrofitted wall (WR), respectively. For the as-built wall, the out-of-plane buckling can be clearly shown in Figure 26 where the relative out-of-plane displacement was 3 cm toward the South over a height of 20 cm. The large out-of-plane displacement shown in the web edge occurred due to the buckling of the longitudinal steel bars at the wall base that caused the crushing of the concrete cover of the wall. Therefore, the as-built wall had a flexure buckling failure mode when loaded under cyclic lateral loads.

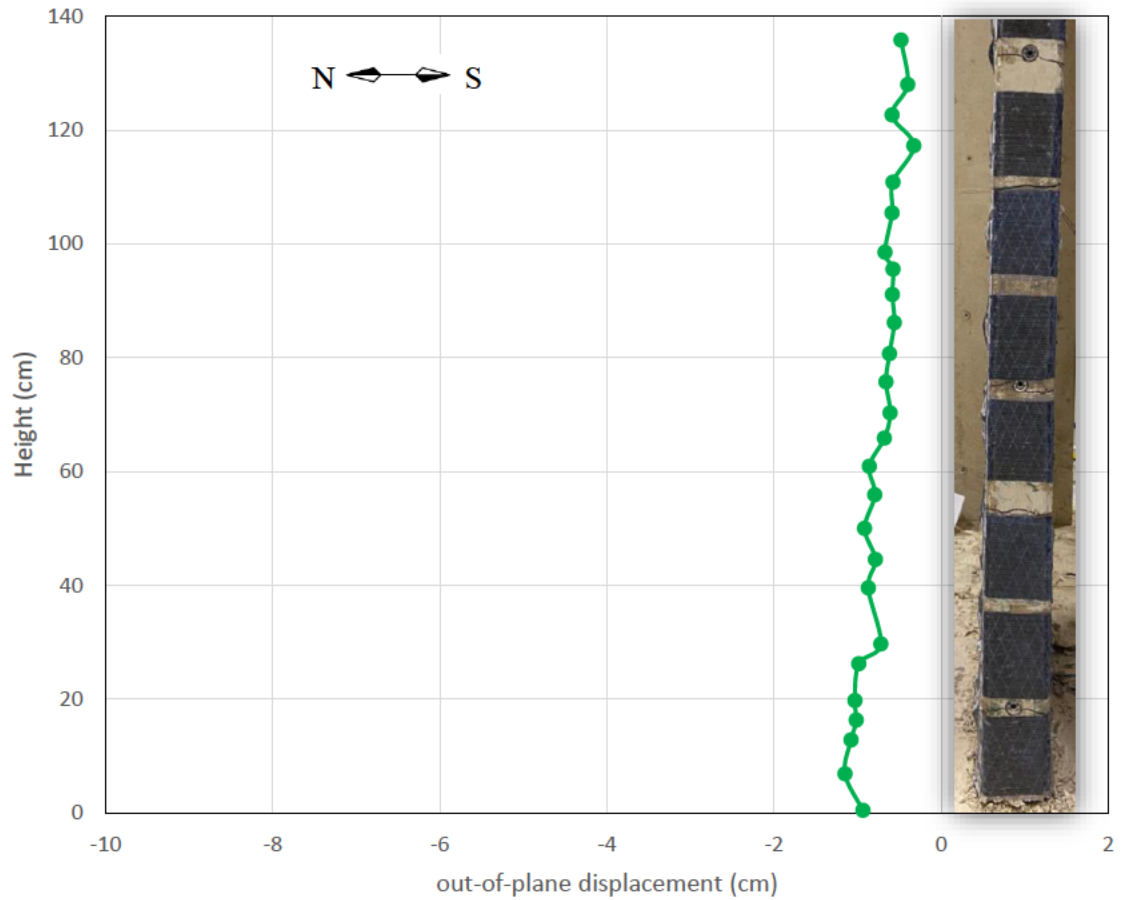
*Fig. 27 Relative Out-of-plane buckling of the retrofitted wall (WR)*

As shown in Figure 27, no out-of-plane buckling was present at the base of the retrofitted wall. It can therefore be concluded that when retrofitting the wall using carbon fiber-reinforced polymers sheets, the flexural behavior of the wall is enhanced. In fact, the lateral buckling was improved and the out-of-plane movements were reduced substantially. This happened because the CFRP laminates provided confinement, preserved the concrete at the web edge, and prevented the concrete from crushing under lateral cyclic loading.

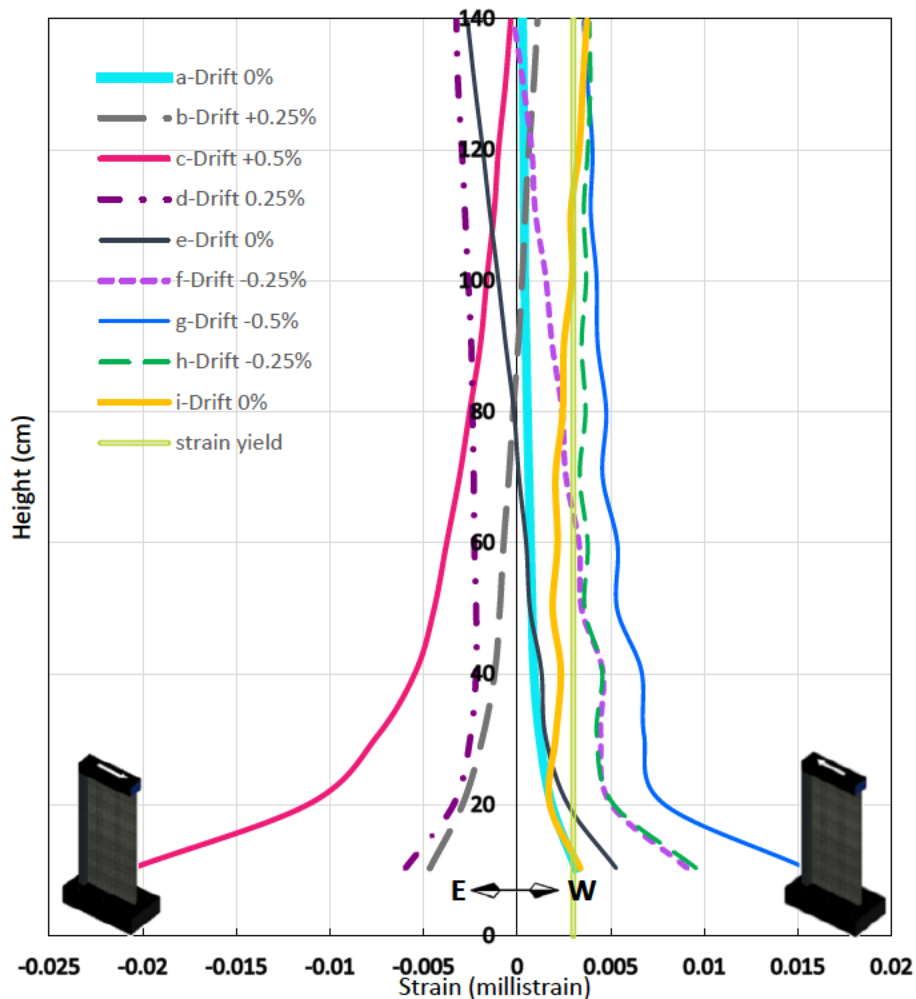
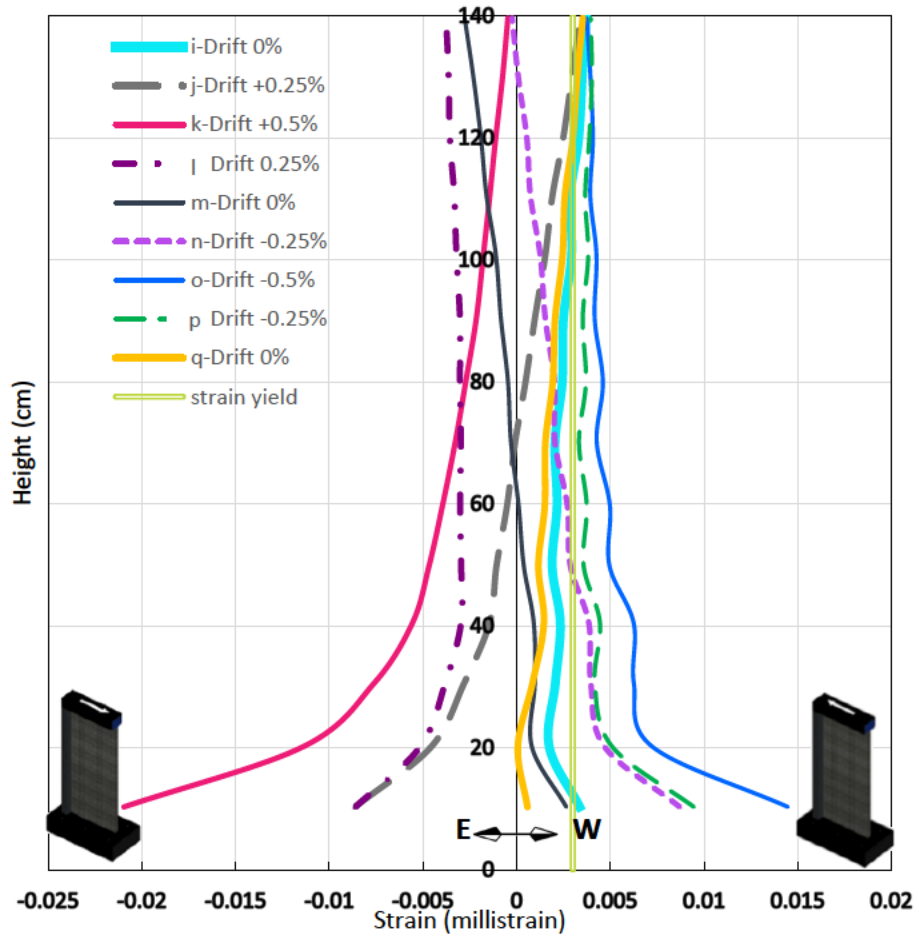
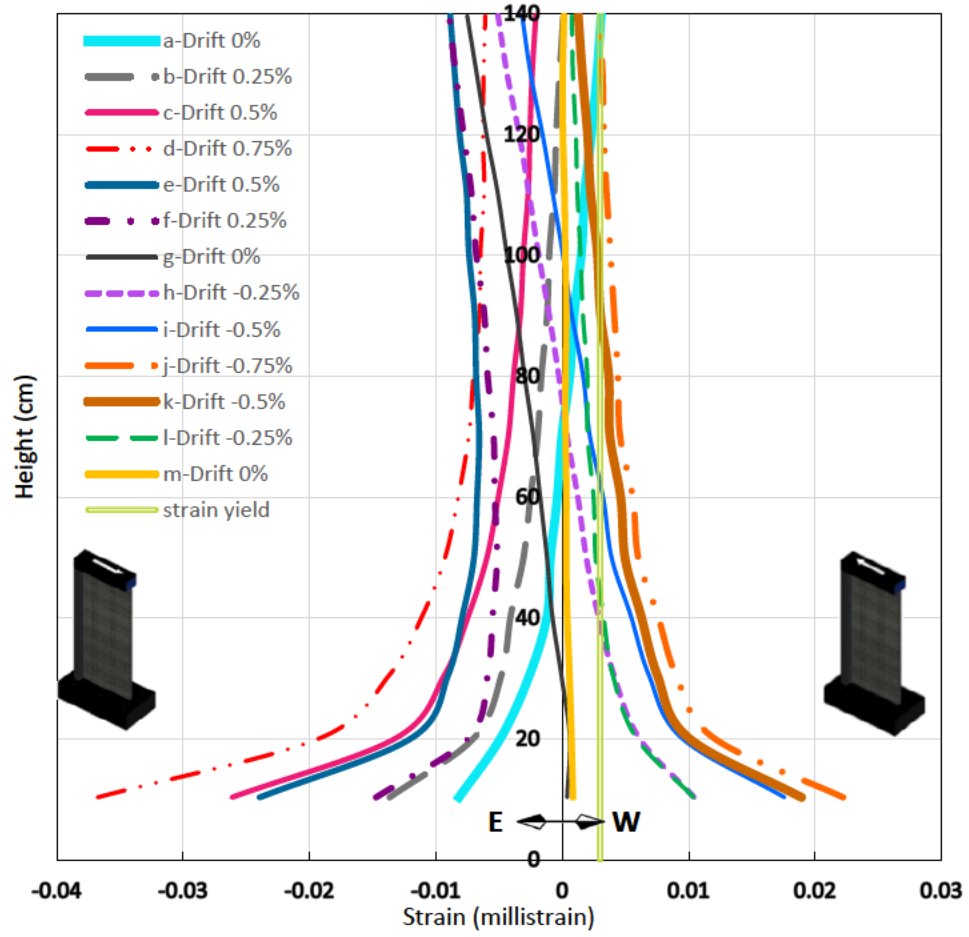
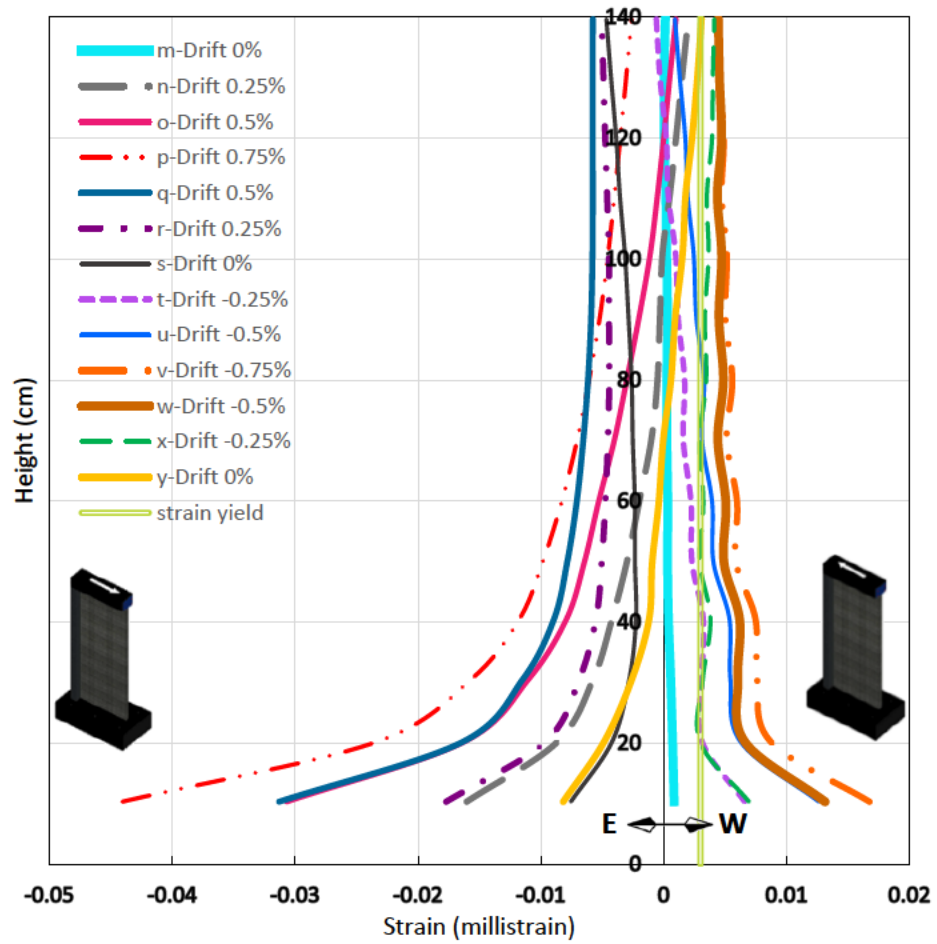
Figure 28 and Figure 29 show the height versus strain of the first and second cycles of the 0.5% drift, respectively. Figure 30 and Figure 31 show the height versus strain of the first and second cycles of the 0.75% drift, respectively. The strains are calculated using the data computed from the cameras to show the wall from the camera's perspective. As illustrated in Figure 32, the strains are calculated between the targets located at the end of the wall; thus, a reading was computed between the targets every 10 cm.

Positive drift implies that the wall was moving towards the East where the web was in compression. Whereas, negative drift implies that the wall was moving towards the West when the web was in tension. It can be concluded that the plasticity spread is going very high. The strain yield, which is equal to 3 millistrain, was reached over a height of 140 cm in the 0.5% drift and 0.75% drift.

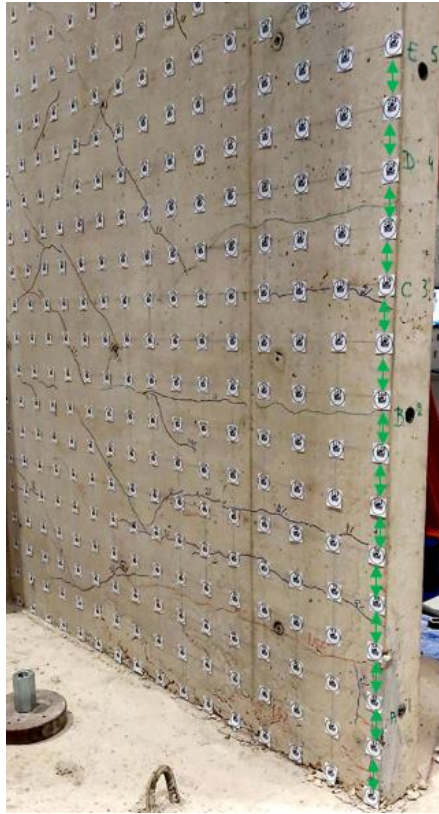
*Fig. 32 Strain readings between targets at the web edge*
