THE KFARNABRAKH LANDSLIDE OF NOVEMBER 30TH, 2015: A Geological and Geotechnical Evaluation of the Landslide and Risk of Future Failures

**THE KFARNABRAKH LANDSLIDE OF NOVEMBER 30TH, 2015:
*A Geological and Geotechnical Evaluation of the Landslide
and Risk of Future Failures***

Report of the NSF Sponsored GEER Association Team

GEER Association Report No. GEER-047

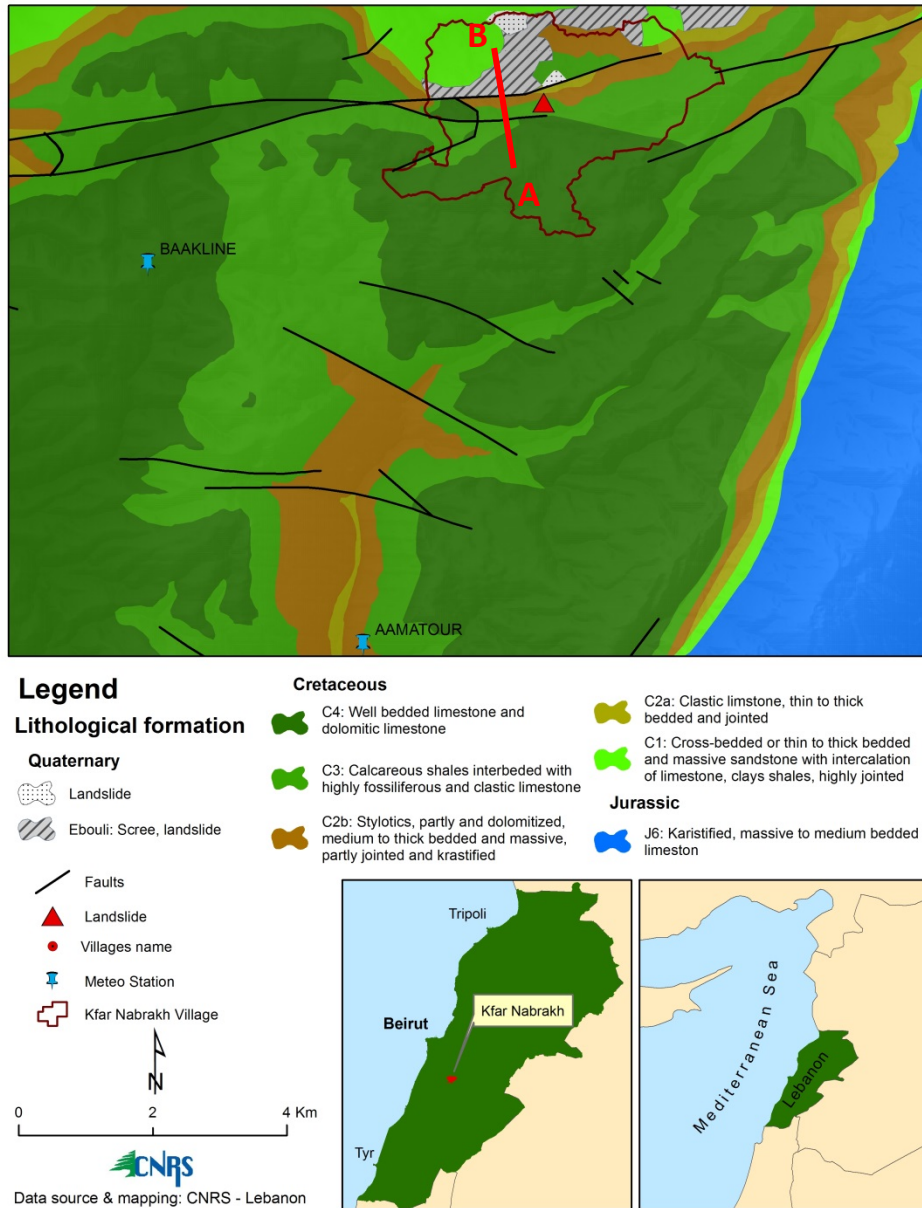
Figure 6: Geologic Map of the Kfar Nabrah area.

flow. It is worth mentioning here that several small faults exist in the area (see Figure 6 in the following section), although most of these are not active.

The Kfarnabrakh area consists mainly of pseudo-tabular lower Cretaceous rocks. These are incised by the westward flowing Safa River. An entire stratigraphic sequence can be observed on the northern flank of this drainage facing Kfarnabrakh as shown in Figure 6. A cross-section of the formations near the failure area along line AB is presented in Figure 7. The stratigraphy is superimposed over the cliff surface image in Figure 8 to show the alignment of the different strata with the outcrop.

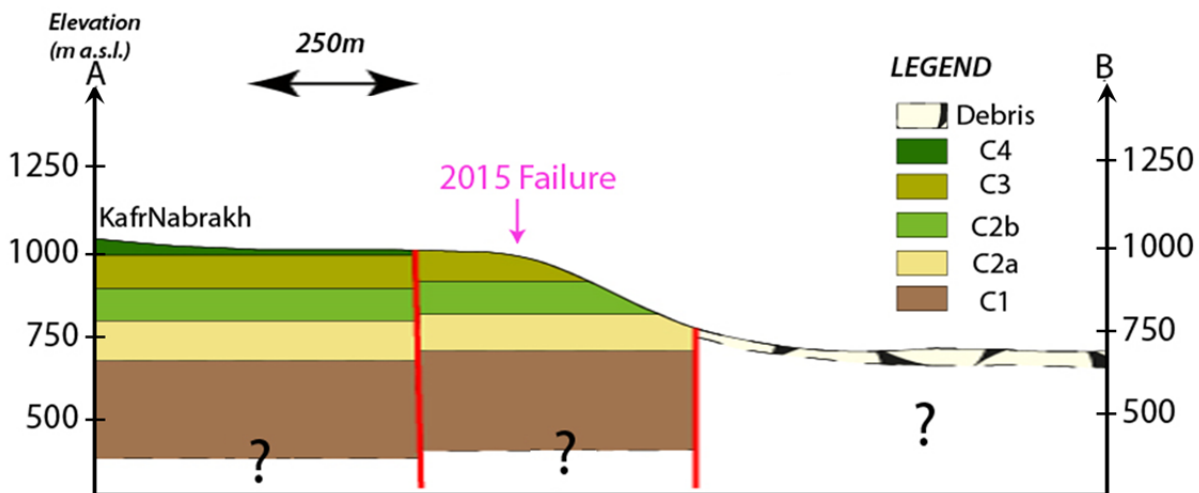
Figure 7: Geologic cross section along line AB from Figure 6

The C3, also known as the Hammana Formation, consists of an approximately 120m of thin-bedded, marly limestone and shales, upgrading into moderately thick-bedded limestone, interbedded with marl The rocks composing this formation are usually highly friable and poor conductors of water. This reflects their low shear strength and low permeability. **The 2015 failure zone is stratigraphically located in the mid C3 formation as indicated on Figures 7 and 8 below.**

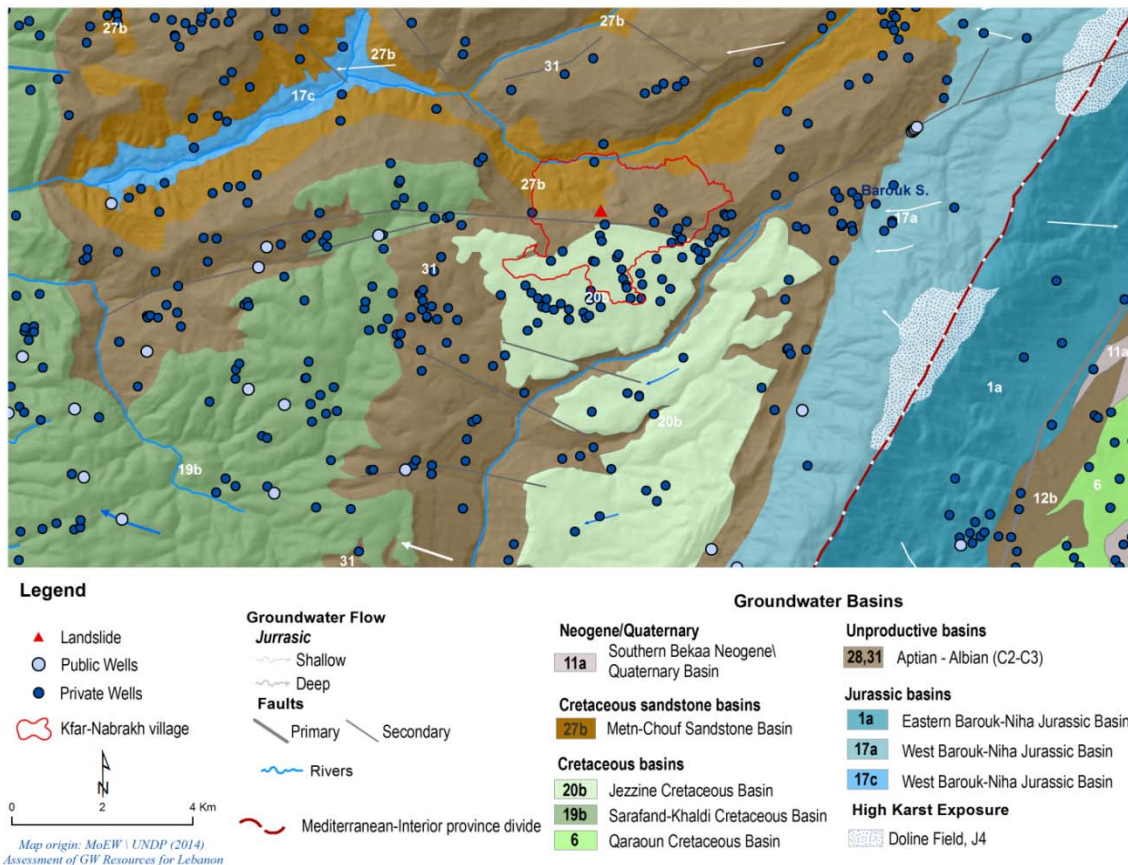
Figure 9: Hydrogeologic map of the surrounding region

Figure 9 shows the local hydrogeology with the different basins and surface flow channels. The location of the landslide (presented by the red triangle on the map) indicates that the cliffs fall in the Aptian-Albian (C2-C3) unproductive basins. However, there is the Jezzine Cretaceous Basin on the southeast side and Metn-Chouf Sandstone basin on the north east of it. These 2 basins can provide a water source for flow through the highly jointed C2 formation in which the failure has occurred. This scenario explains the presence of water springs at the top and bottom of the cliff, even though it falls in a non-productive formation. It also explains the high density of wells in the area.

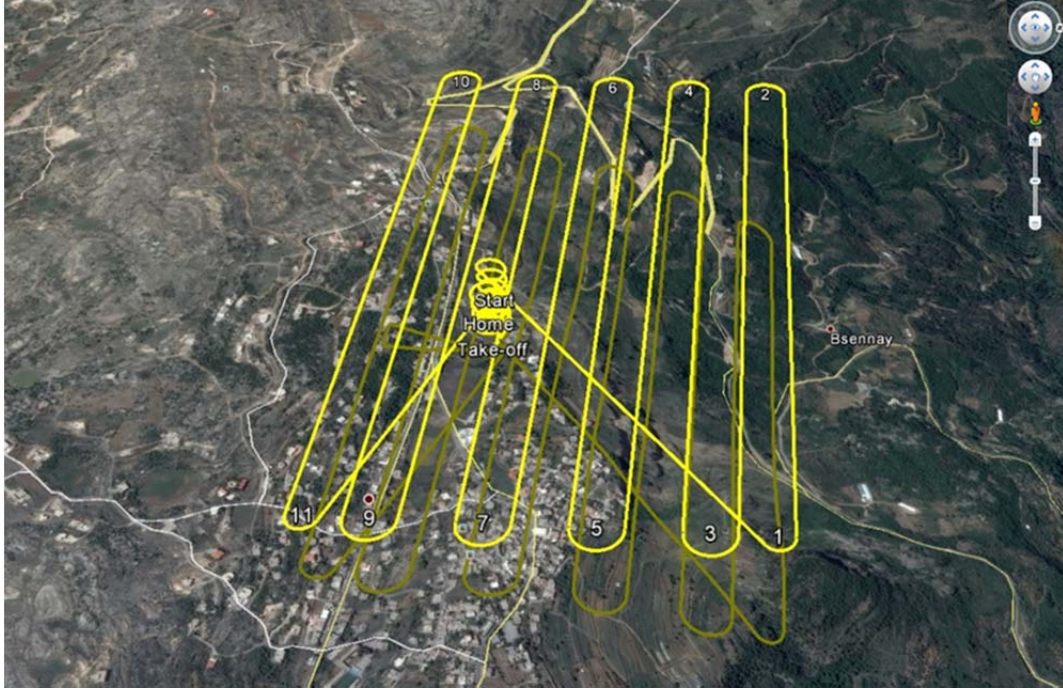
Figure 10: Drone Flight path (From Google Earth Pro)

The surveying flight for Kfarnabrakh was carried out on the 25th of December 2015. The area of the slide and its surrounding was recorded in 11 East–West strips (Figure 9). A GoPro camera with a focal length of 30 mm was used and the total surface area covered was around 0.652 km² (65.2 Hectare). This surface area was covered by 363 aerial photographs with a long-track

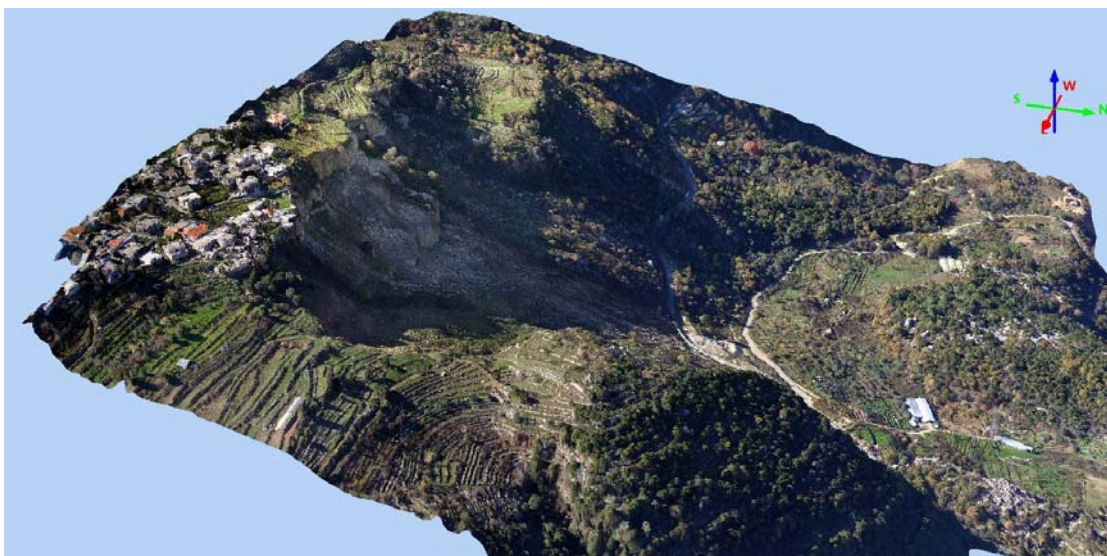
Figure 11: Point cloud 3D representation for Kfarnabrakh landslides

Finally, in order to benefit from the 3D stereo capability of the aerial photo acquisition, both the orthorectified blocks of the image and the produced DSM were synchronized into the same extent and resolution so that they can be combined into 4 raster bands R, G, B, Z. The results are shown below in Figure 11.

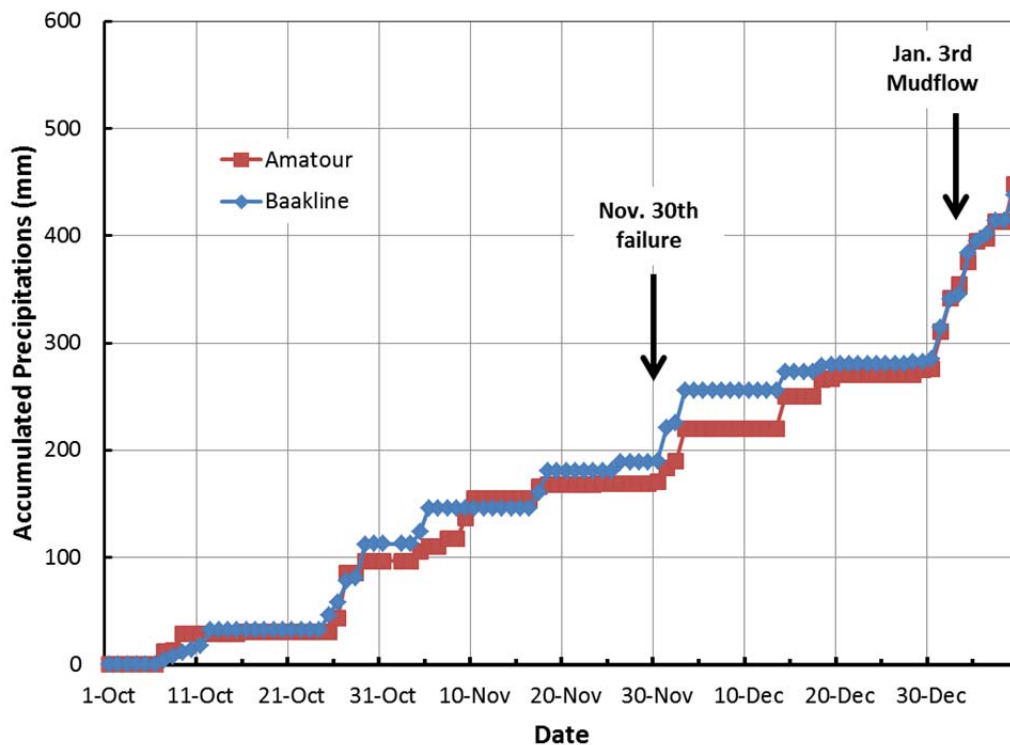
Figure 12: Rainfall data starting one month prior to the landslide

Rainfall data were collected from two stations located closest to Kfarnabrakh. The Amatour station is located 5.6 km south of Kfarnabrakh and about 160m lower in elevation above sea level; the Baakline station is about 6 km south west of Kfarnabrakh and 175m lower in elevation. The location of the 2 stations relative to the area of the failure is included in Figure 6. Figure 12 shows the accumulation of rainfall starting October 1st, 2015 through January 9th, 2016. The rainfall data was collected every 2 hours at both stations. The records confirm the local residents' recollection that there was no major rainfall in the days leading to the landslide on November 30th. The records also show over 110mm of precipitation in the 3 days leading to the January 3rd, 2016 debris flow that lead to overtopping of the protection wall and complete closure of the road at the toe of the cliff.
